# Loss of control and near collision with terrain involving Leonardo Helicopters AW139, VH-TJH

Near Katoomba, New South Wales on 26 March 2021

**ATSB Transport Safety Report**

AO-2021-018

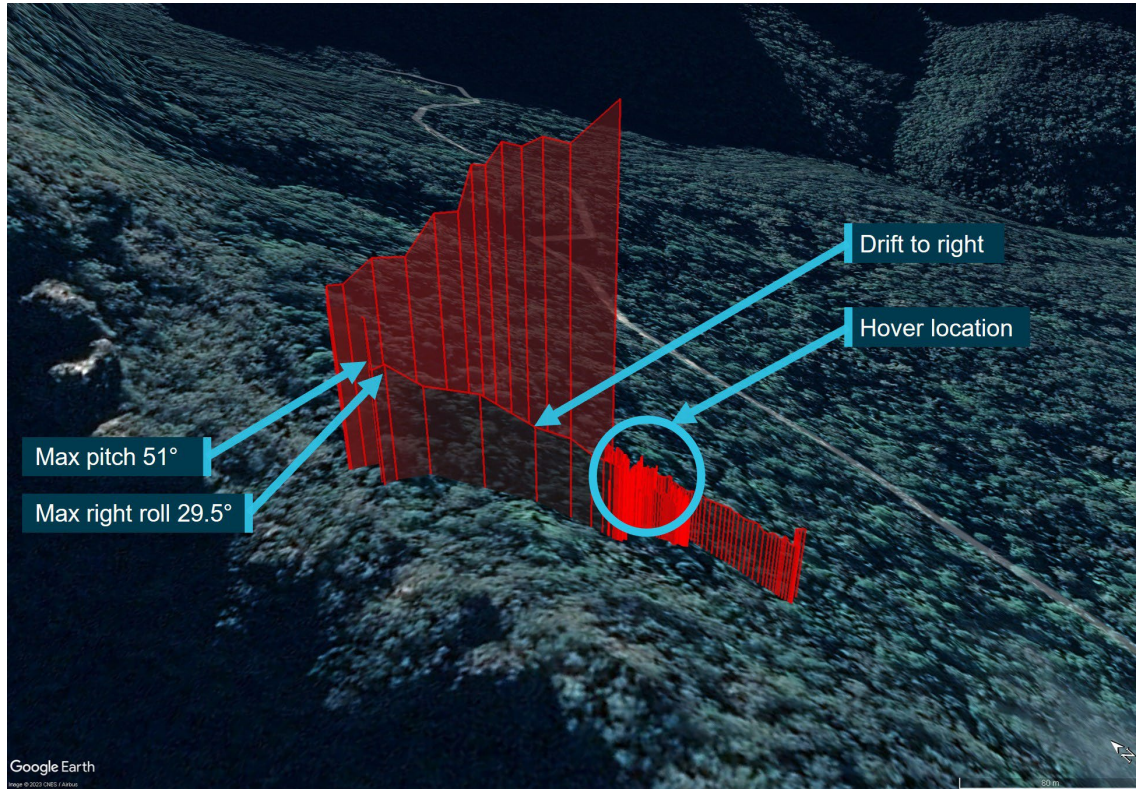
**Figure 5: Flight data for VH-TJH showing the hover, drift and recovery.**

Once established in the winch position, and after a final scan for obstacles, the ACO started winching the paramedic down. With about 12 ft of cable payed out, the paramedic's head was just past the level of the flight step, underneath the rear sliding door. At this point, during one of their scans while checking the engine torque, the pilot detected movement of the helicopter and looked up. About the same time, the ACO also noticed the aircraft had moved out of position and called to the pilot 'you're drifting right, you're drifting right', 'hold', 'hold'. Despite this command, the helicopter continued moving to the right and forwards towards rising terrain. The ACO then called 'You're going to crash, you're going to crash, move back and up', and a 'bank angle' warning sounded.

The pilot recovered control of the aircraft and climbed away from the cliff as the paramedic held onto the flight step. During the recovery, an over-torque warning illuminated. A subsequent review of recorded flight data (Figure 5) identified that during the initial drift out of position the aircraft was banked right up to approximately 30° and during the recovery manoeuvre it was pitched nose-up to about 51°.
