Collision with terrain involving Robinson Helicopter Company R22 Beta, VH-LOS

36 km south of Ramingining, Northern Territory, on 14 November 2022

ATSB Transport Safety Report

AO-2022-057

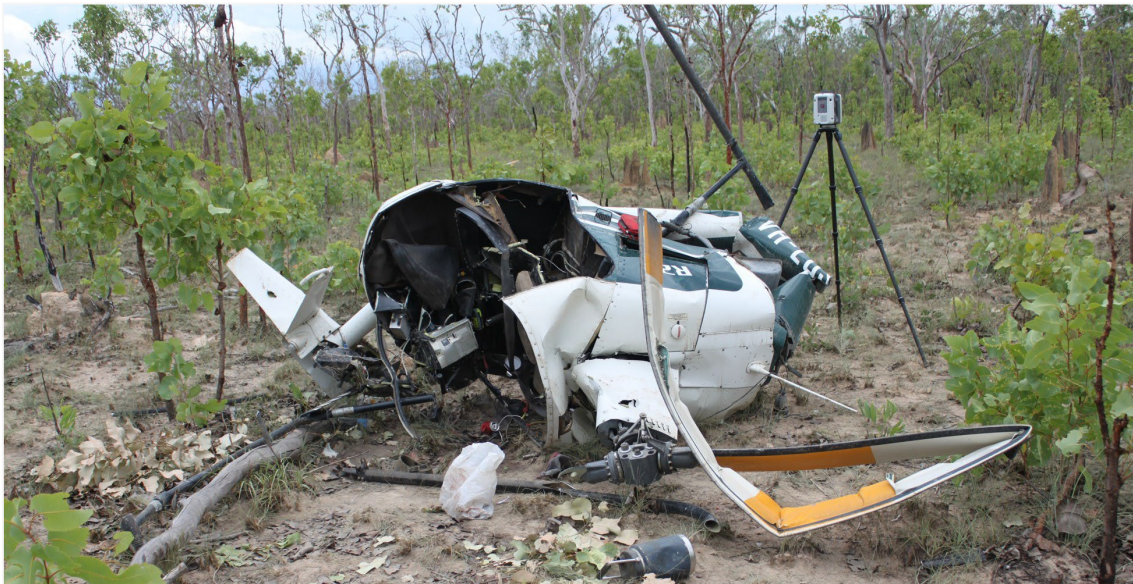
Figure 3: VH-LOS wreckage

The helicopter was found on its left side, with significant compression of the nose and underside of the forward left section of the fuselage (Figure 3). The compression damage indicated that the helicopter collided with terrain at about 45° nose-down, and 30° left side low. There was a short wreckage trail extending about 13 m, with all helicopter parts present at the accident site and no evidence of an in-flight break-up.

Indentations on the terrain nearby indicated a main impact point about 6 m aft and 4 m right of where the helicopter was found. Anthills forward of the main impact point showed damage consistent with having been struck by the rotor blades, and both rotor blades presented with evidence of ground strikes. One main rotor blade was liberated as the result of a ground strike,

and was found about 30 m to the right of the wreckage trail. The cockpit windscreen had shattered and remnants were scattered around the accident site along with the contents of the aircraft.

The tail cone and tail rotor assembly remained connected to the fuselage, however presented as deflected down and curled under the helicopter. Site examination showed that both of the bladder-type fuel tanks remained intact and contained fuel. Examination of the helicopter's flight control system and drive train did not indicate any pre-existing defects that could have affected the control or function of the helicopter. Damage signatures to engine rotating components indicated that the engine was operating at the time of the collision with terrain.

The significant nose-down and left-side down attitude of the aircraft wreckage, and the short wreckage trail, were consistent with the pilot flying at slow speed and developing an unusual aircraft attitude in the moments prior to collision. The wreckage, being only 6 km from the last known position of the helicopter, indicates that the disorientation and collision occurred soon after the commencement of the flight in dark night conditions.

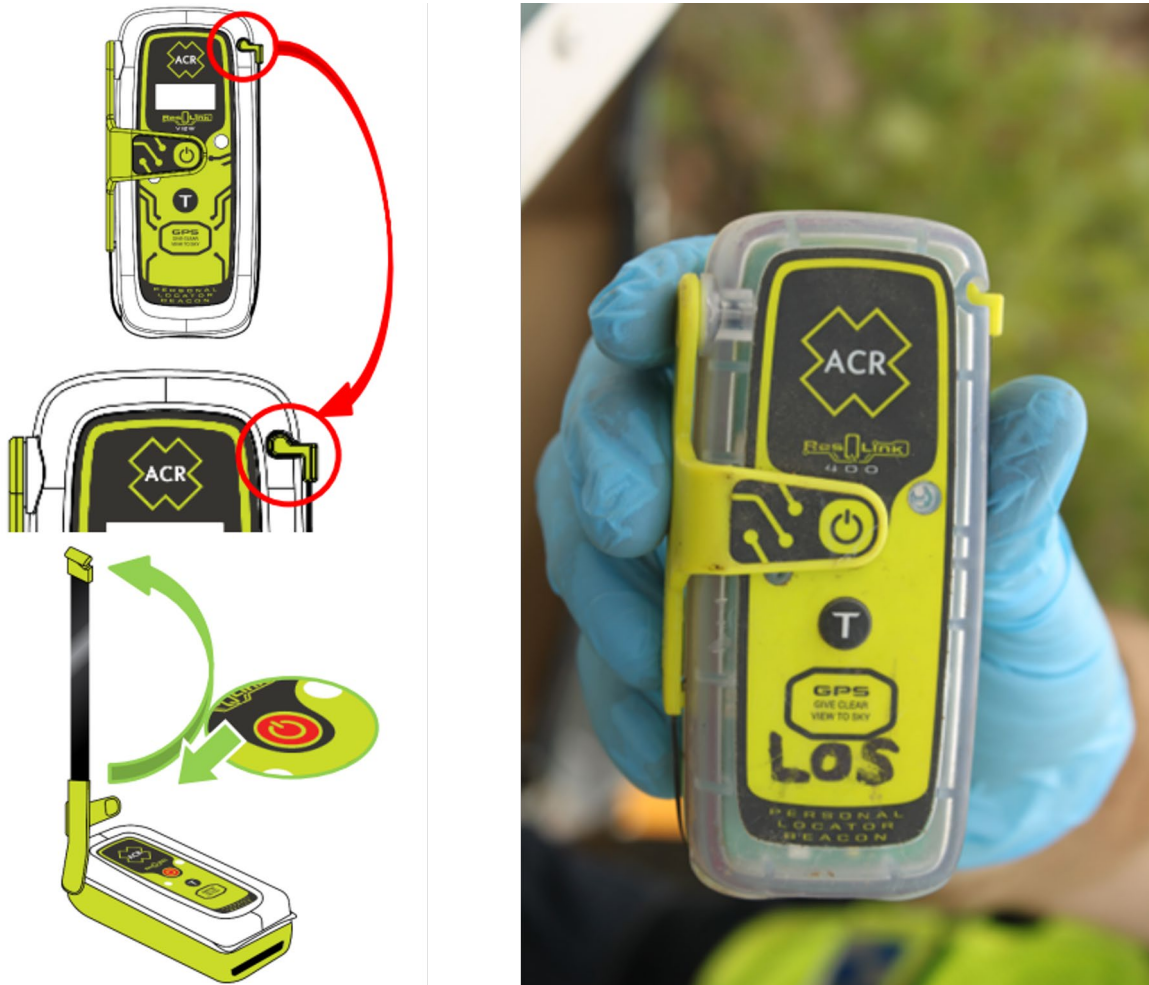
The ATSB observed that the PLB remained inside the helicopter post-accident, and was attached to the helicopter’s centre console. There was no apparent damage to the unit, and the battery was in-date. The antenna was in the folded-down position with the on/off button covered. There was not evidence that the pilot had attempted to operate the PLB after the accident.

Figure 4: ResQLink activation instructions (left) and condition in-situ at VH-LOS accident site (right). The image on the right shows the antenna and power button guard remained in the down position

When the helicopter collided with terrain, conditions were dark and the pilot may not have been able to locate the PLB. Once outside the helicopter, in poor visibility and with limited mobility (due to the significant leg injury), the location of the PLB inside the helicopter was effectively inaccessible to the pilot. This highlights the advantage of carrying a PLB on the person of pilots, particularly in one-person operations.
