Tail rotor blade strike involving Leonardo Helicopters AW139, VH-TJK

Cabbage Tree Bay, New South Wales on 30 May 2021

Aviation Occurrence Investigation (Short)

AO-2021-022

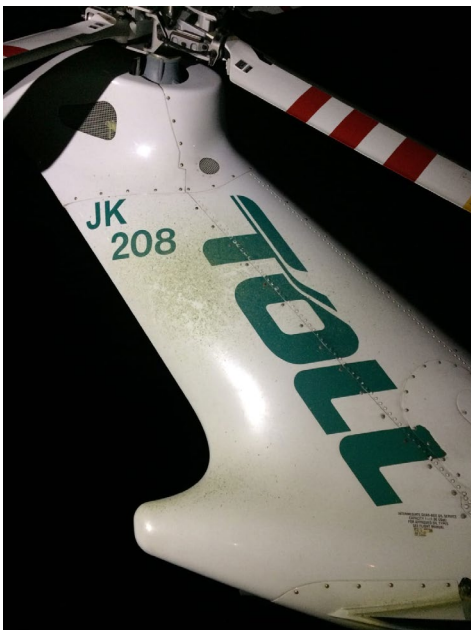
Figure 4: Evidence of foliage contact on the vertical fin

During the later stages of the approach into an unimproved helicopter landing site, the aircraft's tail rotor struck a small tree. The contact was not identified by the crew. Having assessed the landing site as unsuitable, the crew discontinued the approach and diverted to a landing site about 1 km away. After shutting down, the flight crew conducted a walkaround inspection of the helicopter and identified evidence of foliage contact on the vertical fin.

After shutting down, the ACO and pilot conducted a walkaround inspection of the helicopter using hand-held torches. While inspecting the vertical fin, green material indicating contact with foliage was identified (Figure 4). The pilot then briefed the medical crew that the aircraft would be offline and notified the operator's management of the incident.

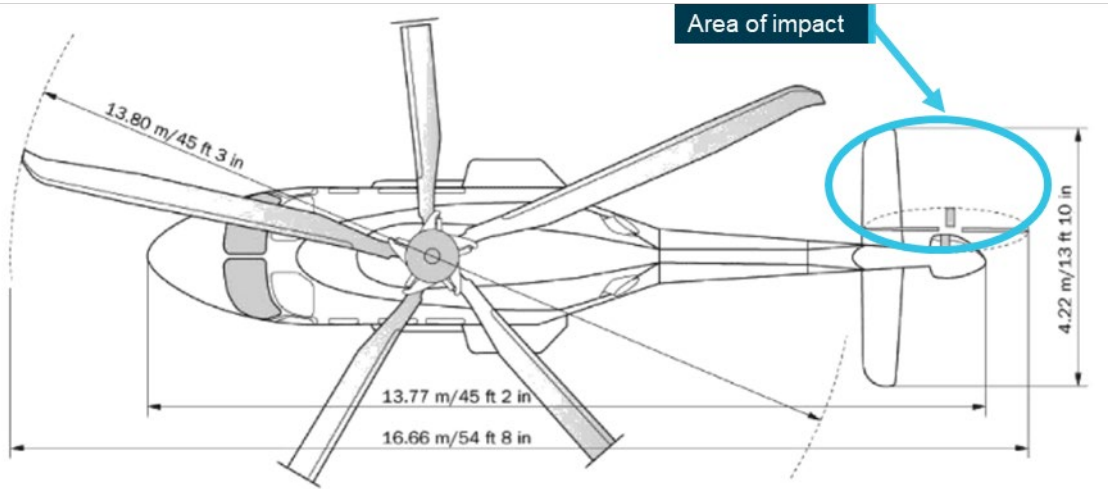
Figure 5: Area of impact with tree

The tail rotor of the AW139 is a critical component of the aircraft's flight control system, providing the necessary lateral force to counteract the torque generated by the main rotor system. Figure 5 outlines the aircraft dimensions and the area of foliage contact.

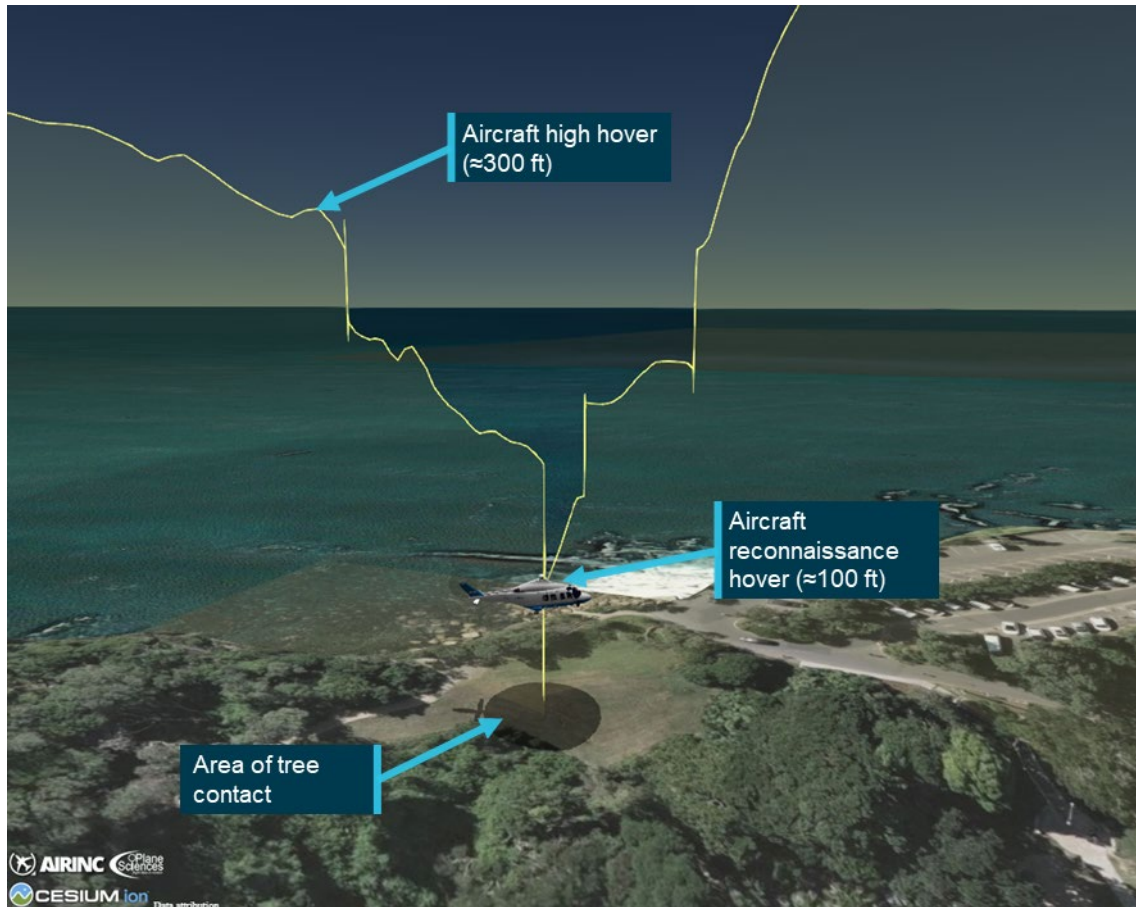
Figure 5: Hover heights prior to entry into HLS

The crew completed 2 hovers, a high hover at approximately 300 ft and a low hover at approximately 100 ft (Figure 6).

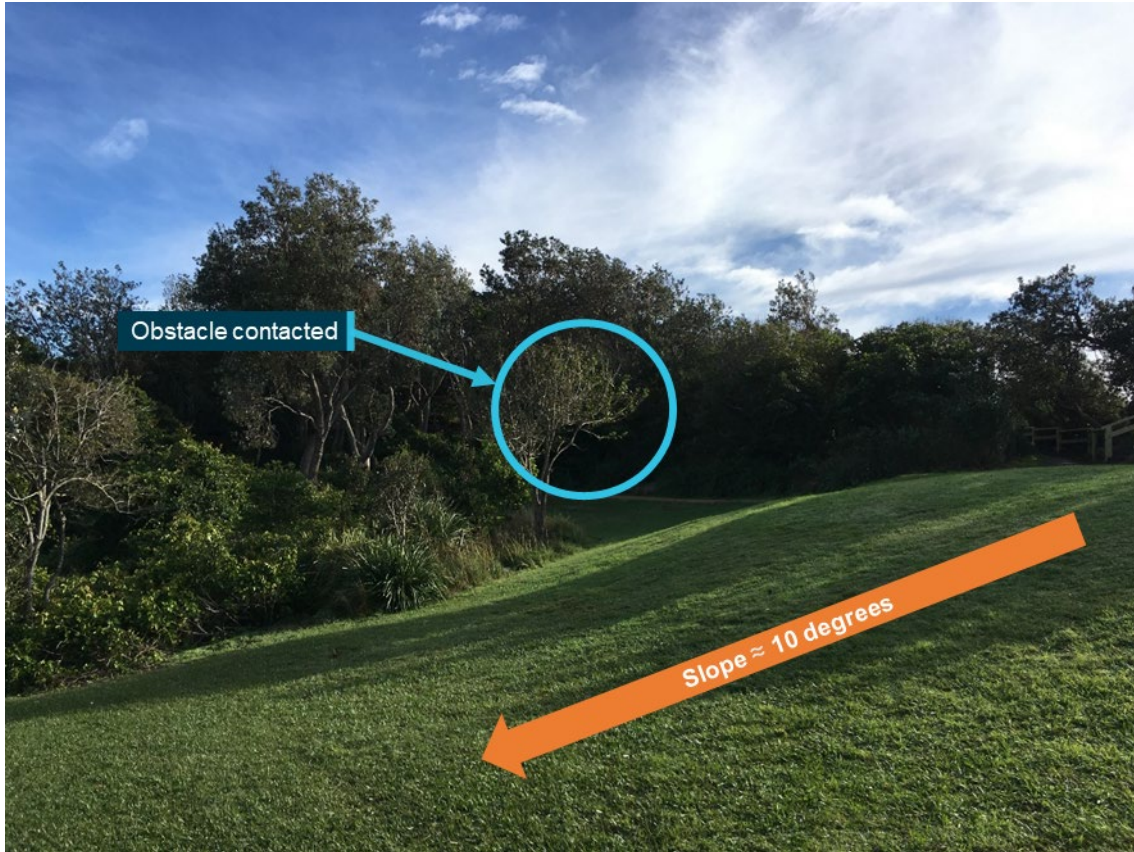
Figure 6: HLS slope and obstacle location

When manoeuvring into the landing site, the ACO did not communicate the proximity of the obstacles at the rear of the aircraft and as such both the pilot and the flight paramedic were unaware of the hazard they posed.

The HLS had a slope of 10° towards the west, which was undetected by the ACO (Figure 7). The pilot advised that slope was difficult to detect using both NVIS and white light. The operator's operations manual indicated that the slope limitation for the helicopter was 10° in all directions. The pilot advised that they had intended to check the slope in a low hover and even if there had been no other concerns, they may not have landed in the HLS due to the slope.

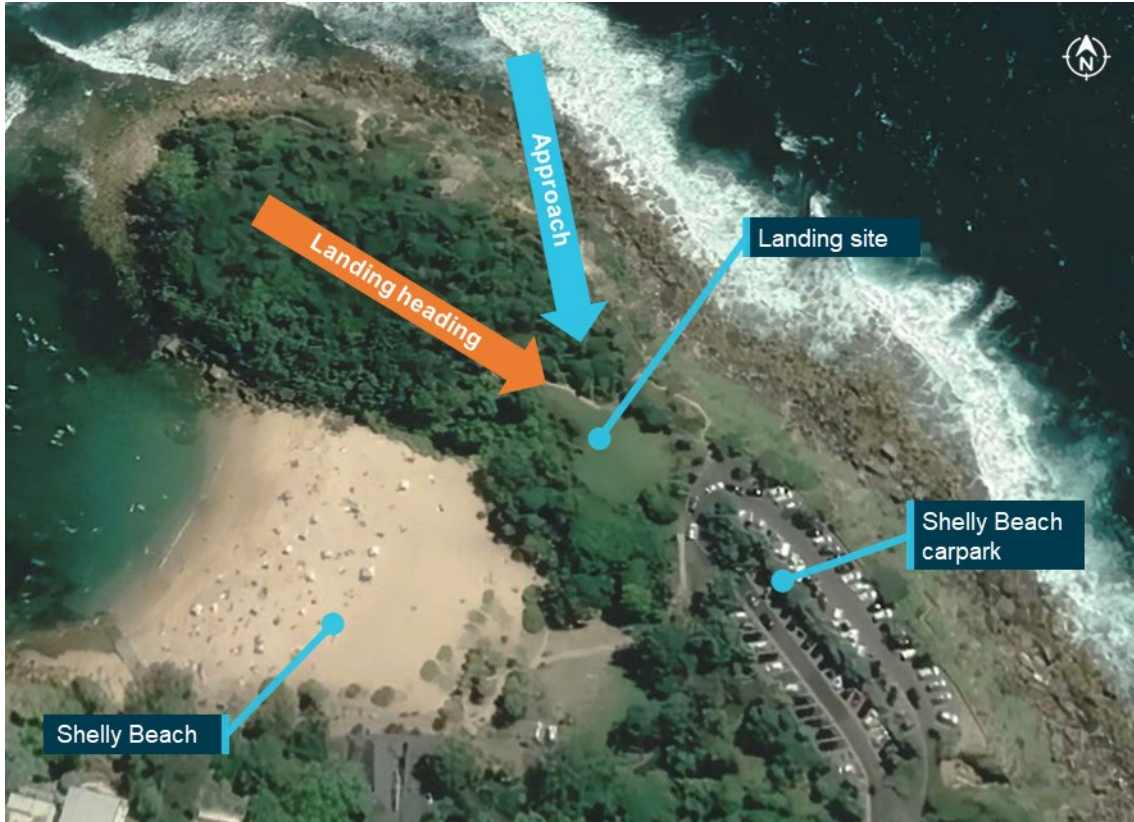
Figure 7: Approach and intended landing orientation

Figure 8 shows the approach and intended landing directions. The plan was that when the helicopter was established in a low hover over the landing site, the nose would be turned right so the tail would fit in the cut-out area.

At night, with an approach to the south, it would be difficult to land in the pad due to the slope at the south-eastern corner requiring the aircraft to be close to the obstacles on the non-active side of the aircraft (the side opposite to where the PIC [pilot in command] and ACO are operating). However, at the time of the incident, the crew believed that they could achieve the required minimum operating procedure of a 10-foot obstacle clearance. This assessment reduced the margins of any drift or yaw as experienced by the incident crew. Had the crew planned to achieve the preferred 20-foot obstacle clearance, it is likely that the contact with the tree may not have occurred.

The operator confirmed that the same confined area had been used for a task by day, in good conditions, on 26 January 2021, however it was approached from the reciprocal direction. The reciprocal direction allows a larger landing area with more obstacle clearance due to the reduced slope.

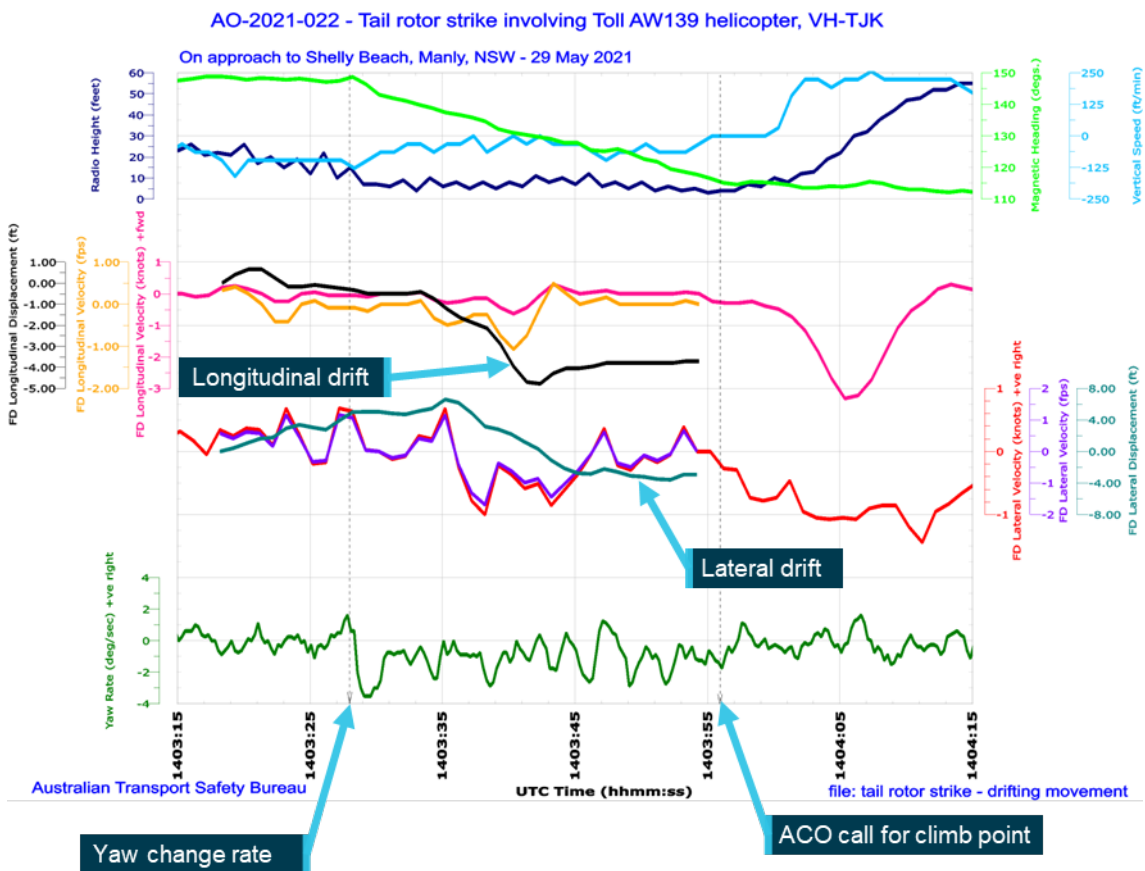
Figure 8: Aircraft flight data

The MPFR data indicated that in the 30 seconds prior to the ACO instructing the pilot to climb, the aircraft experienced a 30° yaw to the left, a 2 ft lateral drift to the right followed by an 8 ft drift to the left, and a 3.5 ft longitudinal drift rearwards before a slight forward movement of 1 ft, as outlined in Figure 9.
