In-flight fire and collision with terrain involving Beechcraft B58 Baron, VH-NPT

near East Kimberley Regional Airport, Kununurra, Western Australia on
16 April 2022

ATSB Transport Safety Report

AO-2022-026

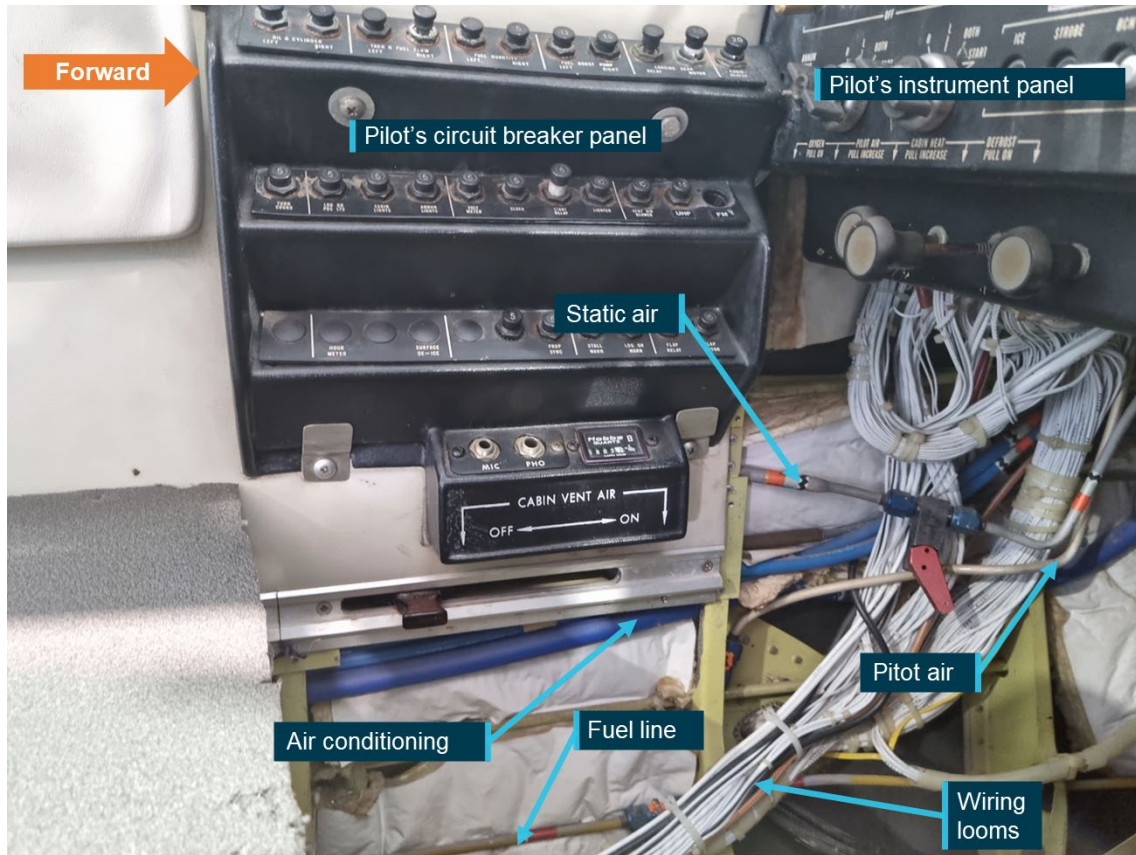
Figure 7: Circuit breaker and instrument panel of an exemplar B58 showing the position of wiring looms.

Electrical power was supplied to several systems including drive motors for the landing gear and flaps, aircraft lighting, avionics and communications. A circuit breaker panel on the pilot’s left side protects the circuits from overload and damage. Wiring was routed from the circuit breaker and instrument panels down along the left side of the aircraft in a series of looms. Figure 7 shows the area forward of the circuit breaker panel and below the pilot’s instrument panel in an exemplar aircraft.

Wiring for both the indication and operational systems are contained in wiring looms that pass through the area where the pilot first observed the smoke. These looms run near one another and the aircraft structure. Undetected damage could occur to or within the wiring looms, providing an ignition source from chafing, overheating of wiring or wires shorting to another wire or the airframe. Due to the destruction of the aircraft wreckage the ATSB was not able to determine the exact sequence of events that led to the electrical fault, the initiation of the fire and the other electrical anomalies that occurred.

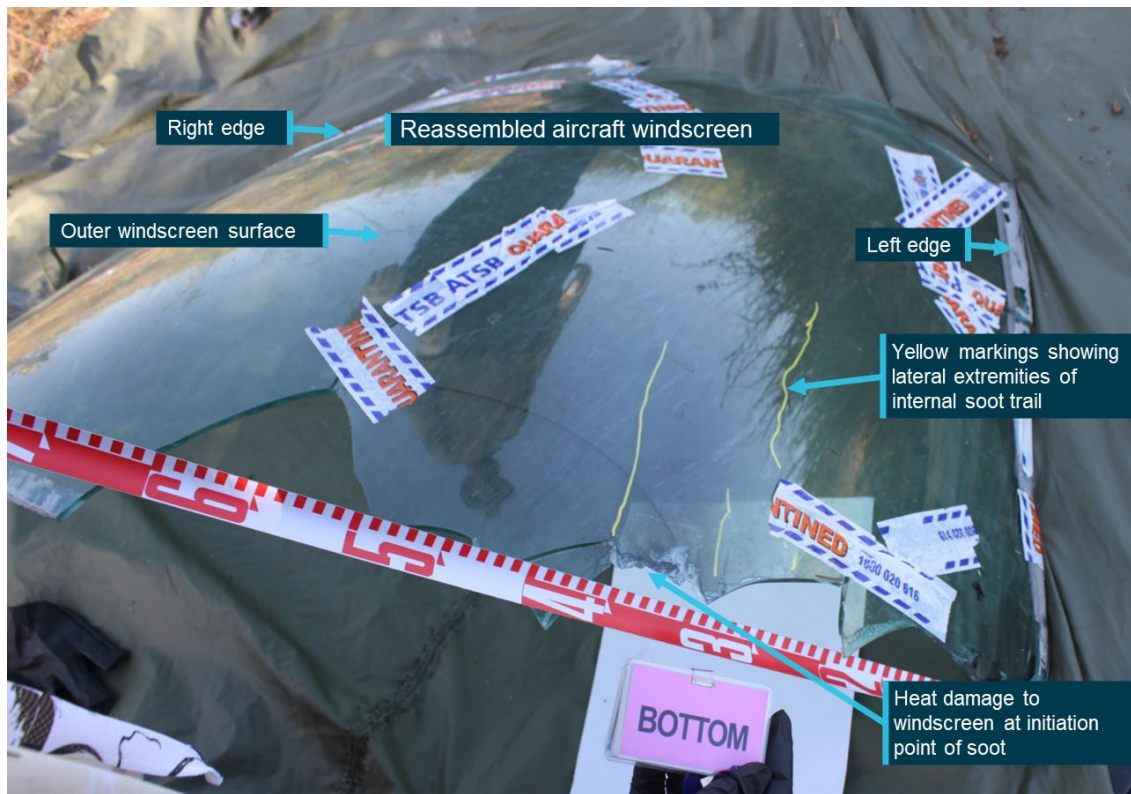
Figure 8: Reassembled aircraft windscreen showing soot trail outline and heat damage

The ATSB was able to reassemble almost the entire windscreen on-site (Figure 8). Once reassembled a soot trail was visible on the internal surface of the left side of the windscreen. The trail, emanating from the bottom of the windscreen, was approximately 34 centimetres from the left edge. The soot was of sufficient thickness that a clearly visible trail was able to be wiped into it. At the point where the soot trail initiated, the windscreen material exhibited a different failure mode, likely associated with significant heat.

Due to environmental conditions on-site the soot trail was not easily visible in captured image. The outside surface of the windscreen was subsequently marked on site with yellow paint marker identifying lateral extremities of the soot trail.
Source: ATSB

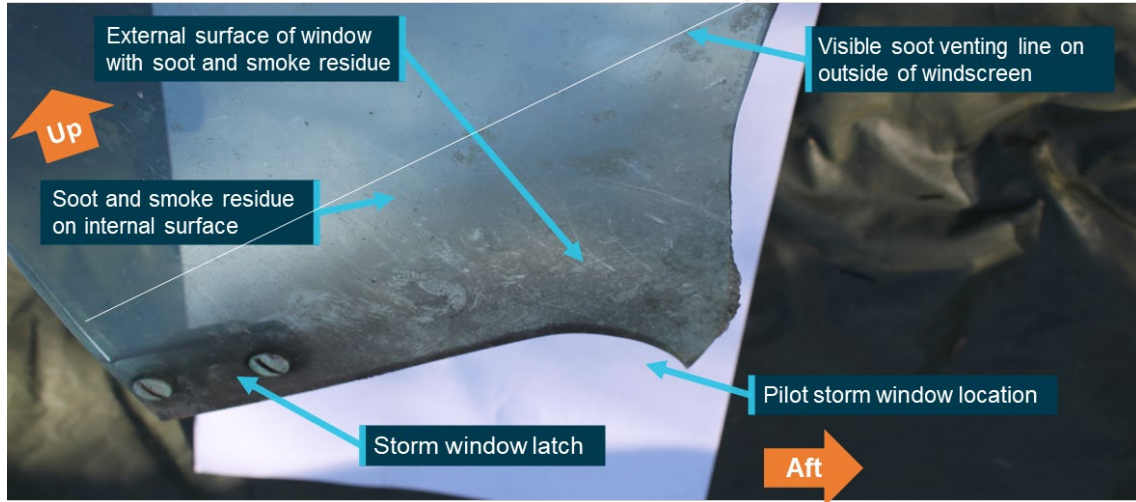
Figure 9: Smoke and soot indications on window surfaces adjoining the pilots storm window

The upper, aft corner of the pilot's storm window surround (Figure 9) was located with the outer surface down, closer to the post-impact fire than the windscreen. Soot was located on both sides with the external surface, consistent with soot being drawn out of the window by the airflow.

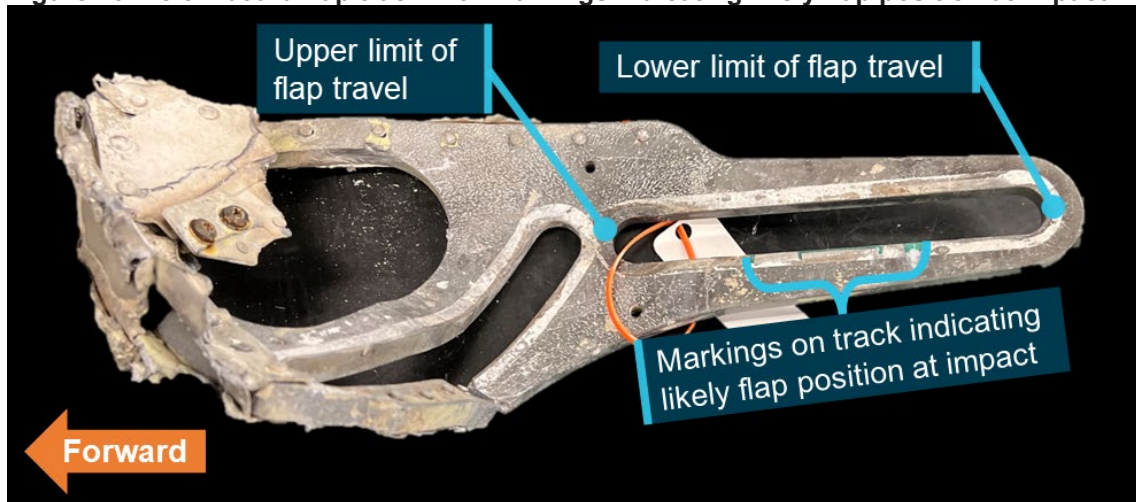
Figure 10: Left inboard flap track with markings indicating likely flap position at impact

Due to fire damage to the flap actuators, the specific position of the flaps at impact was unable to be determined. The aircraft's flap tracks were recovered for further examination at the ATSB's technical facilities in Canberra. Impact markings on the flap tracks indicated that the flaps were likely extended to the first of the 2 flap positions (15°) at the time of impact (Figure 10). This corresponded with both the pilot's report of having extended the flaps one position prior to activating the landing gear and the operator's procedures that required first stage flap extension as part of the setup of the aircraft for the approach.

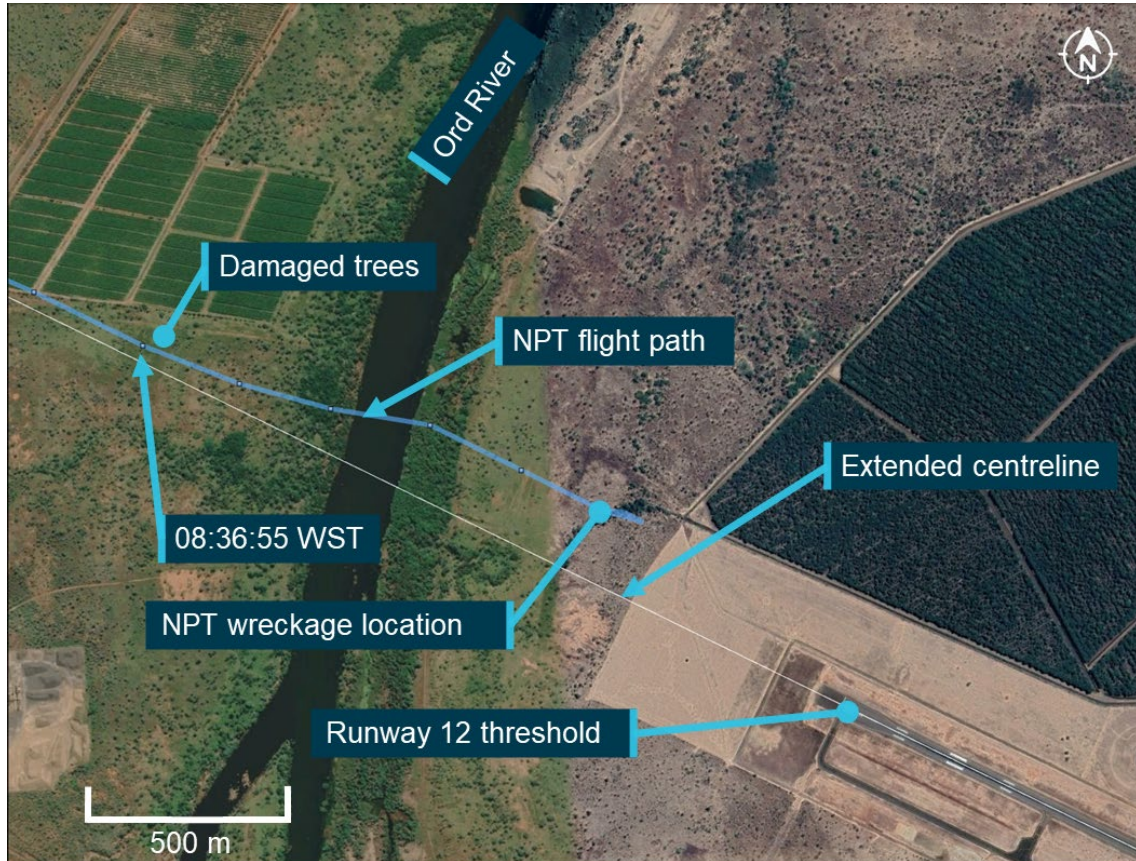
Figure 11: Possible tree strike location

The trees were approximately 500 m west of the river and 60 m north of the extended runway 12 centreline (Figure 11). Their position was consistent with the aircraft’s approach path, and were close to the lowest point in the aircraft’s flight path data on the western side of the Ord River. Tree damage was between 15 and 20 ft above ground level and the direction of the breaks and fallen limbs were consistent with the aircraft’s direction of travel.
