Collision with terrain involving Kubicek Balloons BB78Z, VH-RJR

15 km north-west of Moorabbin Airport, Victoria on 20 April 2022

ATSB Transport Safety Report

AO-2022-028

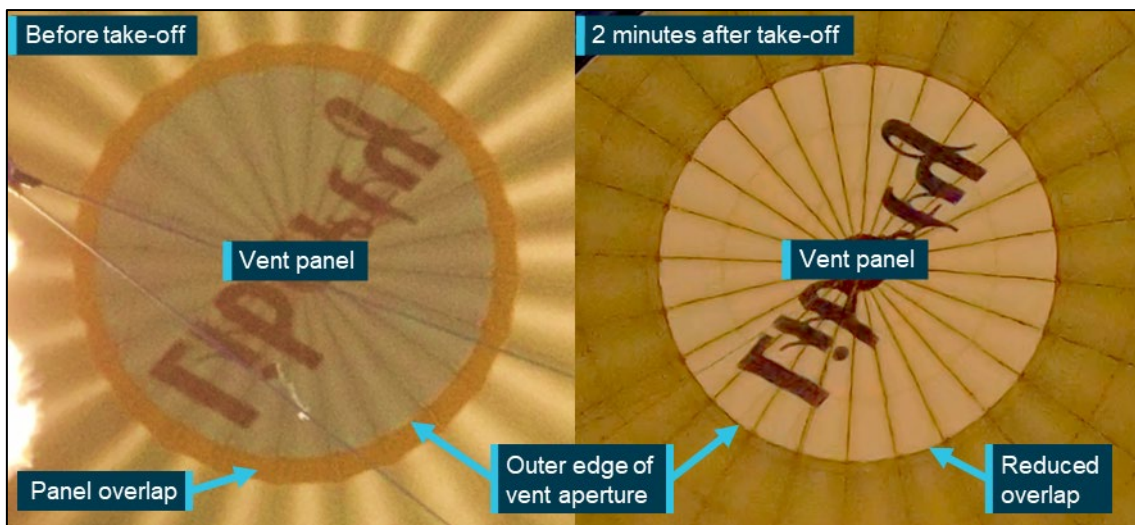
After the pre-flight inspection, the passengers boarded the balloon, and at 0635, the balloon departed for an anticipated 1-hour flight. The pilot noticed during the pre-flight heating and initial stages of the flight, that the overlap of the vent panel – a fabric panel used to vent air out of the circular opening at the top of the balloon (vent aperture) – and the vent aperture was smaller than on other Kavanagh balloons they had flown. However, the deflation system was sealing correctly during these stages, and so the pilot was not concerned. Passenger images showed the vent panel before take-off and about 2 minutes after take-off (Figure 1). The image taken shortly after take-off showed that the vent panel was close to, or was, pushing through the vent aperture.²

Figure 1: Vent panel before (left) and after (right) take-off

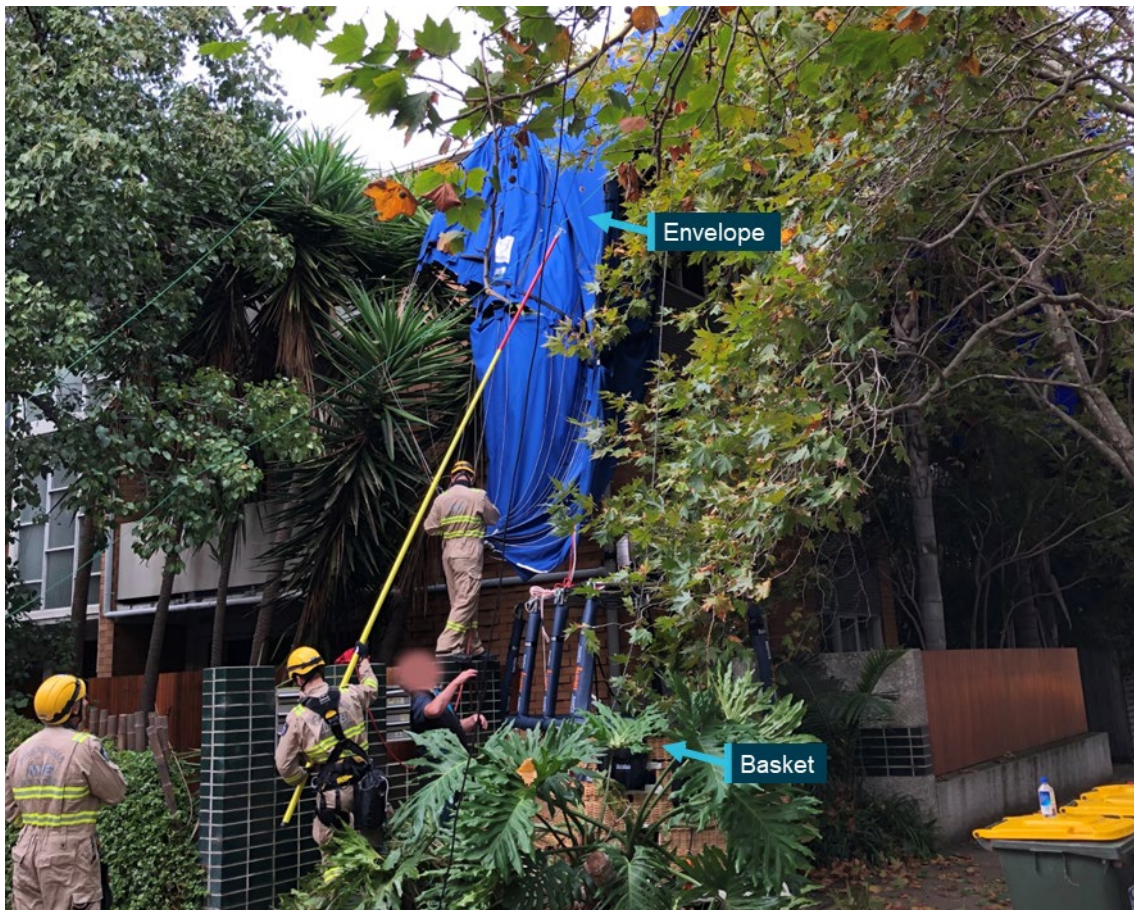
The basket came to rest outside the entrance of an apartment building and the envelope deflated over the building’s roof (Figure 3). The balloon and basket sustained minor damage during the forced landing, and 3 passengers sustained minor injuries.

Figure 3: Balloon landing site during the post-incident recovery

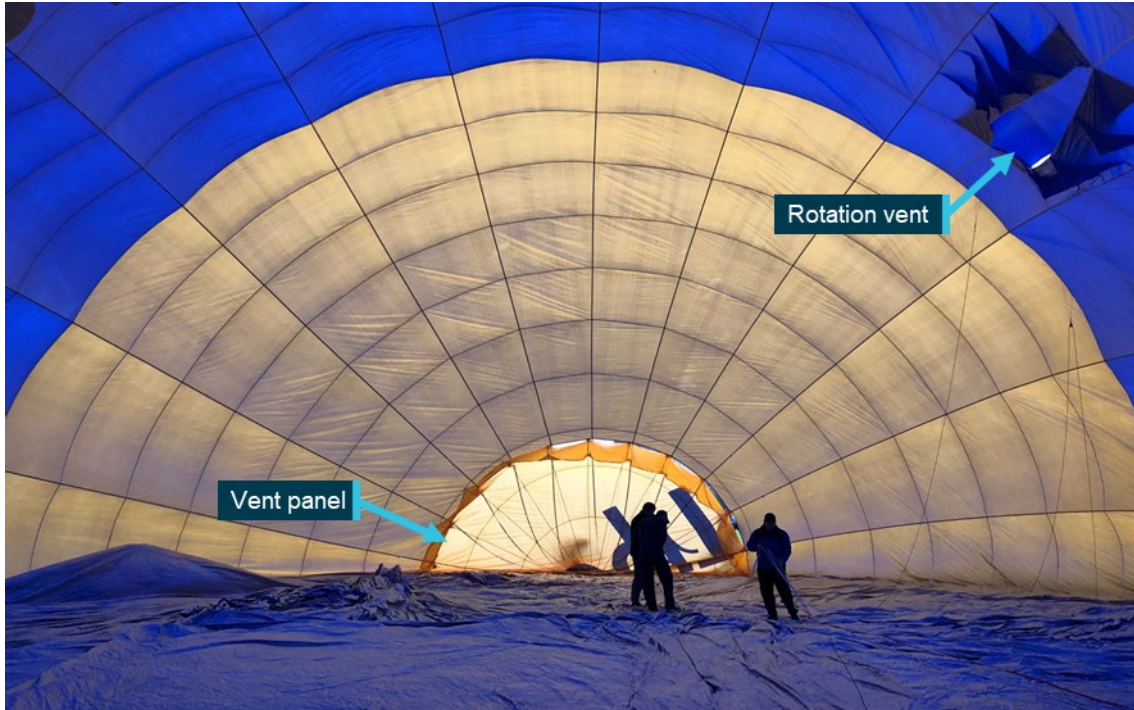
The envelope was first inflated on the ground using a fan to conduct an external and internal inspection of the envelope (Figure 8), with the following observed:

- pulleys and rope lines were serviceable
- there was minor impact damage to the envelope fabric from the landing
- the temperature streamer was intact and the temperature indicator colour was unchanged.

Figure 8: Internal envelope inspection

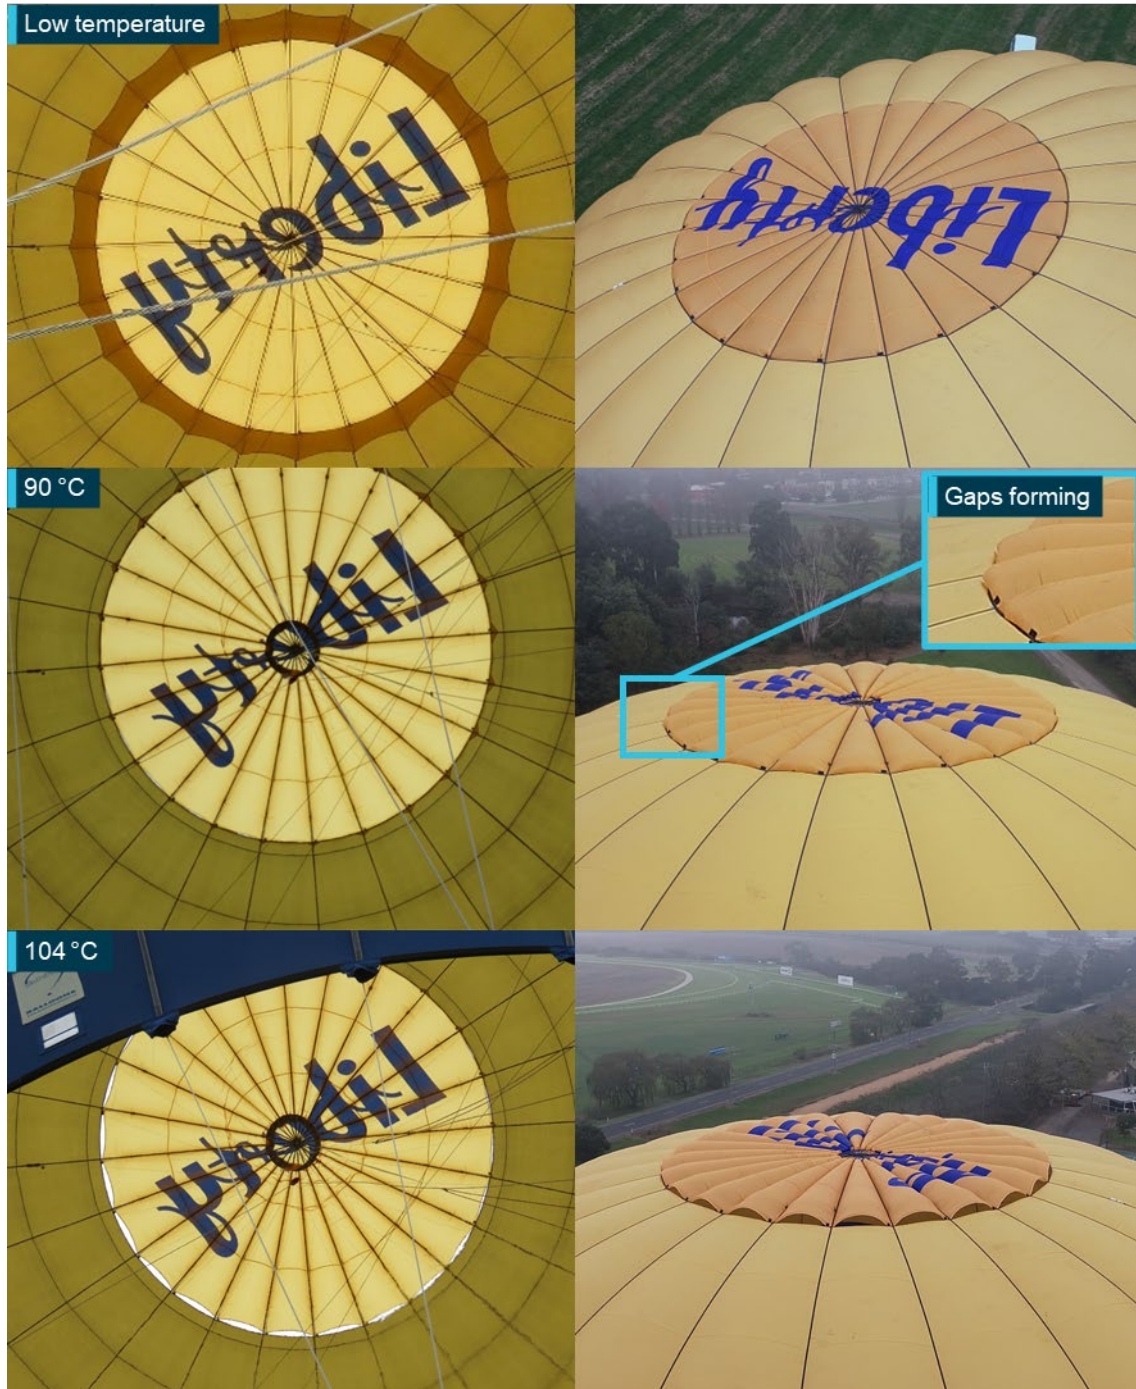
The internal envelope air temperature was increased by operating the burners, while external and internal camera footage of the vent panel was taken (Figure 9). At low temperatures, the vent panel began to push up against the internal envelope and vertical load tapes as designed, creating a seal. At about 90 °C, edges of the vent panel between the vertical load tapes pushed up through the aperture creating many gaps for internal envelope air to vent out. Attempts to seal the gaps using the parachute vent line and white line were unsuccessful. At higher temperatures, the gaps became larger and more numerous.

Photos and video taken during the test indicated vent panel behaviour similar to that shown in the passenger's video of the incident flight (Figure 1). The incident pilot also reported that the vent gaps were very similar to those observed during the incident flight. The balloon envelope was subsequently shipped to the manufacturer's headquarters in Czechia for further examination.

Figure 9: Deflation system testing

The post-incident testing arranged by the ATSB on VH-RJR indicated that gaps in the deflation system were forming between the vent panel and edge of the vent aperture at about 90 °C internal envelope temperature. This temperature was below the reported temperature reached during the manufacturer test with similar ambient conditions (temperature and altitude) such that similar internal envelope temperatures created comparable internal envelope pressure. To examine this discrepancy, Kubicek used software to estimate the actual envelope air temperature reached during the test. The software estimated that the maximum internal envelope temperature only reached about 89 °C instead of the 114 °C recorded on the report.

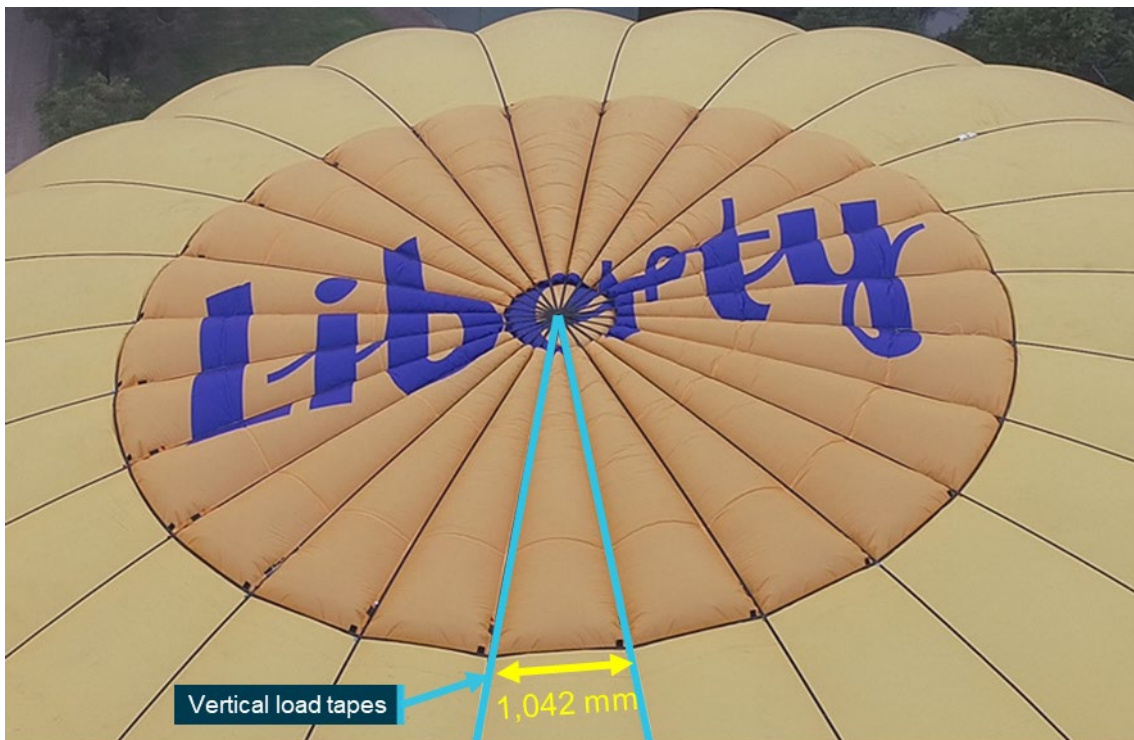
After the incident, Kubicek compared the manufactured deflation system dimensions with the original design drawings and found no differences. The design differences between the VH-RJR deflation system and the same size deflation system fitted to the manufacturer’s larger certified balloons was also reviewed. This found that when incorporated into the smaller BB78Z balloon, the vertical load tape spacing at the edge of the vent panel (Figure 10) differed from other designs as follows:

- VH-RJR BB78Z with 24 gores and 4.0 m radius vent aperture – 1,042 mm spacing
- Standard BB78Z with 24 gores and 3.6 m radius vent aperture – 940 mm spacing
- Standard larger balloon with 28 gores and 4.0 m radius vent aperture – 893 mm spacing

Figure 10: VH-RJR vent panel spacing between load tapes

As this was the only major difference in the system geometry it was concluded that this [was the] probable cause of the [air] leak. The increased load tape spacing allowed the vent [panel] fabric to slip through, being pushed by the inner pressure of the envelope [air]. The inner pressure also prevented return of the vent panel to its closed position.

- The balloon's modified deflation system had longer spacing between the vertical load tapes at the vent aperture edge compared to the standard deflation system design. This spacing allowed normal envelope pressure to push the vent panel upwards through the vent aperture, allowing air to leak uncontrolled out of the envelope.

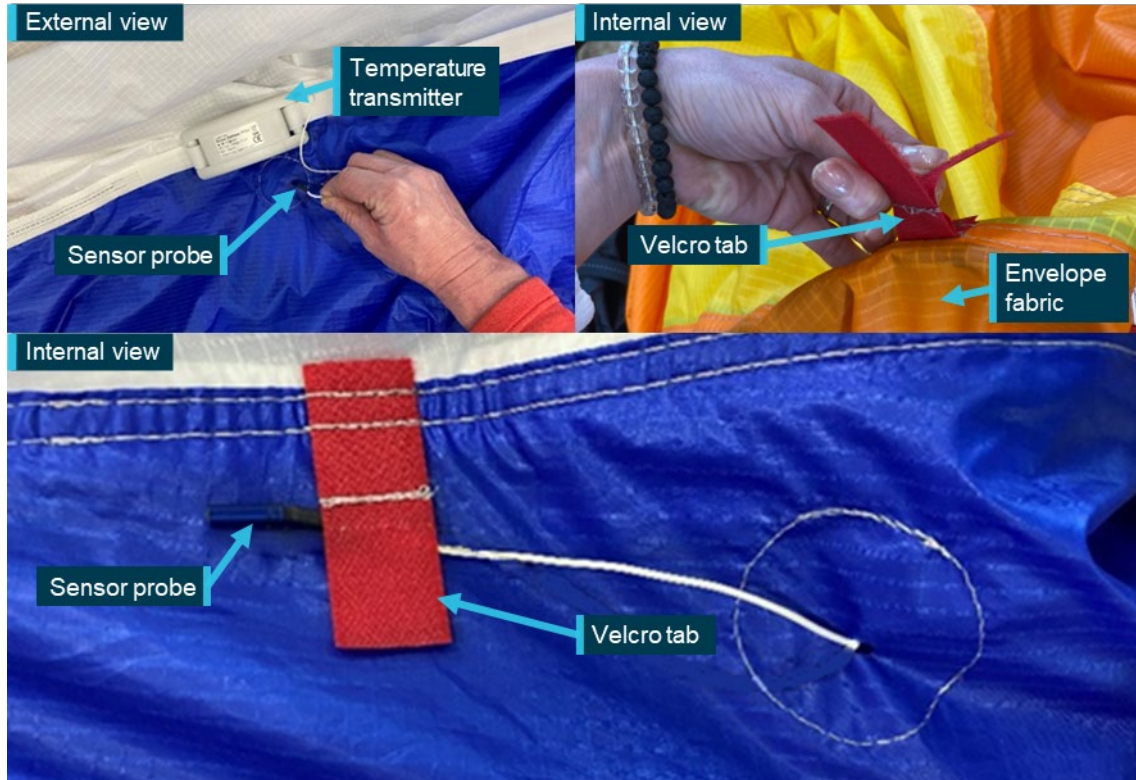
As part of the manufacturer's tethered test, a wireless temperature sensor (probe and transmitter) was fitted to the top of the envelope to record the internal envelope air temperature. The sensor probe was placed inside a Velcro tab designed to measure the temperature at 20 mm from the envelope fabric surface during the test (Figure 11). A receiver located in the pilot's compartment was wirelessly linked to the temperature transmitter and provided the temperature reading during the test.

Figure 11: Envelope air temperature sensor

All balloons manufactured by Kubicek were subject to a tethered test to ensure the balloon flight controls performed correctly and the balloon was in a condition for safe operation. The internal envelope temperature recorded on the VH-RJR manufacturer production test report (114 °C) was above the minimum required value (100 °C). However, based on post-test calculations, the actual temperature reached during the test was probably only about 89 °C. Information on the temperature sensor used during the test, its location, or how it was installed, was not available, so it was not possible to determine the reason for this significant temperature discrepancy.

- Temperature sensors are now calibrated annually.
- The production inflation test procedure has been updated:
 - Roles and responsibilities are more clearly defined.
