Flight below minimum altitude occurrences

40 km south of Cairns Airport, Queensland on 24 and 26 October 2022

ATSB Transport Safety Report

AO-2022-051

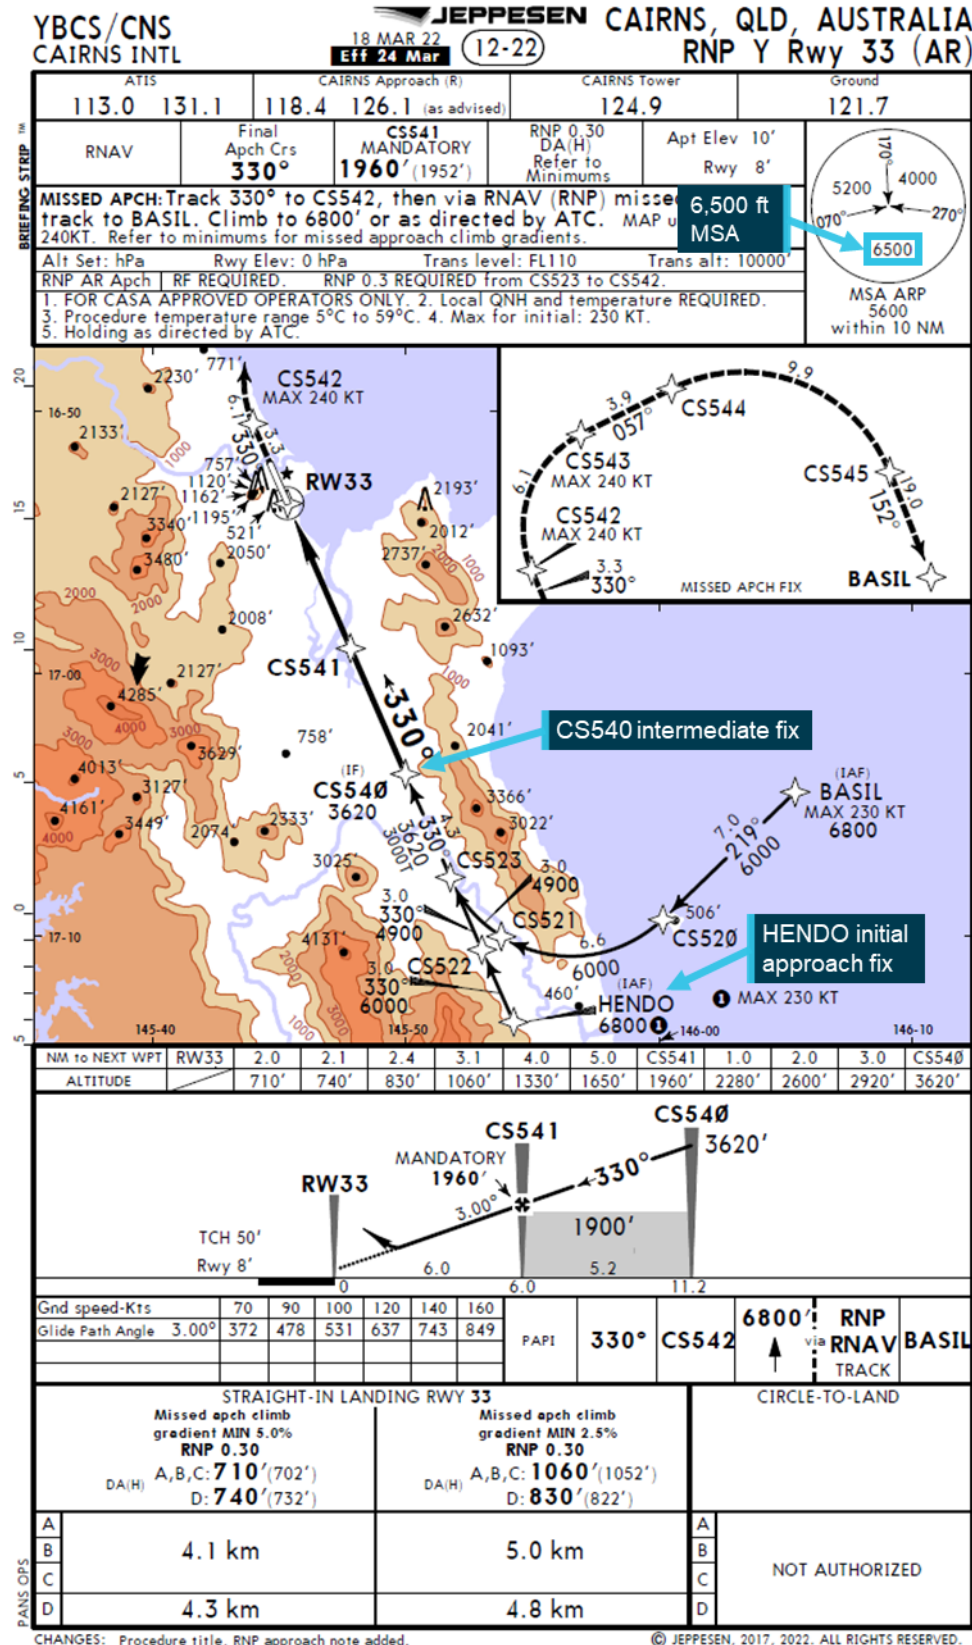
Figure 2: Jeppesen Cairns RNP Y runway 33 approach chart

proceeded via CS520, CS521 and CS523, and from the HENDO IAF via CS522 and CS523. In order to load either path into the FMC, the flight crew needed to select one of the 2 approach transitions, BASIL or HENDO (see the section titled *Flight management computer*).

The flight crew did not recognise that an approach transition selection was required and consequently did not select one. As a transition had not been selected, the FMC presented a discontinuity in the entered flight path from the HENDO waypoint (see the section titled *Flight management computer*). The flight crew misidentified the approach IF, CS540, as the IAF and resolved the FMC discontinuity by connecting the HENDO arrival waypoint to CS540. This selection meant that the 6,800 ft descent altitude constraint associated with HENDO in the RNP approach programming was not loaded in the FMC.

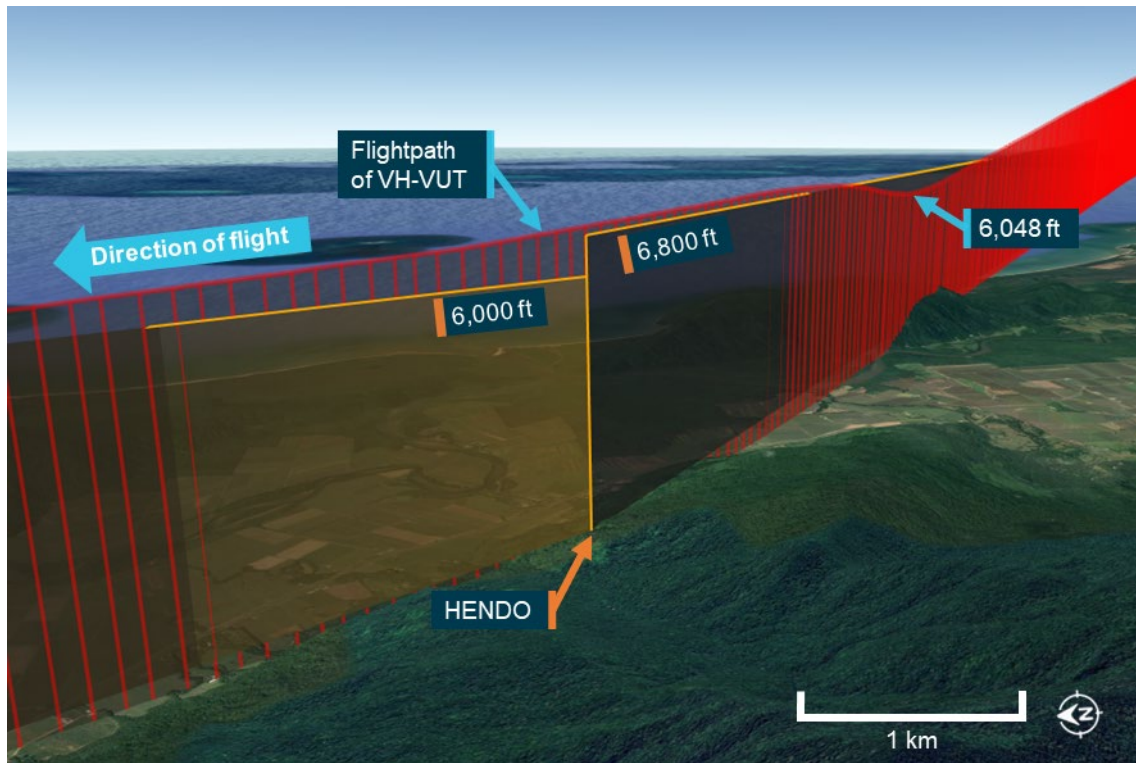
Figure 3: Flight path of VH-VUT

At 2011:38, about 7 NM prior to crossing HENDO, the aircraft descended below 6,800 ft (Figure 3) and 9 seconds later descended below the 6,500 ft MSA. Six seconds later, at 2011:53, ATC observed that the aircraft had descended below 6,800 ft and contacted the crew to confirm the aircraft's altitude. The captain then reselected 6,800 ft and manually arrested the descent. ATC then issued a low altitude alert to the crew and advised them to climb immediately. Three seconds later, at 2012:07, the aircraft stopped descending at about 6,048 ft and then commenced a climb. At 2012:28, the aircraft climbed back above 6,800 ft. No ground proximity warning system alerts were generated during the incident.

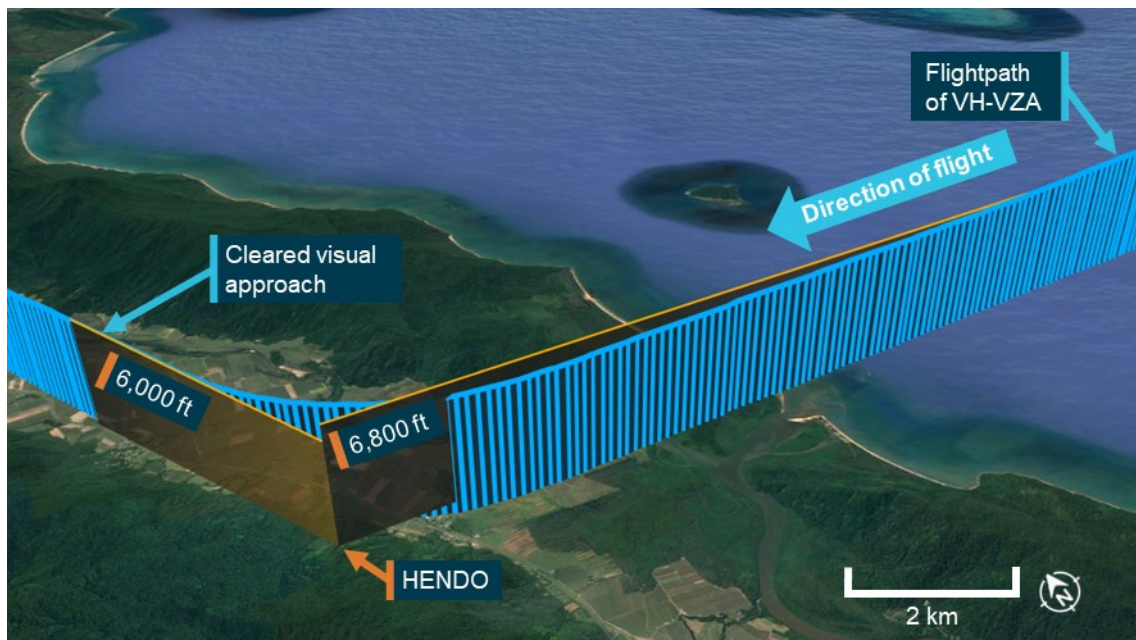
Figure 5: Flight path of VH-VZA

The aircraft passed HENDO at 0811:56 at an altitude of 6,129 ft (Figure 5). The crew recognised that the aircraft had descended early and selected the altitude hold (ALT HLD) autopilot function to stop further descent. Eleven seconds after the aircraft crossed HENDO, ATC contacted the crew to verify that the aircraft had passed HENDO at the correct altitude. ATC then confirmed with the crew that the flight was operating in visual conditions and provided clearance for a visual approach.

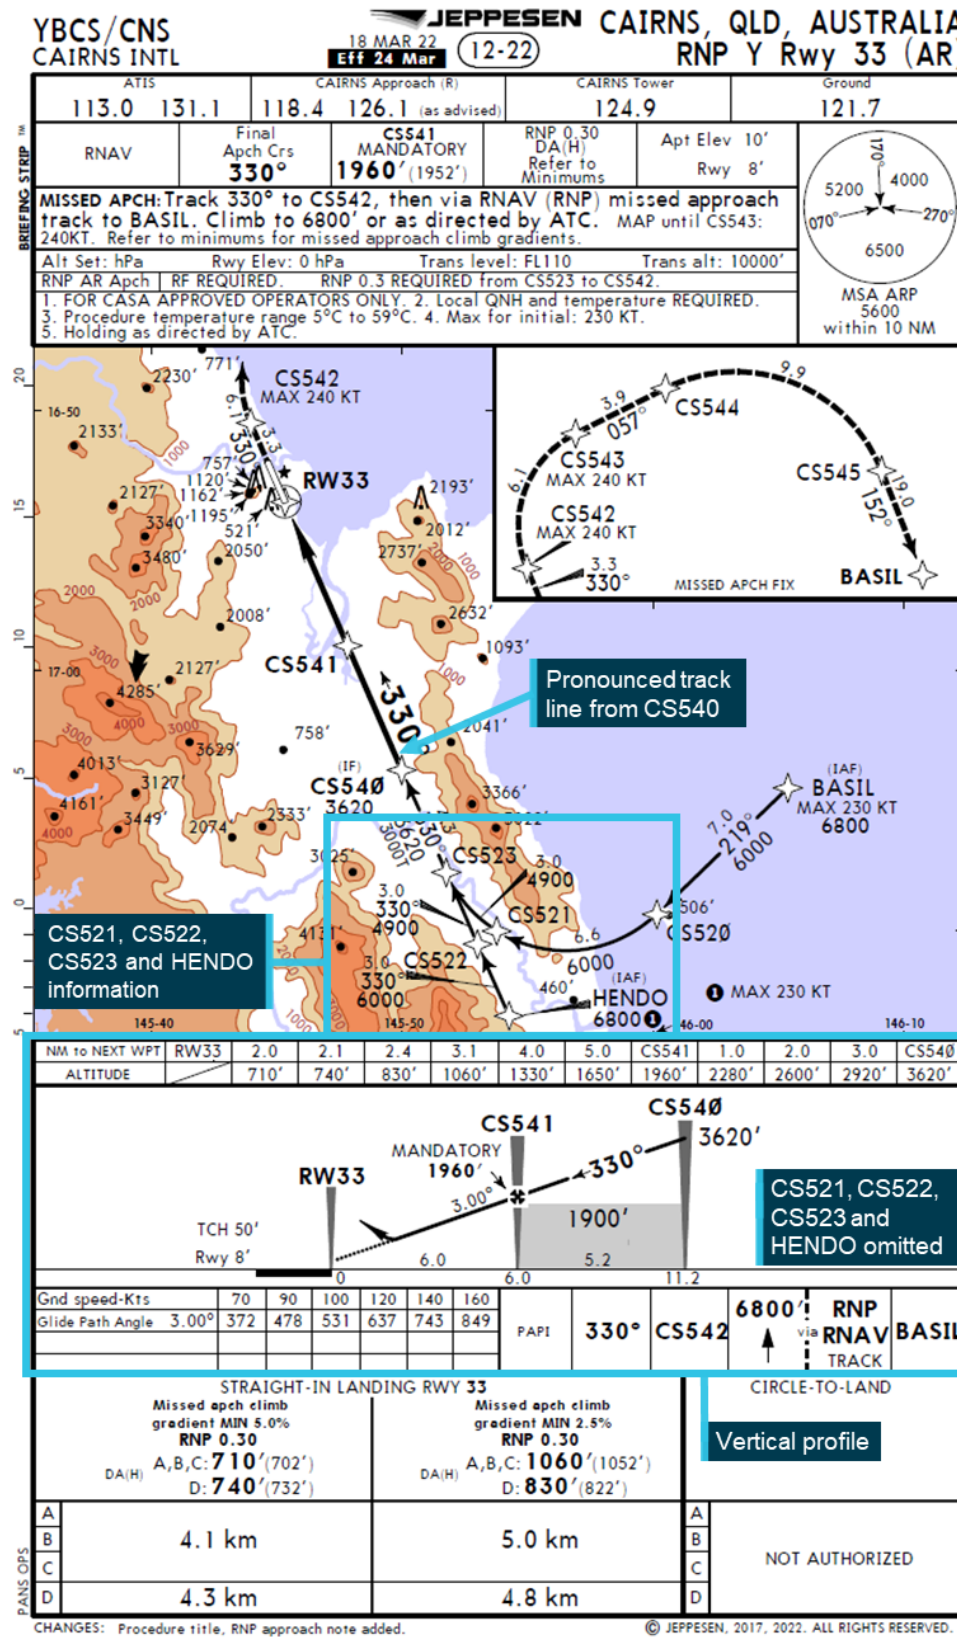
Figure 7: Jeppesen Cairns RNP Y runway 33 approach chart

The Jeppesen chart (Figure 7) vertical profile did not include the waypoints CS521, CS522, CS523 and HENDO. The chart's vertical profile commenced at waypoint CS540 and approach track information on the map was emphasised with a broader line from this waypoint. The information (including altitude constraint information) relating to waypoints CS521, CS522, CS523,

HENDO and their associated segments was presented on the map over shaded topographical information and with an arrow to the associated item.

The missing waypoints on the vertical profile and thicker track line from CS540 on the approach chart likely contributed to the captain of VH-VUT misidentifying that waypoint as the IAF. These missing waypoints were also the waypoints omitted from the FMC programming if an approach transition was not selected. Therefore, their omission was not an immediate indicator of a data entry error.

Furthermore, the Jeppesen chart presented the information (including the altitude constraints) associated with the missing waypoints and segments over topographical information on the map and separated from the relevant waypoints and segments. This reduced the readability of the information and may have contributed to the crews not associating the relevant information with their respective waypoints and segments thereby further reducing the crews' ability to identify the associated altitude constraints.

Two days after the incident, Virgin Australia published a safety update for all flight crew regarding the occurrence on 24 October 2022. This update provided contextual information on the occurrence and highlighted the missing waypoints in the vertical profile depiction on the Jeppesen Cairns RNP Y runway 33 chart. The update also emphasised the requirement for an approach transition selection.

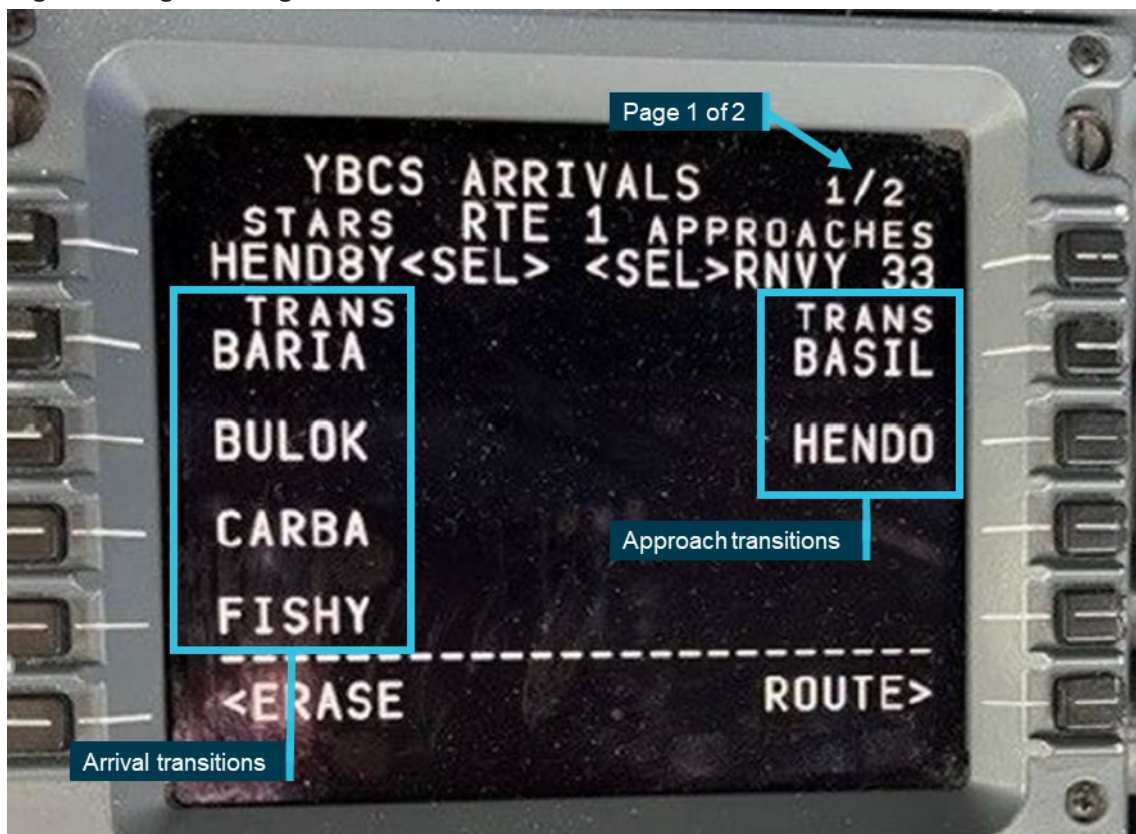
Figure 8: Flight management computer transitions

The arrival and approach transitions were both presented on the same FMC Arrivals page (Figure 8). In the case of the HENDO 8Y arrival, the number of available selection lines on the screen was limited to only display 4 of the 7 available transitions. The remaining 3 available arrival transitions were displayed on a second arrivals page. This second page was indicated by a '1 / 2' (page 1 of 2) at the top right of the screen.

The 2 approach transitions were presented on the right side of the arrivals screen. The crews of both aircraft did not recognise that the right column were approach transition selections.

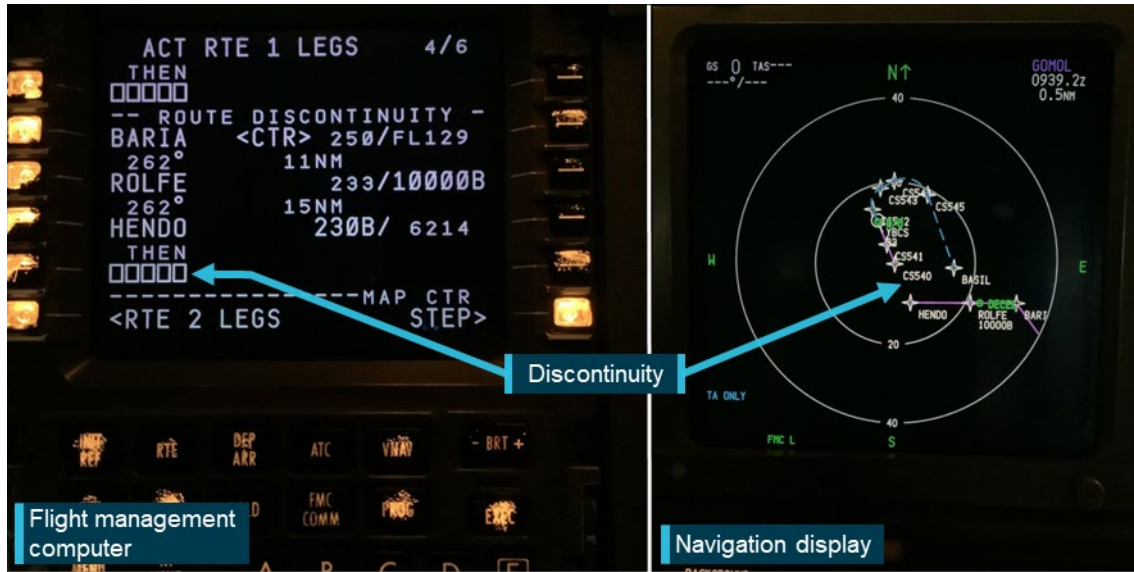
Figure 9: Flight management computer (left) and navigation display (right) showing the discontinuity

As the crews did not select an approach transition, a discontinuity was created at the HENDO waypoint associated with the HENDO 8Y arrival (Figure 9). Both crews resolved this discontinuity by connecting the waypoint HENDO from the arrival procedure to the waypoint CS540 in the approach procedure. As waypoint HENDO in the FMC arrival procedure did not have the 6,800 ft descent altitude constraint (the constraint was only associated with the HENDO approach waypoint), this altitude constraint was not loaded into the FMC. Similarly, the segment minimum safe altitudes associated with waypoints CS522 (6,000 ft) and CS523 (4,900 ft) were not loaded.
