Cabin pressurisation fault, Saab 340B, VH-VEZ

20 km south-west of Goulburn, New South Wales on 25 March 2023

ATSB Transport Safety Report

AO-2023-012

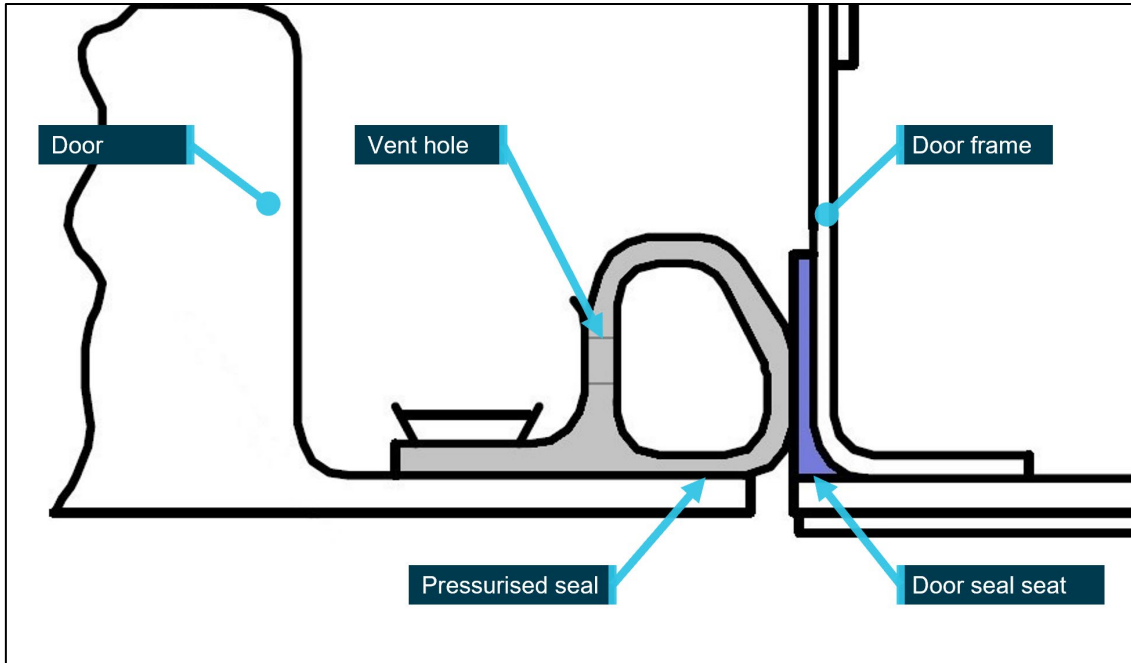
Figure 1: Door seal system

Pressurised aircraft use door seals to help maintain cabin air pressure in flight. The Saab 340B uses a pressurised hose-type seal which is attached to the door. The seal is compressed between the door and door frame when closed and small vent holes in the seal allow cabin air pressure to inflate the seal (Figure 1).
