Wirestrike, Kavanagh Balloons E-240

Bulleen Park, Victoria, on 14 March 2021

Aviation Occurrence Brief

AB-2021-008

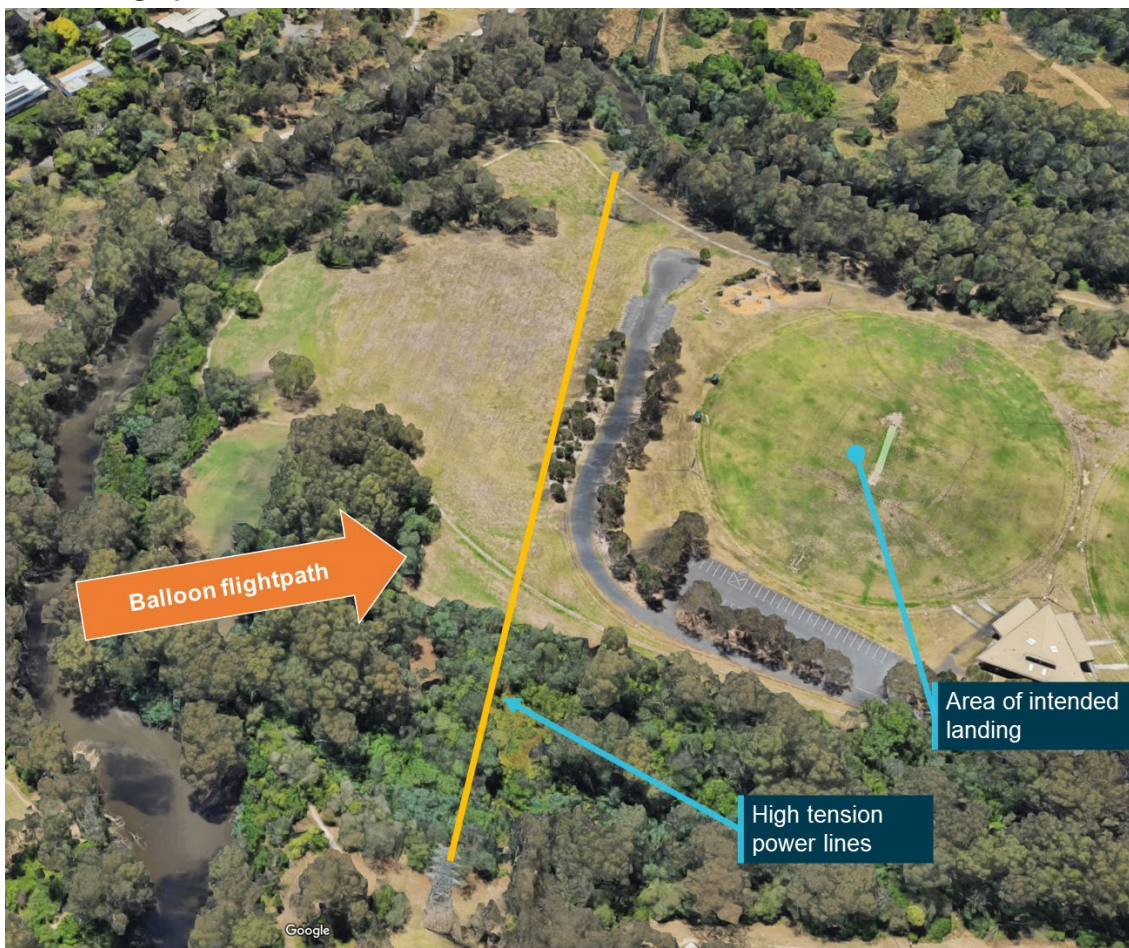
Figure 1: Incident location showing intended landing area, powerlines and approximate balloon flightpath

Shortly before 0830 Eastern Daylight-saving Time,¹ the balloon approached the planned landing area at Bulleen Park. To reach the landing area, the pilot needed to conduct a descent into a westerly wind. This resulted in the balloon descending over powerlines, which varied from the normal practice of passing over significant obstacles while in level flight. The powerlines were adjacent to the landing area, suspended between two high tension towers (Figure 1), and displayed on the pilot's iPad.

The pilot conducted the descent so as to pass above the high voltage wires that they could see. However, due to local lighting conditions, approaching the powerlines in a descent and vegetation in the area, the pilot did not see an earthing wire² that ran 7.43 m above the high voltage wires.

- instituted a policy that if wind conditions do not permit an approach to this landing area to be conducted in level flight, with a minimum of 40 m clearance above powerlines, the flight is to proceed to the next suitable landing site
- reminded pilots that flight should 'always be carried out with extreme care and consideration to avoid powerline contact' in line with the operations manual.

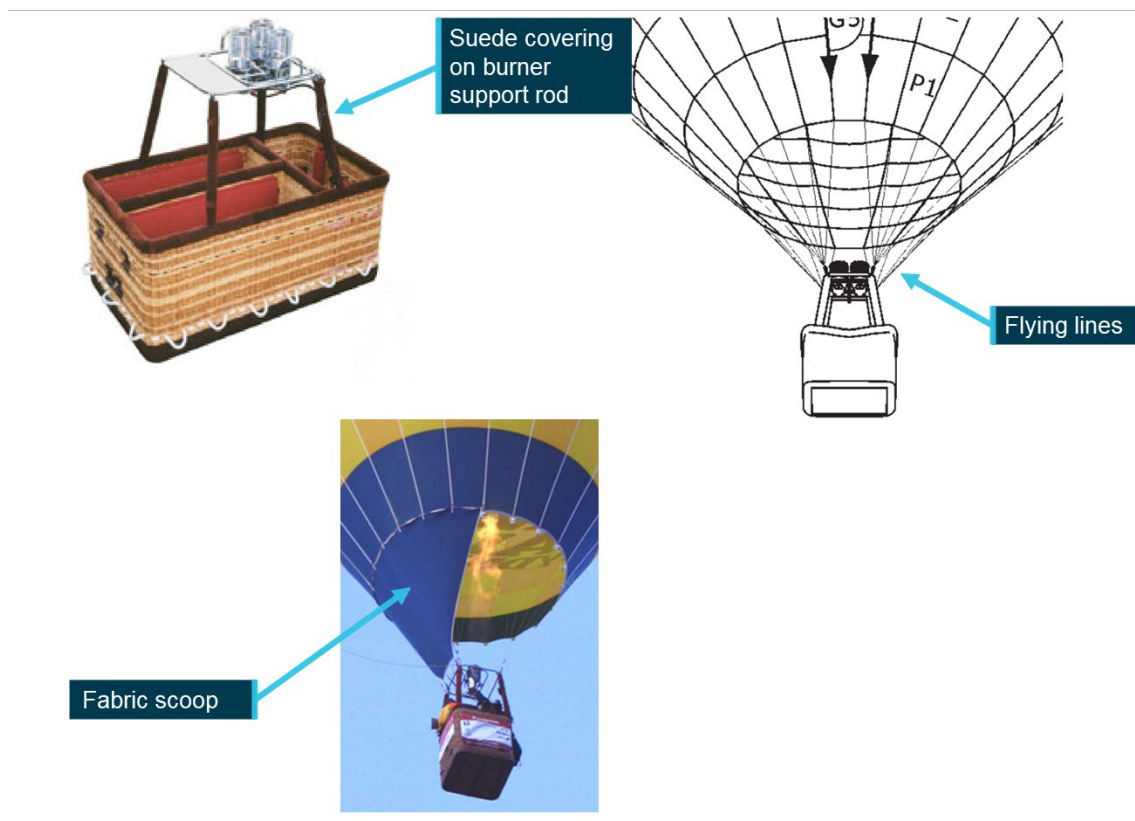
Figure 2: Damage to balloon and basket

During the descent, the balloon's basket struck the earthing wire, which arrested its forward momentum. The basket remained held against the earthing wire, and above the high voltage wires, for about 20 seconds as the pilot engaged the burner to initiate a climb. The balloon then climbed free of the earthing wire, sustaining minor damage in the process.

The flight proceeded to an alternative landing area at Westerfolds Park without further incident. The pilot and passengers were uninjured. The balloon sustained damage to five of the 20 woven stainless steel flying lines, the suede covering on a burner support rod and the balloon's fabric scoop (Figure 2).
