Engine failure involving Cirrus SR22, VH-WYH

7 km S Gilgandra (ALA), NSW, 21 November 2012

ATSB Transport Safety Report
Aviation Occurrence Investigation
AO-2012-154
Final – 23 April 2013

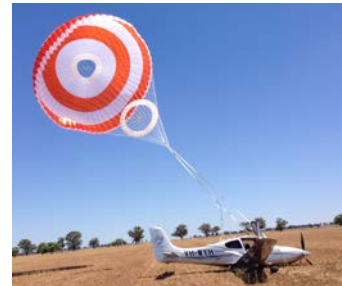
WYH at the accident site

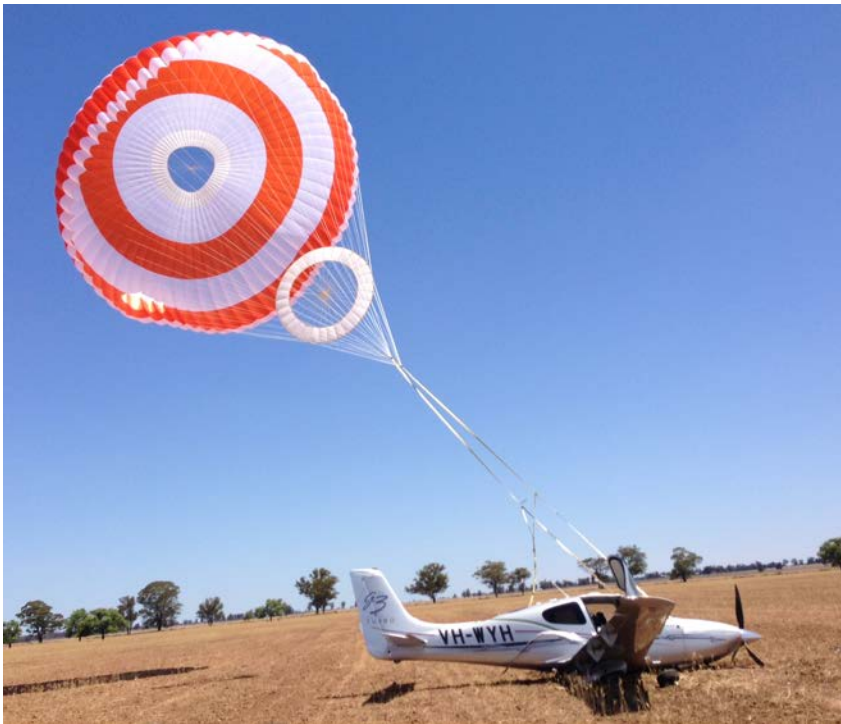
The pilot secured the cabin and about 16 seconds after the parachute deployed, the aircraft impacted the ground in a slight left wing low attitude (Figure 1). The pilot and passenger seat belt air bags deployed and the pilot and passenger exited through the passenger door. The pilot received minor injuries and the passenger was uninjured.

Figure 1: Parachute inflated at accident site

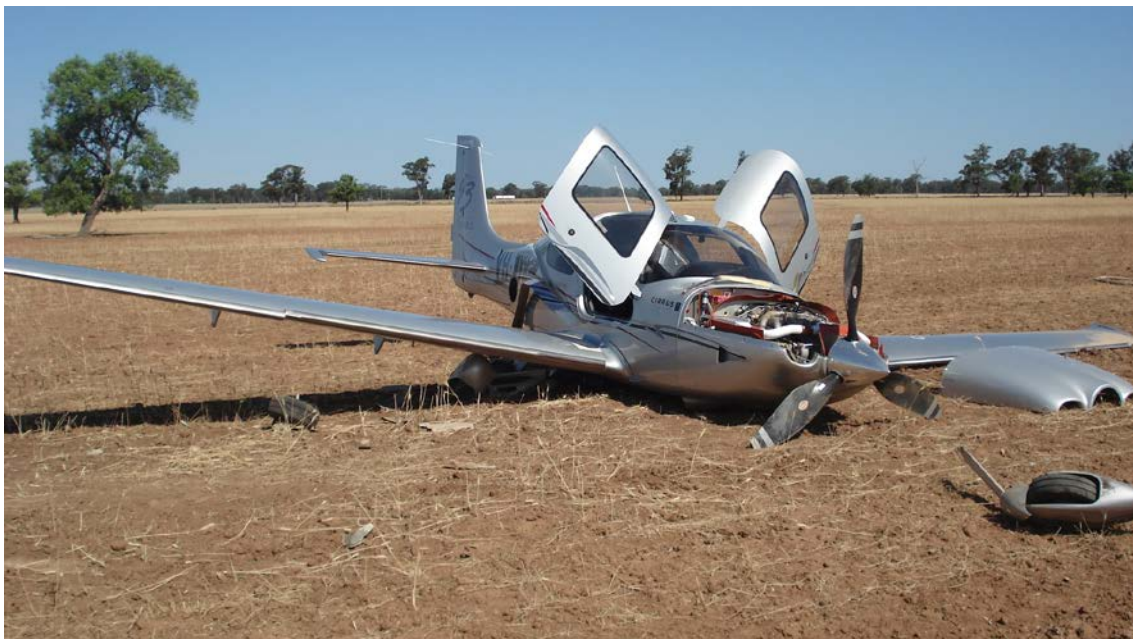
The pilot indicated that there was no sign of an external oil leak from the engine and there was no oil on the windscreen (Figure 2).

Figure 2: WYH at the accident site

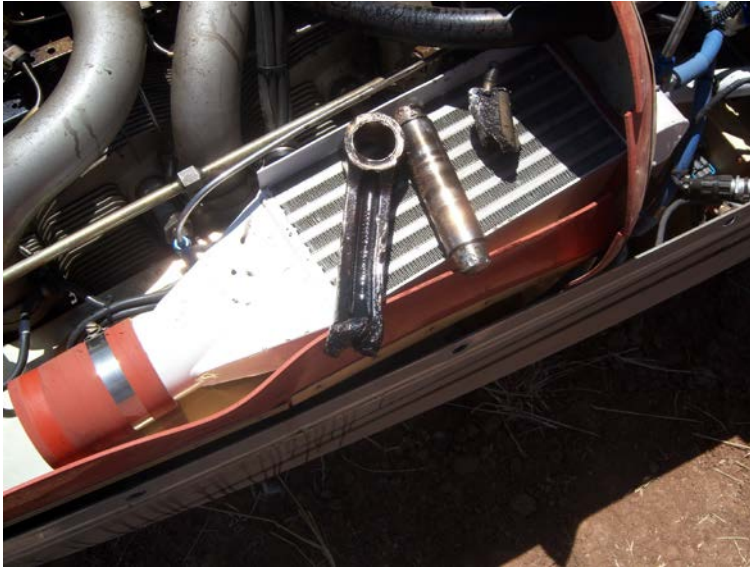
The engine was removed and examined at an engine overhaul facility. The inspection revealed that the number two cylinder connecting rod (Figure 3) had separated from the crankshaft due to extreme heat and ruptured the crankcase. A detailed examination did not identify any external oil leaks or internal defects that were not as a result of the lack of oil. 2.1 quarts of oil was drained from the engine sump.

Figure 3: Engine number two cylinder failed parts

The average oil consumption for the combined accident and previous flight was about 0.5 quarts per hour which is near the upper end of the maximum oil consumption⁷ for the engine.
