# Separation issue between a Kavanagh Balloons E-300, VH-LPG, and freight train 4K26

near Northam Aerodrome, Western Australia, on 11 November 2015

**ATSB Transport Safety Report**  
Aviation Occurrence Investigation  
AO-2015-136  
Final – 13 April 2016

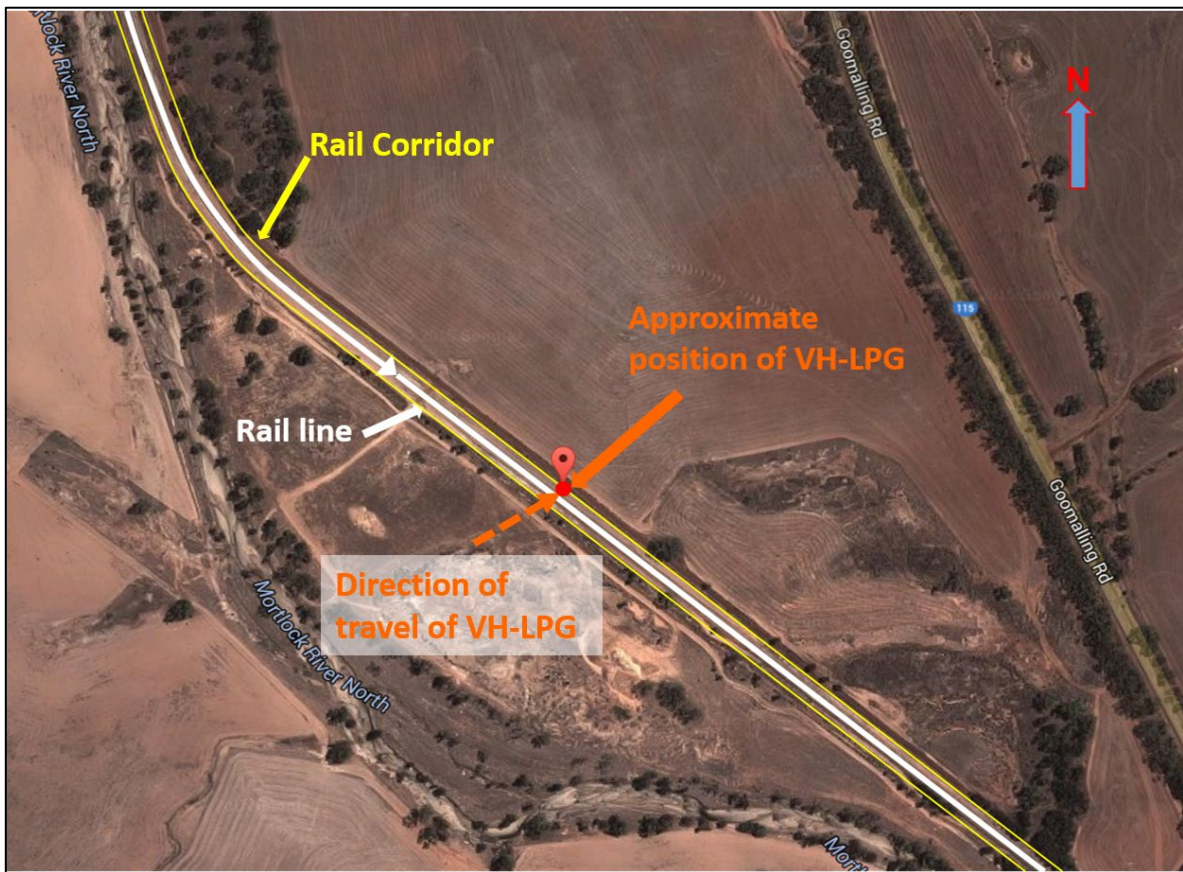
Early on the morning of 11 November 2015, a Watco freight train, 4K26, was travelling southbound on the Frenches to East Northam rail line in Western Australia. The train was travelling at about 60 km/hr along a section of track as it approached a left corner, approximately 3 km north of Northam (Figure 1). As the train rounded the corner, the driver saw a hot air balloon in close proximity to the rail tracks. The driver observed that the balloon was low to the ground and inside the rail corridor,<sup>1</sup> to the left side of the track (Figure 2).

**Figure 1: Location of incident with rail line (white) showing direction of travel of the train, the approximate width of the rail corridor (yellow), the direction of travel of the hot air balloon (orange dashed line) and the approximate position of the hot-air balloon (red mark)**

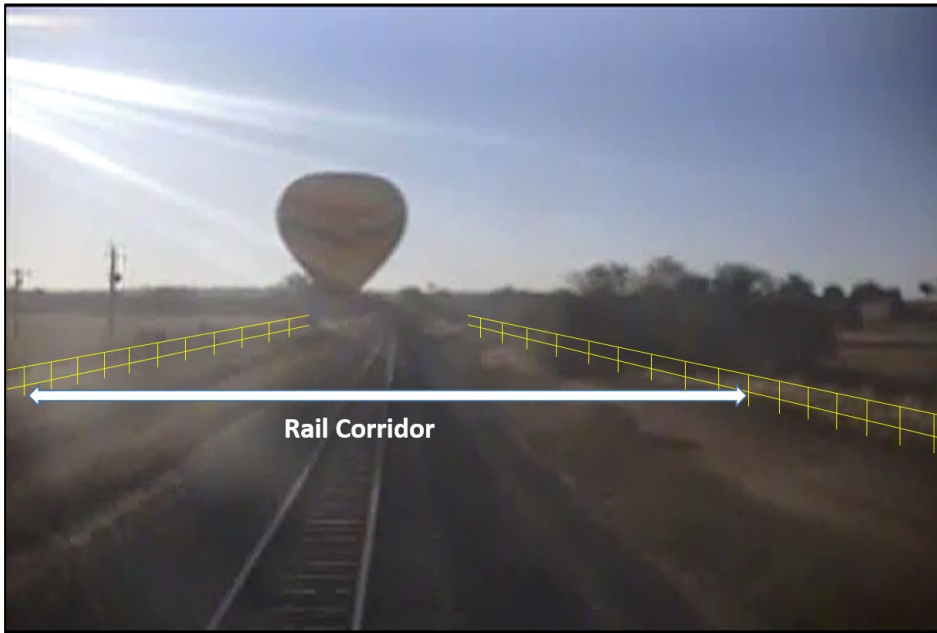
**Figure 2: View from train driver's cabin as the train rounded the corner with the approximate position of the fences (yellow) either side of the rail line marking the rail corridor**

The driver estimated that the balloon was approximately 200–300 m in front of the train and applied full service brakes. However, the driver realised there would be insufficient distance for the train to come to a complete stop before passing the balloon. At the same time as applying the brakes, the driver also sounded the train's horn to warn the balloon that the train was approaching. The driver slowed the train to about 20 km/hr as it passed the balloon.

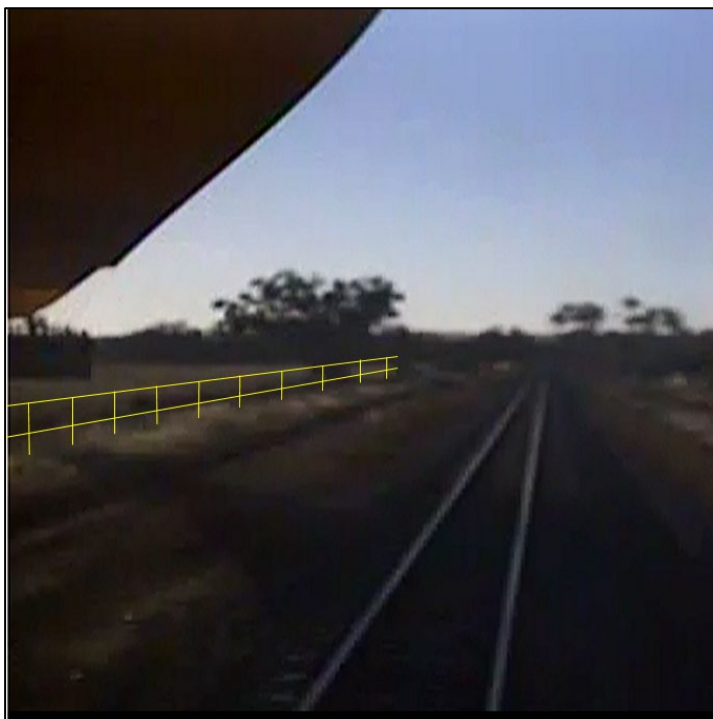
**Figure 3: Picture from the train driver's cabin just before the train passed the balloon's position with the approximate position of the fence on the left side (yellow)**

The pilot crossed the rail line from the south-west to the north-east at a height of approximately 50–60 ft, and then descended to around fence top height. The pilot's intention was to land inside the paddock, just after the fence line at the edge of the rail corridor. As the train came around the corner, the hot air balloon was on descent to the paddock. When the train passed the balloon, the pilot reported the basket was just above fence height and moving away from the rail tracks. The balloon crossed over the fence and landed in the paddock without incident.

The balloon operator is amending the Low Flying Operations section of their Operations Manual to include the following:

- A minimum height of 50 feet shall be maintained when the flight path of the balloon will cause it to cross over a road reserve or rail corridor.
