# Hard landing involving Kavanagh Balloons E-300 VH- LPG

near York, Western Australia, 16 July 2016

**ATSB Transport Safety Report**  
Aviation Occurrence Investigation  
AO-2016-080  
Final – 14 October 2016

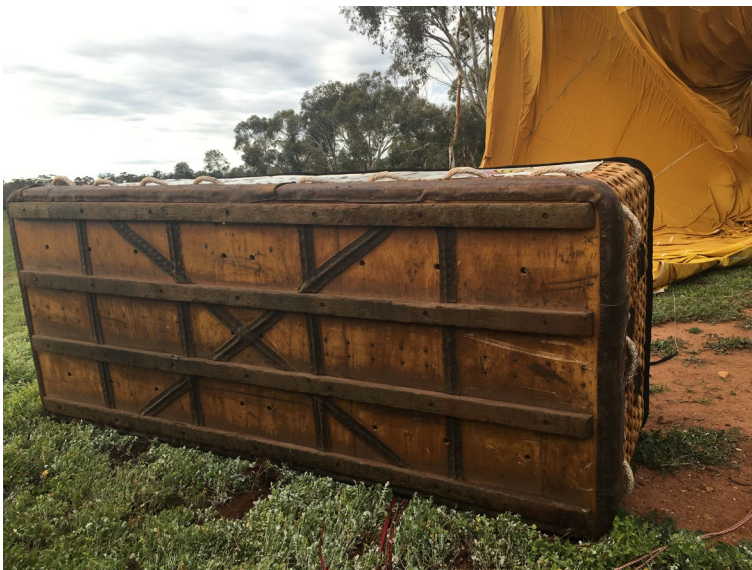
**Figure 1: Final resting position of VH-LPG**

The balloon departed at about 0700 Western Standard Time (WST), and reached a maximum altitude and speed of about 3,500 ft above mean sea level (AMSL) and 39 kt, respectively. The balloon tracked in a south-easterly direction. During the flight, the pilot instructed the ground crew to proceed to the racecourse at York, WA, to meet the balloon for the landing. After about 52 minutes of flight covering a distance of about 33 km, the pilot made an approach to a vacant paddock near York. The balloon made an initial ground contact with about 15 kt forward speed. When the balloon struck the ground, the pilot was ejected from the balloon basket. The basket was then dragged over the top of the pilot as the balloon envelope continued to deflate. The balloon envelope came to rest draped over trees and a fence with the basket lying on its side (Figure 1).

The pilot was seriously injured and air lifted to the Royal Perth Hospital. One passenger received a minor injury and the balloon sustained minor damage.

The pilot of the balloon was seriously injured during this accident and therefore not able to participate in an interview. There was no pilot restraint harness fitted to the balloon on the incident flight.

The operator has modified all their hot-air balloons and fitted them with pilot restraint harnesses.
