Engine failure involving a Boeing Company 737-838, VH-XZB

En route from Auckland, New Zealand to Sydney, New South Wales, on
18 January 2023

ATSB Transport Safety Report

AO-2023-007

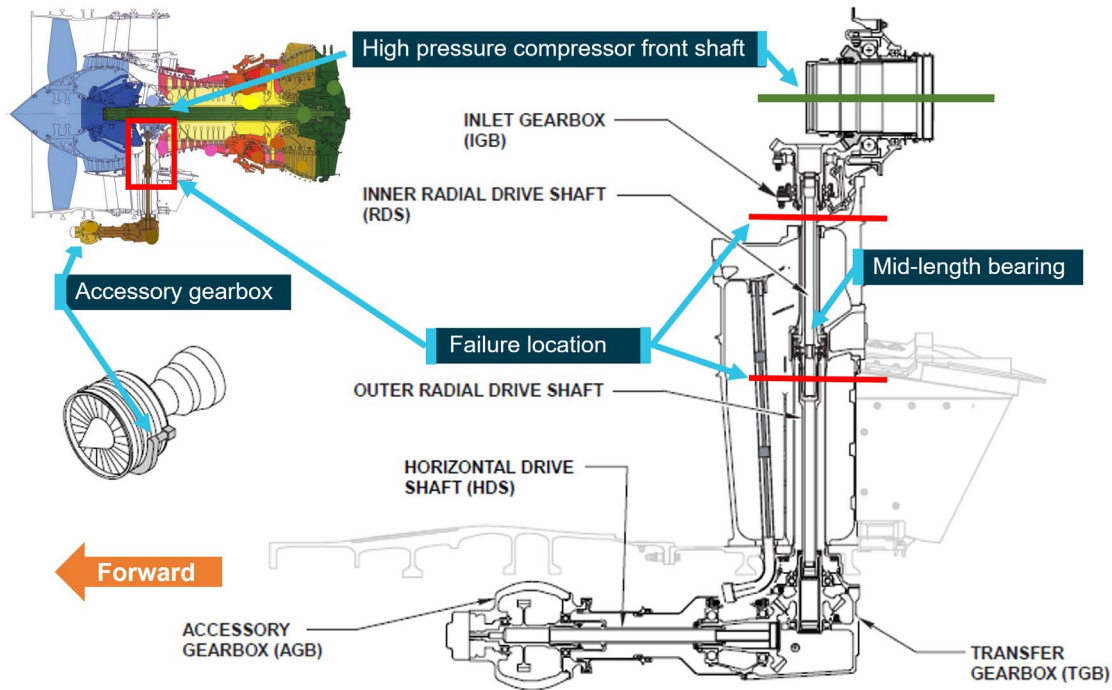
Figure 2: CFM56-7B engine, showing the accessory gearbox location, associated driveshafts and failure locations (red line)

An engine teardown inspection was conducted by the engine manufacturer at their technical facility in Malaysia and was observed by Qantas and the Air Accident Investigation Bureau Malaysia (on behalf of the ATSB). The examination identified that the inner radial driveshaft separated at 2 locations, at the mid-length bearing and near the upper spline (Figure 2). Subsequently, the mechanical discontinuity between the HPC shaft and accessory gearbox resulted in loss of fuel pump pressure and uncommanded shutdown of the engine. The mid-length bearing oil feed nozzle appeared clear (nil blockage). There was secondary damage to some components as the engine spooled down.

The failed driveshaft also prevented the starter from driving the HPC, which prevented the in-flight engine restart.¹²

The manufacturer advised that the level of deterioration of the failed driveshaft and mid-length bearing prevented identification of the separation initiator. Further, the inner driveshaft oil supply features were destroyed by the bearing failure and therefore its condition at the time of the event could not be determined. Nevertheless, the engine manufacturer reported that the rupture of the inner driveshaft was considered the primary failure.

It was noted that the CFM56-7B world engine fleet had reported 7 similar radial driveshaft bearing events since 2012. However, there was no consistent component time accumulation prior to the failure. At the time of this incident, the approximate totals for the worldwide fleet were 15,200 engines, with 500 million hours in-service and 258 million cycles in-service.

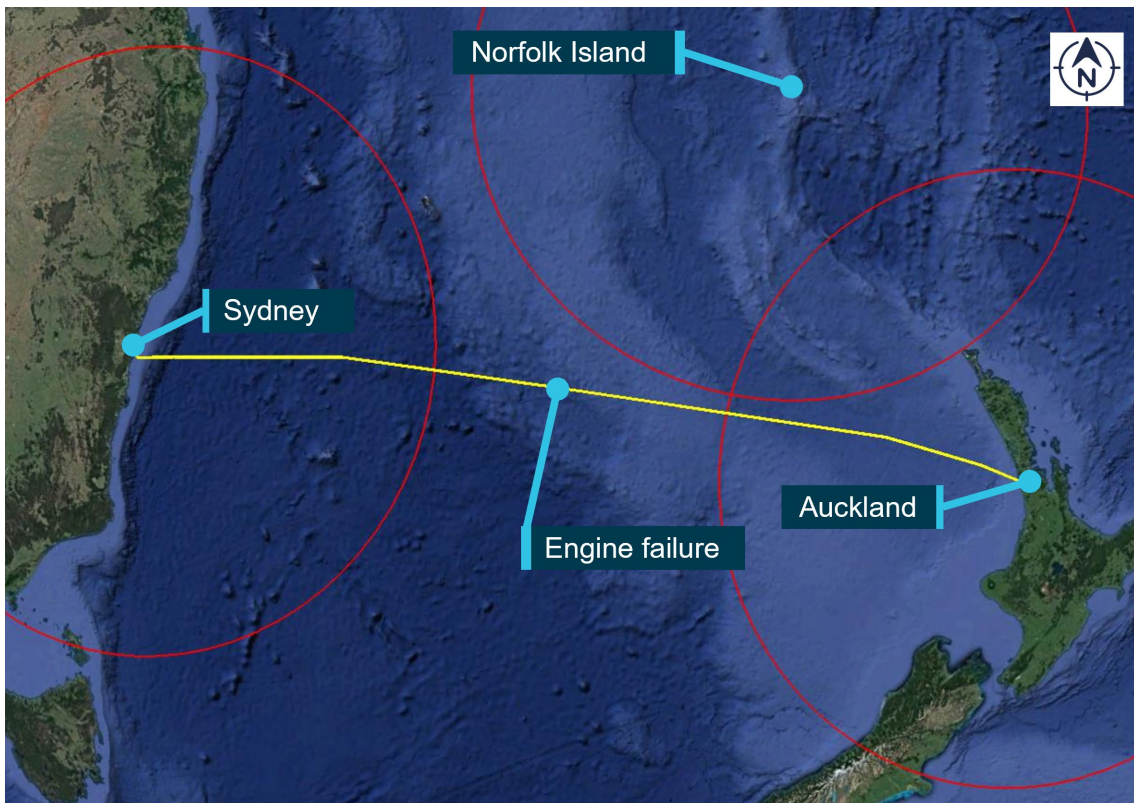
Figure 3: Engine failure location with respect to the 400 NM (741 km) EDTO radius from nearby alternate airports

At the time of the engine failure, the aircraft was located about (distance from) (Figure 3):

- Auckland 611 NM (1,132 km) and a 180° turn
- Sydney 560 NM (1,037 km) continuing on the current track
- Williamtown/Newcastle 550 NM (1,019 km) with a slight diversion to right of track
- Norfolk Island 484 NM (896 km) and a 115° right turn.
