Partial engine power loss and runway excursion involving Cessna 210L VH-FTM

near Groote Eylandt Airport, Northern Territory on 16 June 2023

ATSB Transport Safety Report
Aviation Occurrence Investigation
AO-2023-028
Preliminary – 28 August 2023

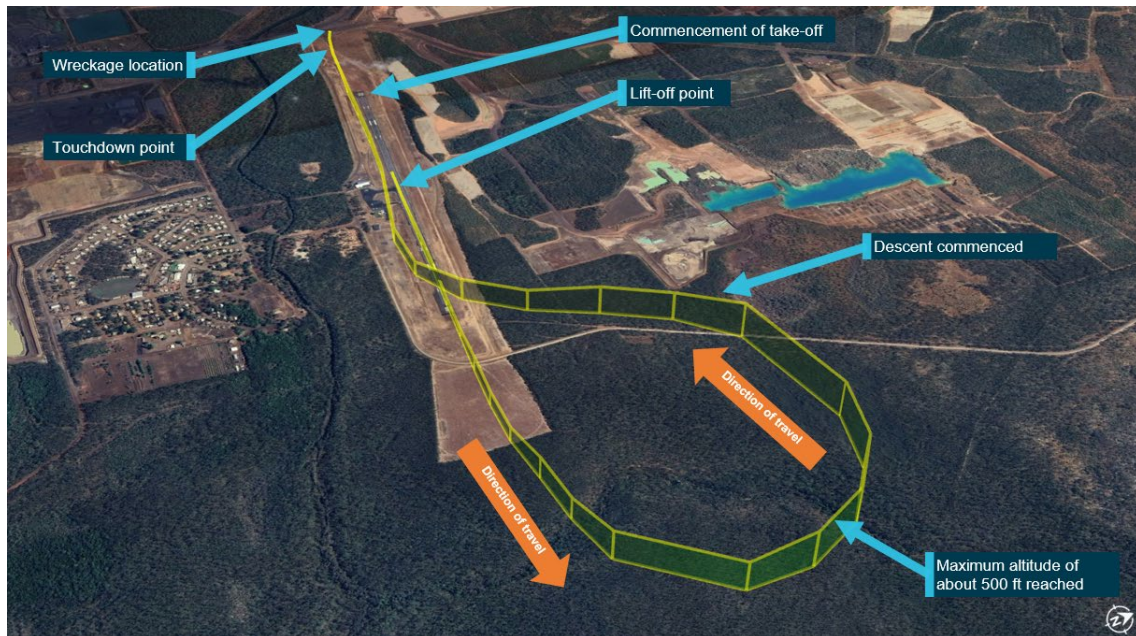
Figure 1: Flight path overview

Based on the pilot recollection and flightpath data recorded on board the aircraft, the aircraft became airborne at about the midway point of the 1,903 m long runway. Shortly after becoming airborne, at an altitude of about 100 ft, the pilot noted engine surging accompanied by fuel flow fluctuations. The pilot continued to climb the aircraft straight ahead with a recorded ground speed of about 83 kt. At about 1349:35, and at an altitude of about 400 ft, the pilot made a broadcast on the Groote Eylandt Airport common traffic advisory frequency (CTAF) advising that they would be returning to Groote Eylandt Airport. At the same time, the pilot commenced a left turn and continued to climb to an altitude of about 500 ft (Figure 1).

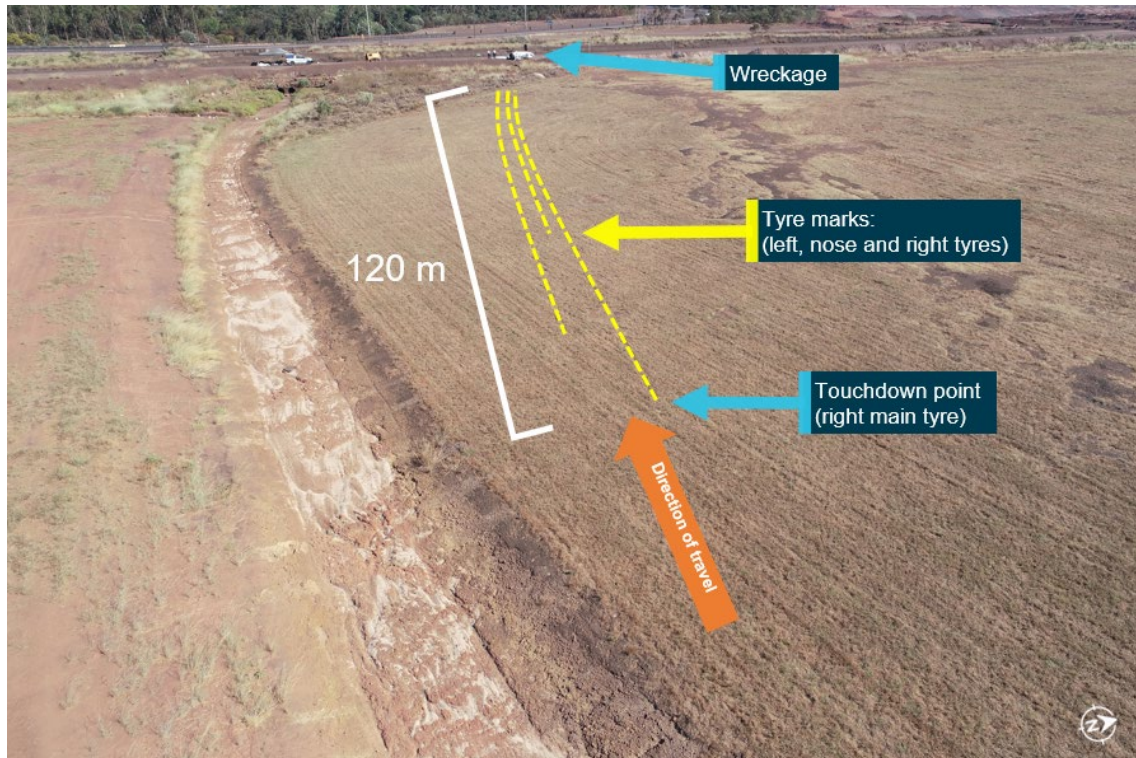
Figure 2: Touchdown point overview

The aircraft was captured by a second security camera as it touched down in a clear grassed area about 500 m west of the threshold for runway 10. The aircraft continued along the ground for about 120 m with a recorded groundspeed of 87–62 kt before hitting an embankment on the eastern side of a culvert (Figure 2). The aircraft traversed the culvert and then struck a larger embankment on the western side. The aircraft flipped and came to rest inverted on a mine service road (Figure 3).

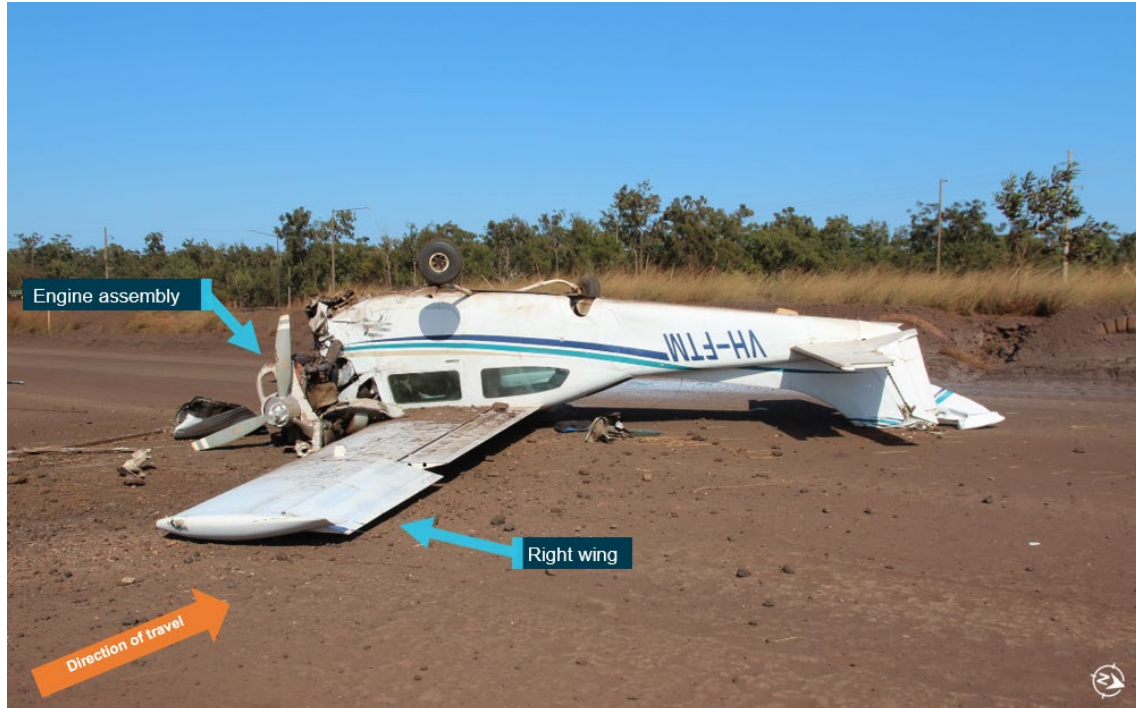
Figure 4: Wreckage of VH-FTM

The ATSB conducted an on-site examination of the aircraft wreckage. The aircraft initially struck the larger embankment on the western side of the culvert in an upright attitude. The culvert was located about 700 m to the west of the threshold for runway 10. The impact resulted in the detachment of the nose wheel and the right lateral displacement of the engine assembly. The aircraft then rotated vertically, pivoting at the nose, before coming to rest inverted (Figure 5).

All major sections of the aircraft's structure were accounted for at the accident site. Flight control continuity was established where possible and wing flaps² were assessed to have likely been in the retracted position at the time of impact, rather than in the landing position. The landing gear was in the extended position and propeller damage was indicative of low rotational power at the time of impact.
