# Close proximity involving Boeing 737, VH-VZO and Airbus A330, VH-EBJ

Sydney Airport, New South Wales, on 5 August 2019

**ATSB Transport Safety Report**

AO-2019-041

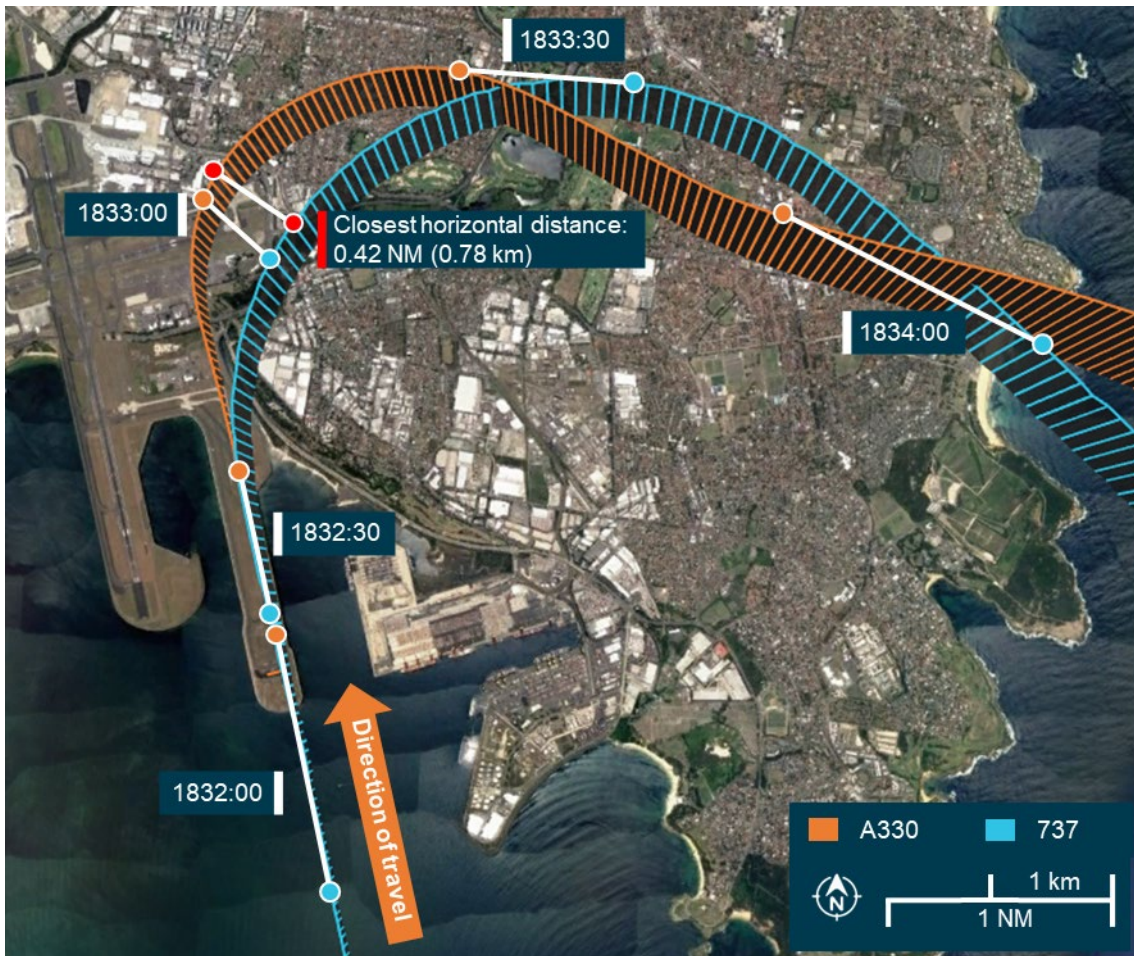
Figure 1: Overview of aircraft flight paths

White lines link the locations of the two aircraft at the same point in time.  
Source: Google Earth, annotated by the ATSB

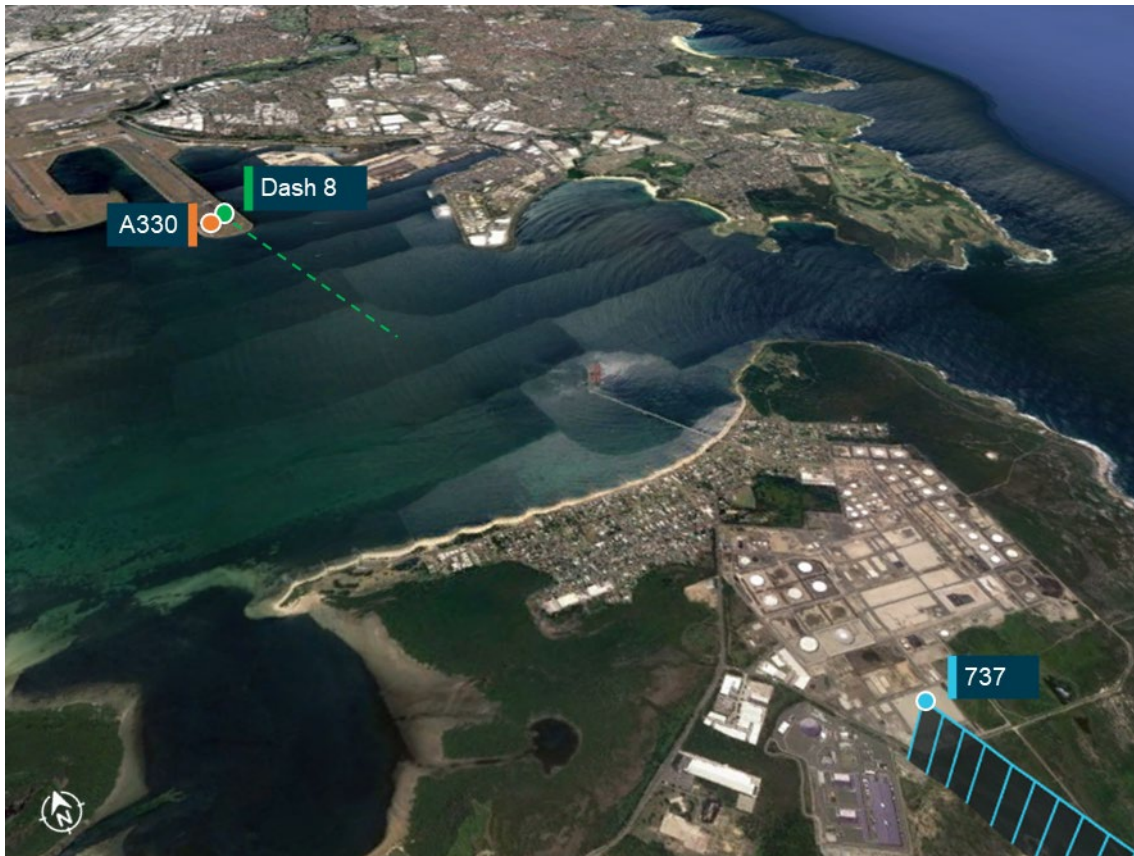
**Figure 4: Position of the 737 when the A330 was instructed to line up**

At 1831:04, as the Dash 8 crossed the runway 34R threshold, the trainee ADC instructed the A330 flight crew to line up and wait on runway 34R (Figure 4).

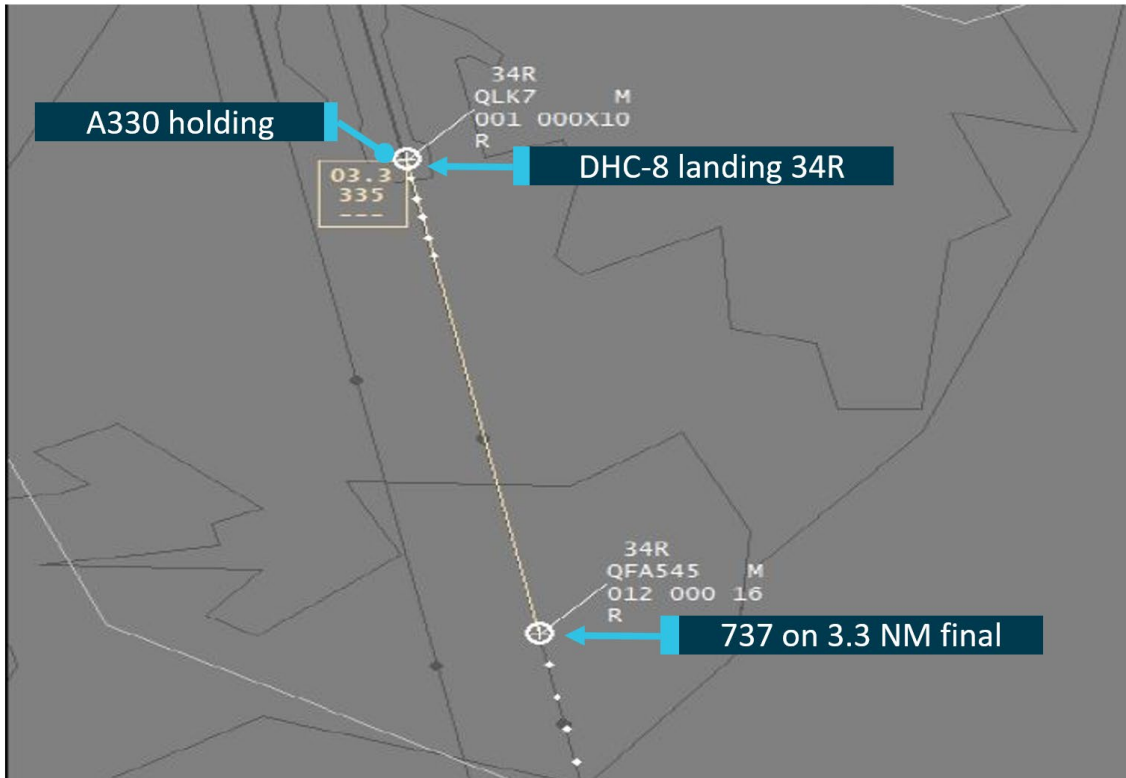
**Figure 5: Representation of an ATC display when the A330 crew was instructed to line up showing location of the A330, Dash 8 and 737 aircraft and an exemplar separation measurement (light yellow).**<sup>11</sup>

At this time, the 737 was 3.3 NM from the runway 34R threshold, fully configured for landing (gear down and flaps 30), and was decelerating through 153 kt (Figure 5).

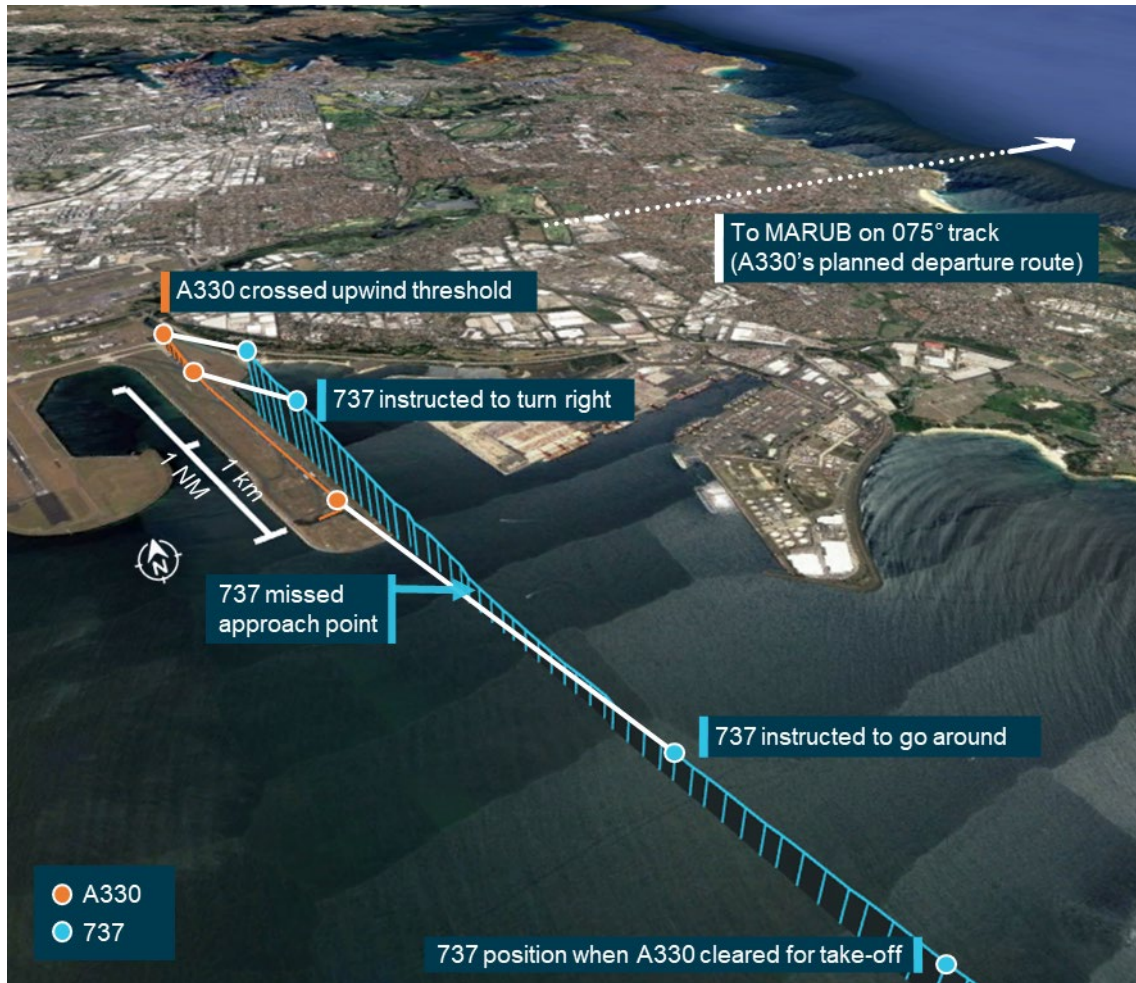
**Figure 6: Sequence from A330 clearance for take-off**

1.8 NM from the runway threshold with a ground speed of 140 kt. The A330 FO pushed the power levers forward for take-off once the aircraft was lined up at 1831:54.

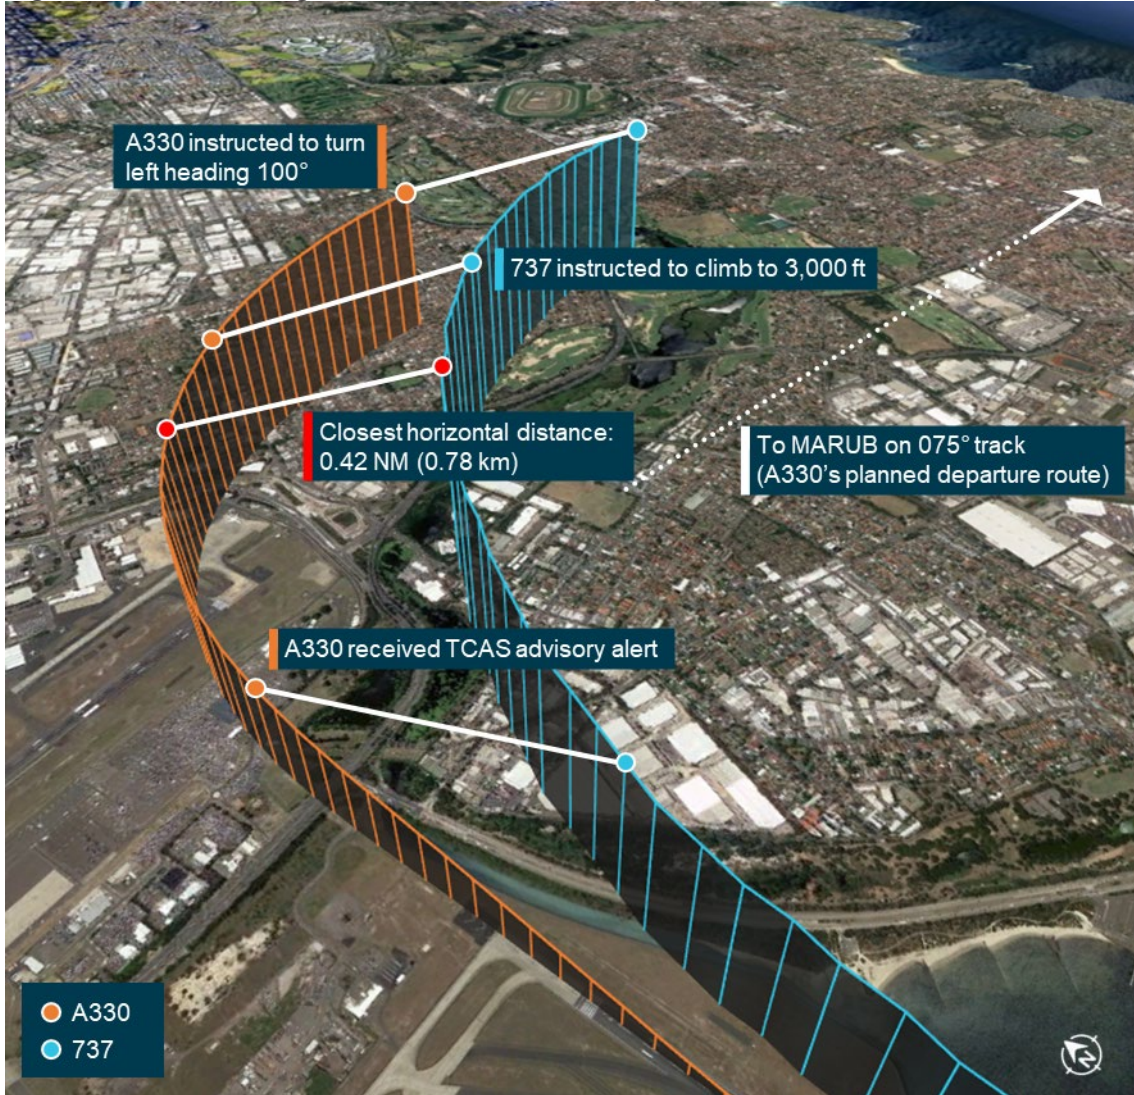
**Figure 7: Concurrent right turns and close proximity**

600 ft apart. In response, the A330 FO verbalised the TA and confirmed that they had control in accordance with Qantas procedures. Figure 7 shows the position and flight paths of the aircraft through this period, and Figure 8 shows how an ATC display might appear if a controller measured the separation at this point.

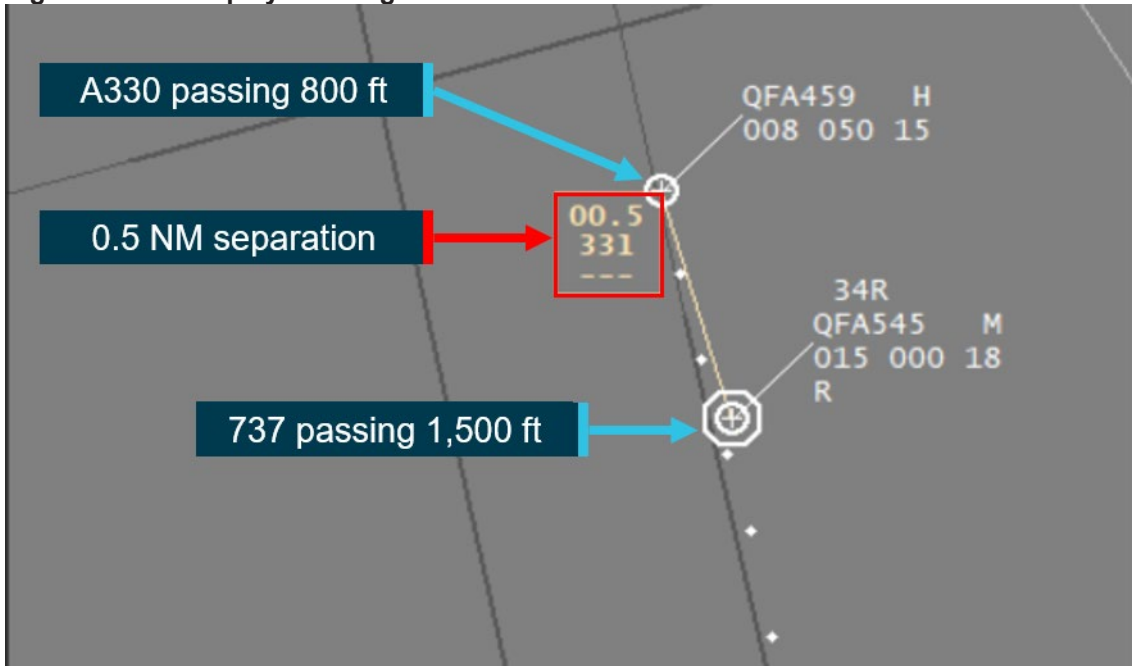
Figure 8: ATC display showing both aircraft at the time of A330 TCAS TA

*Image represents a typical ATC display but is not necessarily representative of the display shown to any controller at the time of the occurrence. The separation measurement was manually added during a later replay of the occurrence and is approximate. Source: Airservices Australia, annotated by the ATSB*

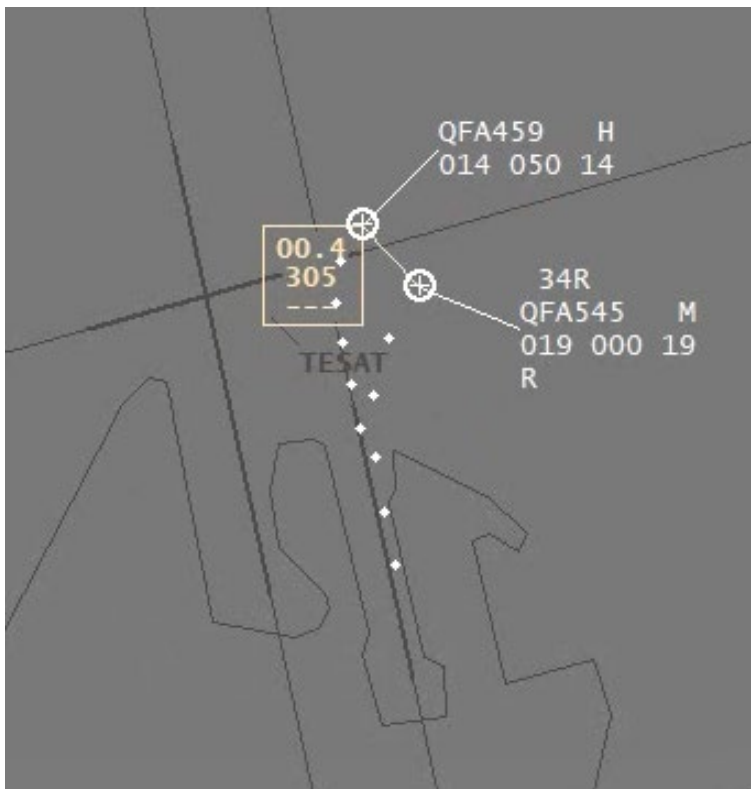
**Figure 9: Indicative ATC display at 1833:03 (the time of the closest horizontal distance)**

The A330’s heading was about 070° at the time, almost directly behind the 737, with both aircraft turning right. The A330 was accelerating slowly through 158 kt while the 737 was maintaining about 205 kt before accelerating further; as a result, the distance widened.

*Image represents a typical ATC display but is not necessarily representative of the display shown to a controller at the time of the occurrence. The separation measurement was manually added during a later replay of the occurrence and is approximate. Source: Airservices Australia, annotated by the ATSB*

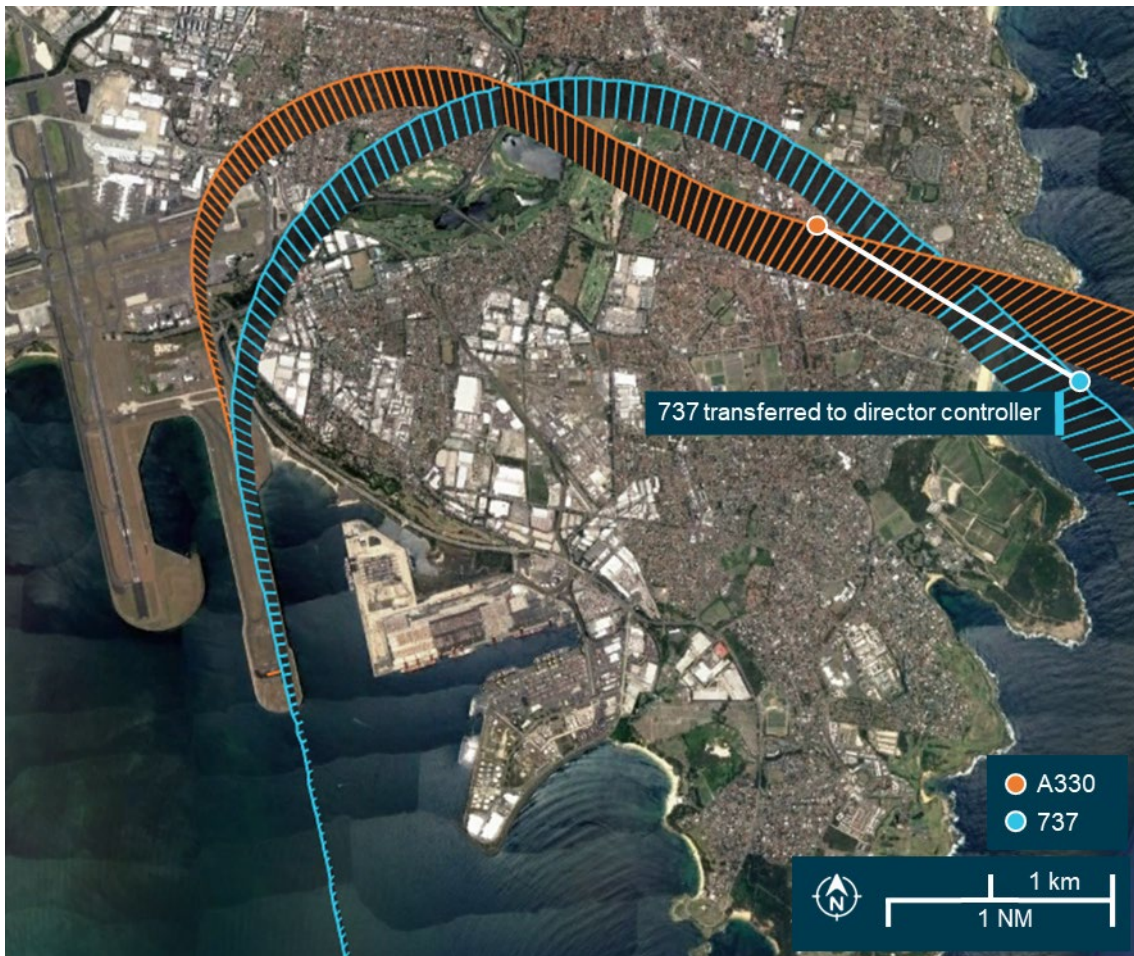
Figure 10: Flight paths after the occurrence

The two flight paths then crossed with the 737 about 0.8 NM (1.5 km) ahead of the A330 (Figure 10). The trainee ADC asked the 737 flight crew to contact the approach controller at 1834:03 without first coordinating with the approach controller. At this time the two aircraft were about 1.2 NM (2.2 km) and 400 ft apart. This was less than the surveillance separation standard required for the transfer without coordination.<sup>20</sup>

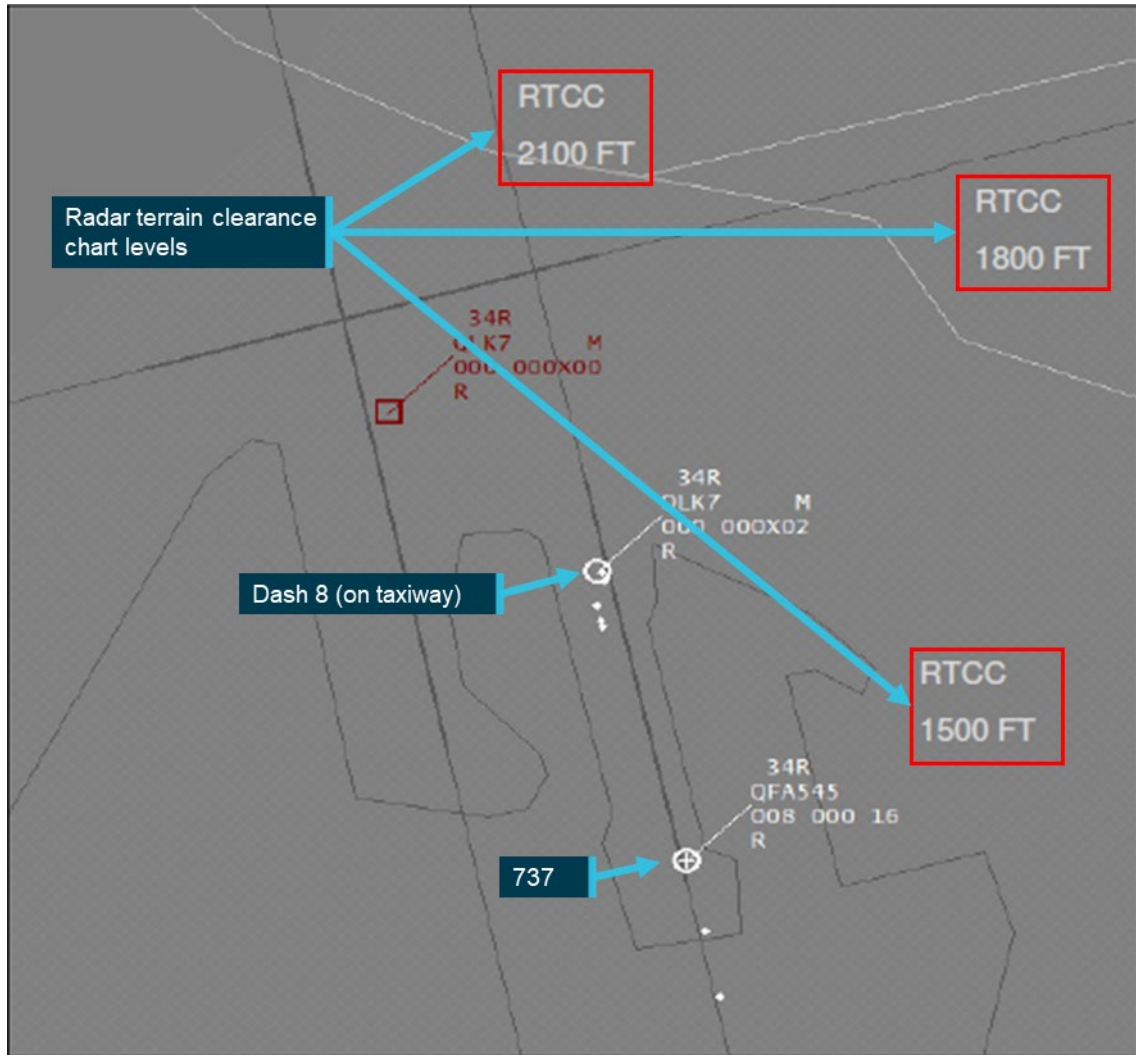
**Figure 11: Extract of replayed ATC display showing 737 location when its crew was instructed to turn right (from 800 ft) and relevant radar terrain clearance chart (RTCC) levels**

situation as the occurrence. The general view was that in line with the requirement for controllers to provide a duty of care in an unsafe situation, their professional judgement was that the least-risk option to aircraft was to issue vectors below MVA at night and issue a safety alert terrain to the flight crew. These controllers were aware this was not in accordance with the MATS but commented that it had become a normalised solution to the hazard.

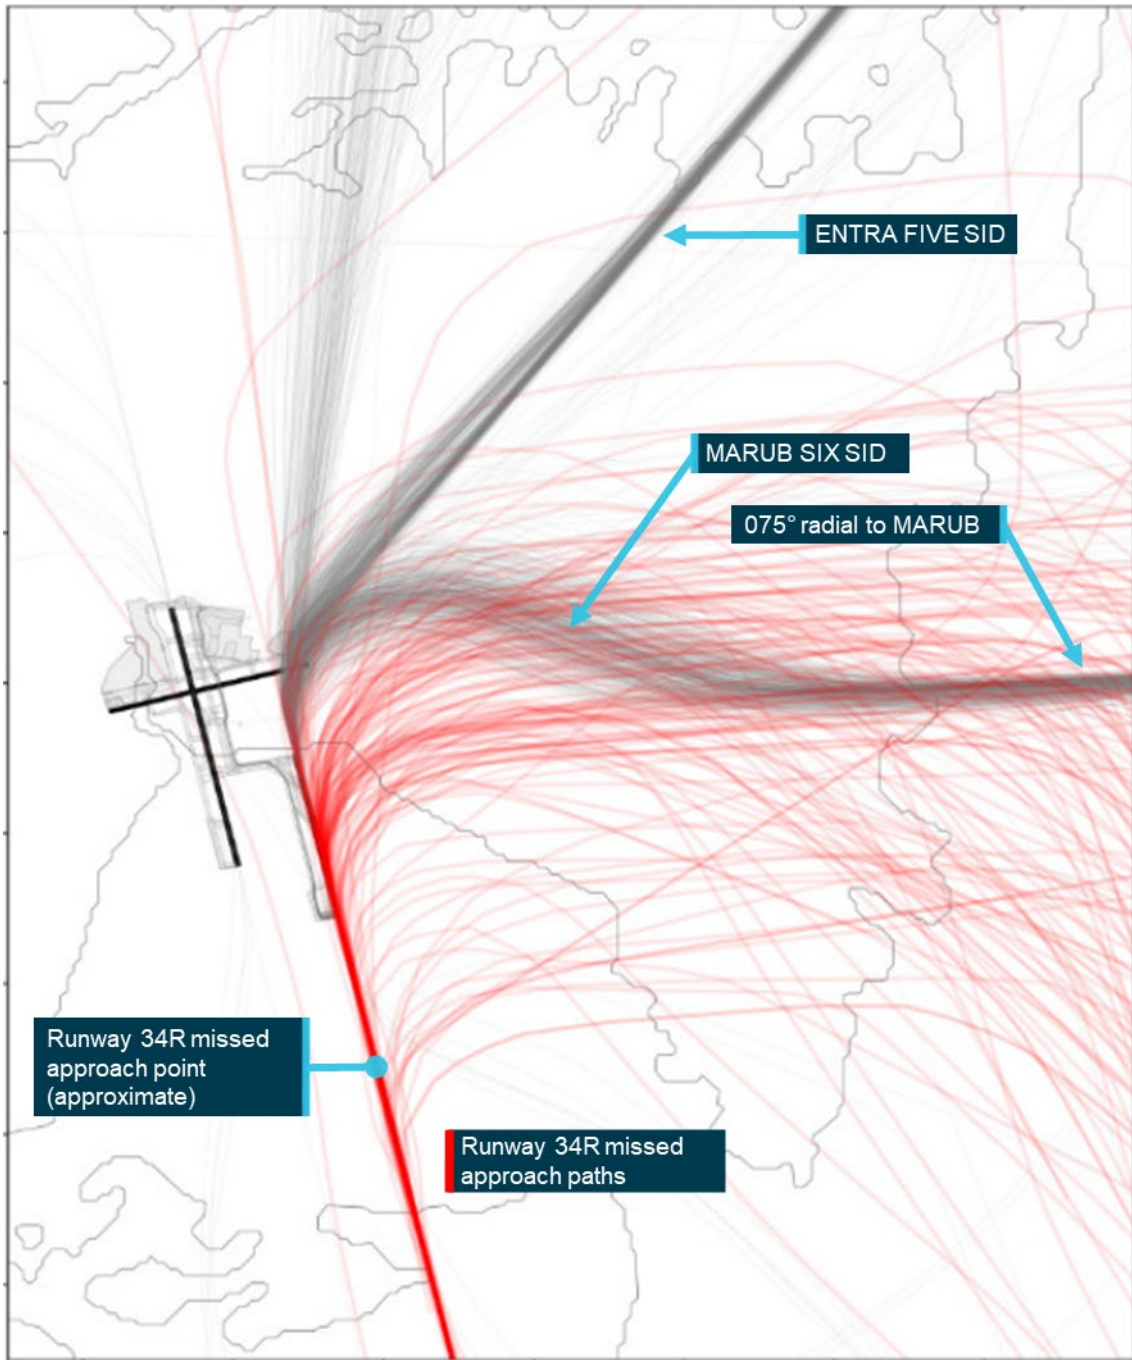
**Figure 15: Aircraft tracks for runway 34R missed approaches (red) compared with tracks following the MARUB SIX and ENTRA FIVE SIDs (grey) from July 2017 to March 2019**

The OJTI reported that in their experience with similar situations to the occurrence, even with 5 NM spacing, a missed approach still results in conflict.

Some of the variation in aircraft tracking, particularly for missed approaches, is likely to be due to control instructions issued. In addition, this diagram shows all departures and missed approaches, not just those that are concurrent, for which additional data was not available. Source: Airservices, annotated by the ATSB.

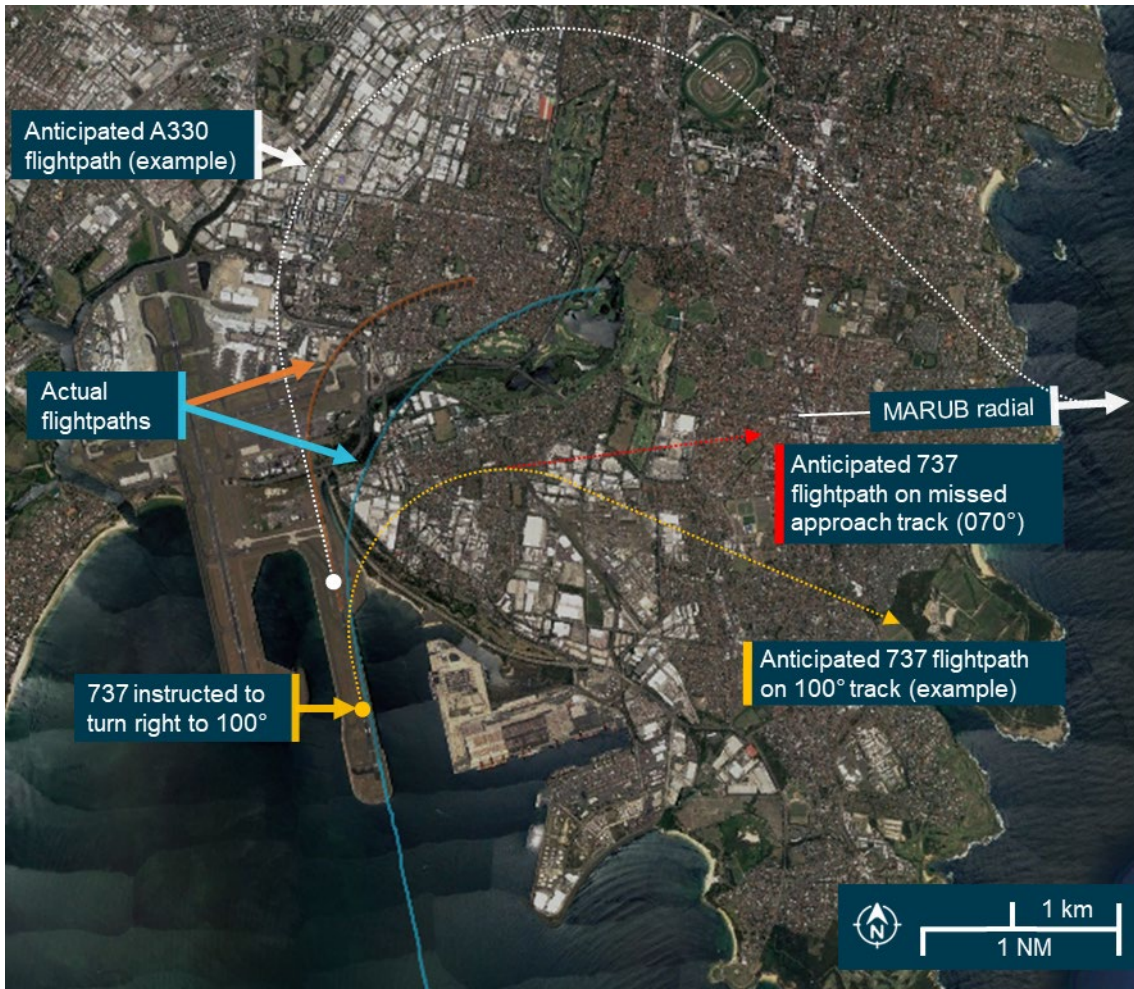
**Figure 16: Trainee ADC’s likely mental model of the approximate flight paths the aircraft were expected to take after issuing the instruction for the 737 to turn**

Partial flight paths of the occurrence aircraft are shown for comparison (in faint orange and blue).  
Source: Google Earth, annotated by the ATSB.

The trainee ADC’s separation model relied on the assumption that the flight path of the A330 would be further north than it was (prior to intercepting the 075 radial). The trainee ADC recalled that the A330’s turn was earlier and tighter than their recollection of other widebody jet aircraft taking off from that runway. Although that was their experience, the flight path was reasonably consistent with typical MARUB SIX departures (see *Missed approach and departure procedures* and Figure 15).

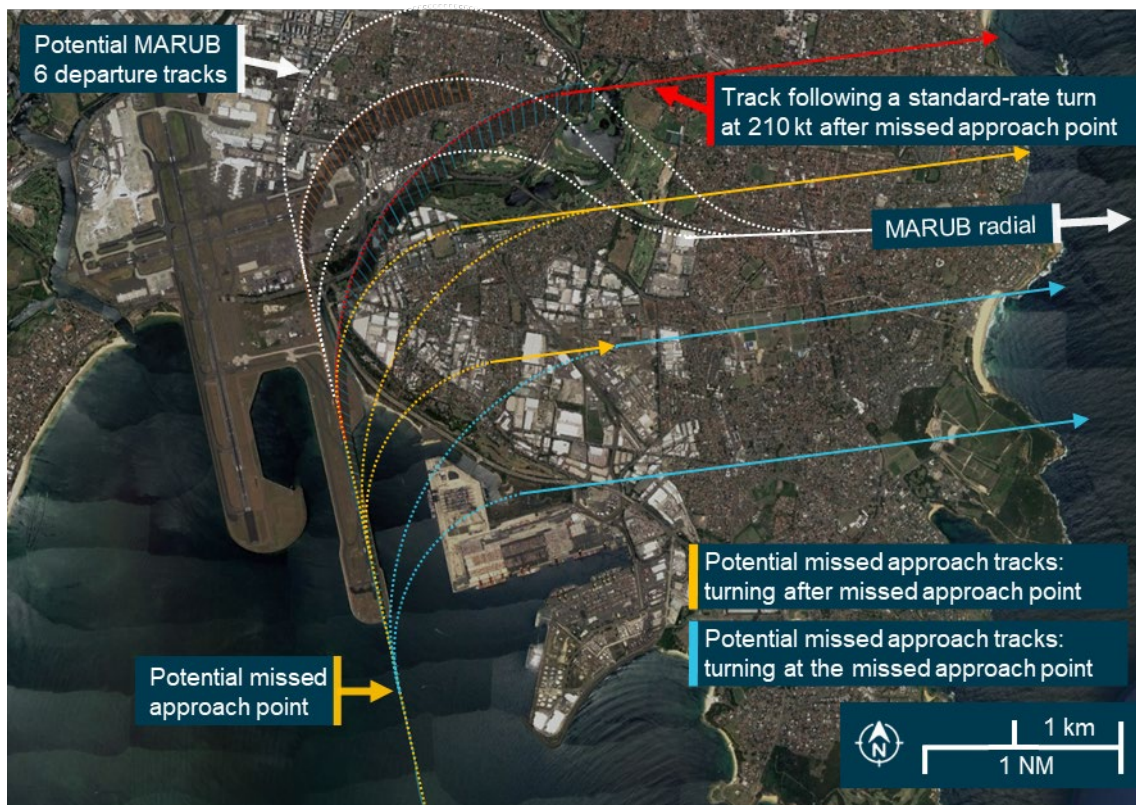
**Figure 17: Potential aircraft tracks for runway 34R missed approaches compared with tracks following the MARUB SIX SID**

Although each instrument procedure separately met regulatory design requirements, the concurrent use of the MARUB SIX SID and the runway 34R missed approach procedure could result in converging flight paths, depending on the timing and radius of each turn as well as the relative speeds (Figure 17).

Standard-rate turns are taken at 25° bank. All turns in blue, orange and white are shown with a constant 0.8-NM radius, which is a standard-rate turn at 160 kt, or a 1.4-NM radius, which is a standard-rate turn at 210 kt. The red turn has a constant 1.4-NM radius. Partial flight paths of the occurrence aircraft are shown for comparison (in faint orange and blue). Source: Google Earth, annotated by the ATSB.
