Fuel starvation and forced landing involving Pilatus Britten-Norman Islander BN2A, registration VH-WQA

Moa Island, Queensland on 3 October 2022

ATSB Transport Safety Report

AO-2022-046

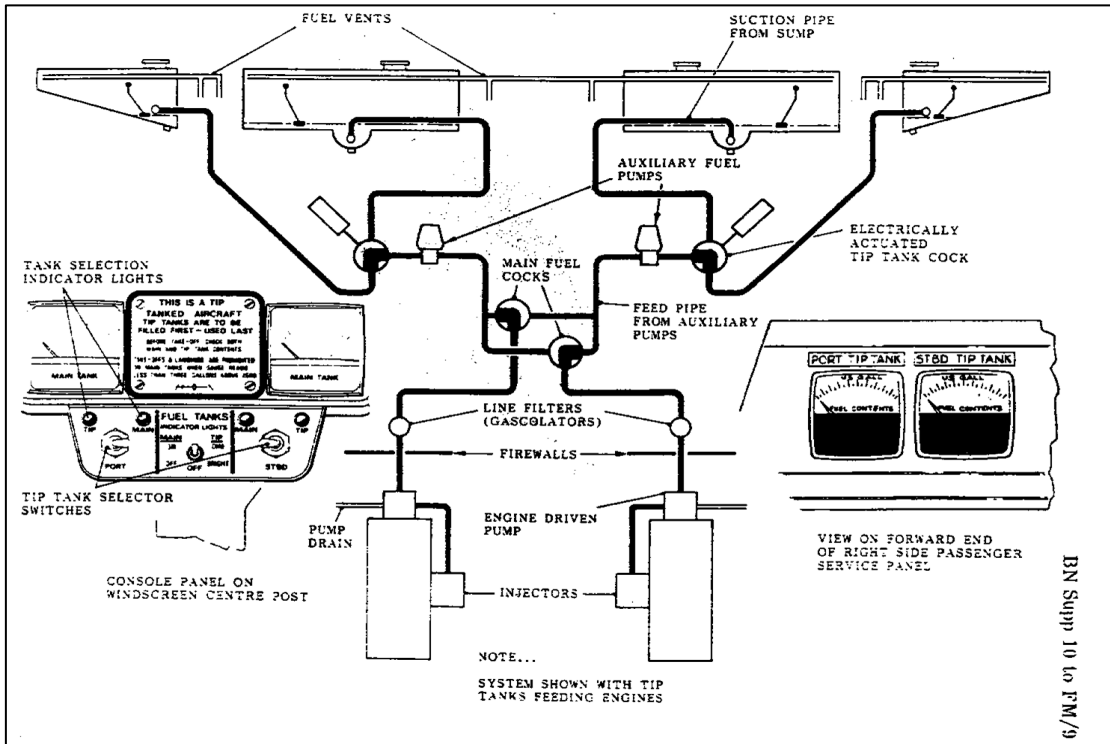
Figure 3: Fuel system

Fuel was fed from either the main or wing tip tanks (but not simultaneously) to the auxiliary fuel pumps, and then supplied to either engine via the main fuel cocks (Figure 3).

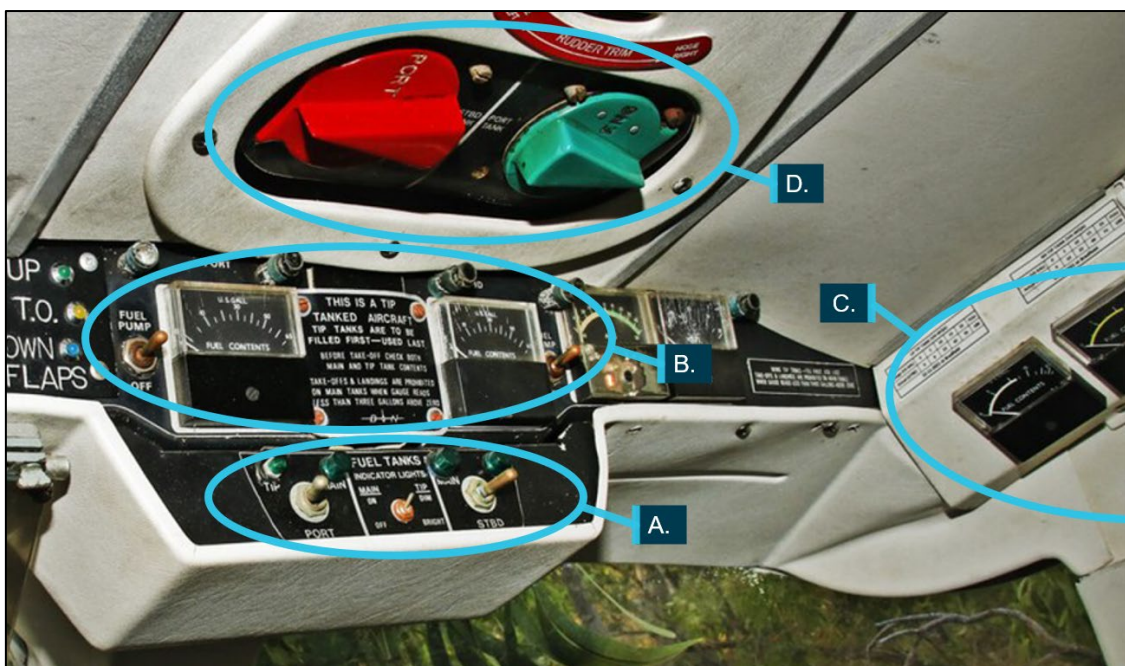
Figure 4: VH-WQA cockpit fuel system configuration

The electrically-actuated tank cocks were controlled via an overhead panel, located above the windscreen central pillar. The panel consisted of port and starboard switches that selected either the wing tip tank or main tank. There was a corresponding indicator light for each selection. The panel also contained a switch that controlled the brightness of the tip tank indicator light when that tank was selected (dim or bright). The same switch also determined the main tank indicator light when that tank was selected, either on or off (for the tip tank light positions of dim or bright, respectively) (Figure 4, Label A).

The main tank contents indicators were located above the fuel tank section panel, with corresponding auxiliary fuel pump switches located either side (Label B). The wing tip tank contents indicators were located on the right side of the cockpit above the side window (Label C). The main fuel cock rotary selectors were located above the main tank contents indicators (Label D).

- The pilot did not use the aircraft's wing tip tanks in accordance with the flight manual. In addition to aircraft structural considerations, this also increased the likelihood of an inadvertent inappropriate fuel tank selection.
- For Britten-Norman Islander aircraft fitted with wing tip tanks, but without the alternative pilot interface per service letter number SL145, the configuration and location of the fuel controls and tank quantity gauges were probably not conducive to rapid and accurate interpretation.

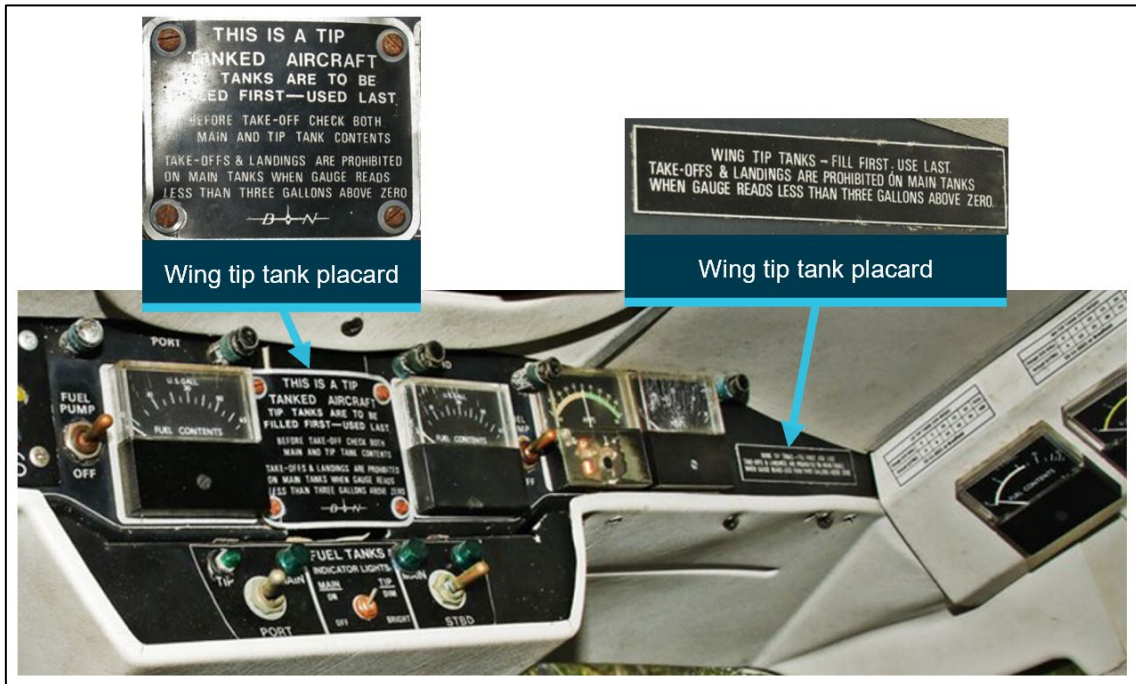
Figure 5: VH-WQA fuel system placards

Fuel system placards,⁴ highlighting the configuration and usage of the fuel tanks, were located between the main fuel contents indicators and to the left of the wing tip tank contents indicators (Figure 5). The placards indicated that wing tip tanks were to be used last (after main tanks), and that main tanks were not to be used for landings when the gauge reads less than 3 gallons.

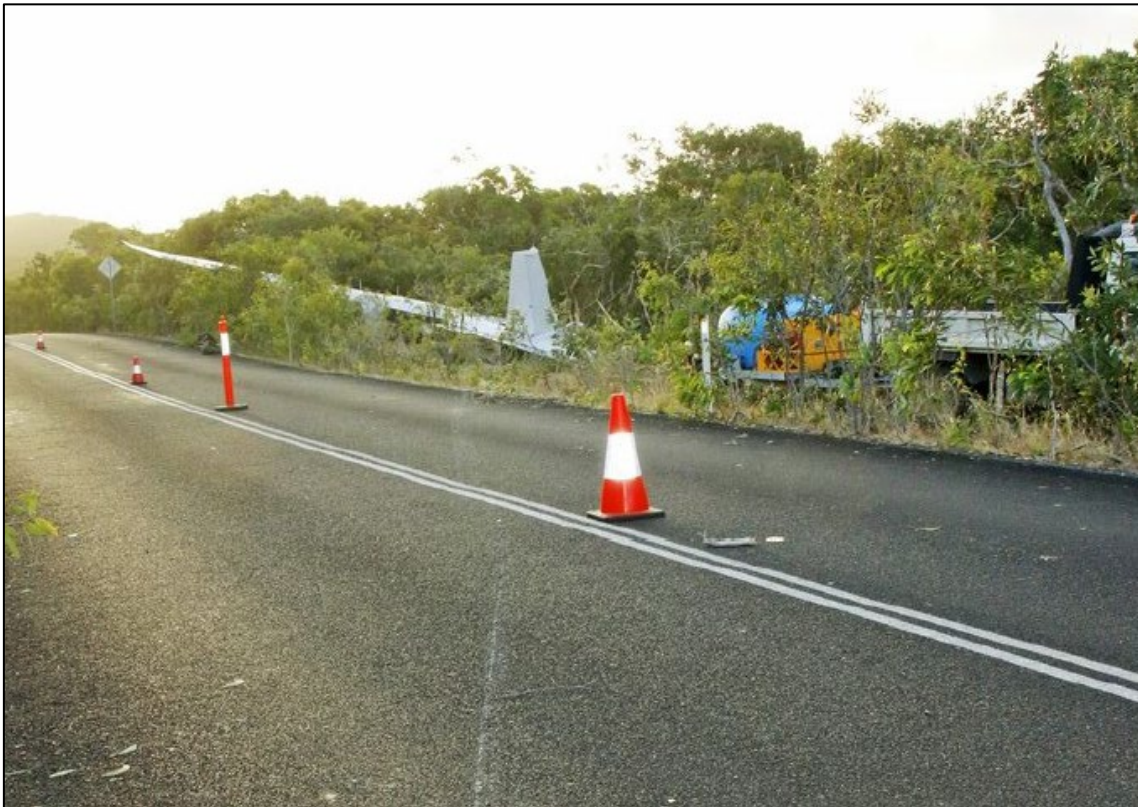
Figure 6: Accident site from road

The wreckage was located a short distance from the road in an area of low foliage approximately 6.5 km ENE of Kubin Airport. The undercarriage and empennage were separated from the aircraft and the fuselage was resting right wing low (Figure 6 and Figure 7). No obvious airframe or engine defects were reported by those that attended the site.

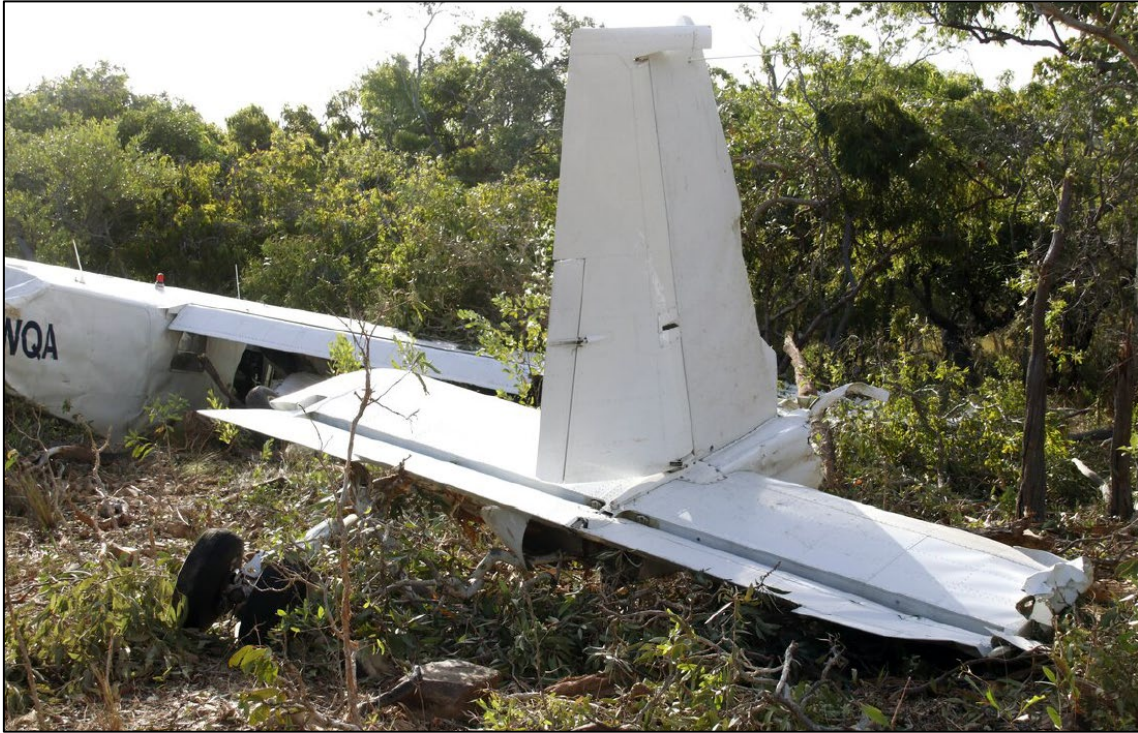
Figure 7: Accident site

The right main tank and wing tip tank were ruptured during the accident sequence. The left main fuel tank and wing tip tank were reported as being intact and found to contain approximately 60 l, and less than 500 ml of fuel respectively. No fuel contamination was apparent and the fuel selectors were found to work correctly when electrical power was applied to the aircraft. Table 2 depicts the positions of the fuel controls as documented in forensic photographs taken shortly after the accident. The wing tip tanks were selected for use, the auxiliary pumps were on and the main fuel cocks were selected 'off', which was consistent with the pilot's recollection of the occurrence.
