Pylon support link assembly fracture involving Bell 206L, VH-JSU

60 km south-west of Deniliquin Aerodrome, New South Wales, on 9 December
2022

ATSB Transport Safety Report

AO-2023-002

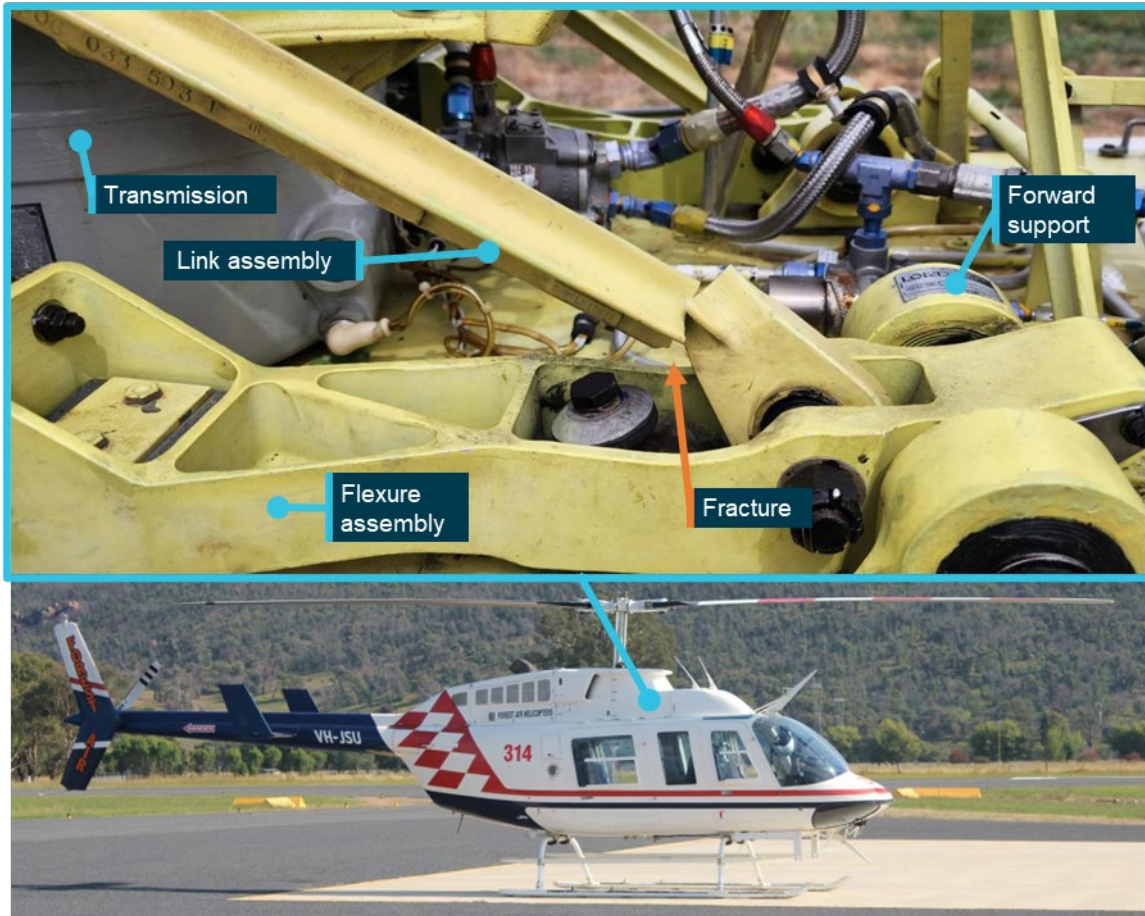
Figure 1: Right, forward, pylon support link assembly fracture

It was subsequently found that the right, forward, transmission link assembly had fractured (Figure 1). It was noted that the fractured ends of the link had become fouled on each other, which was considered to be the reason for cessation of the airframe vibration.

The uncommanded helicopter pitch nose-up and roll to the left was consistent with fracture of the right, forward, pylon support link assembly. Previous occurrences have resulted in a partial loss of control and forced landing, resulting in helicopter damage. The pilot in this instance was able to apply compensatory control inputs and continue the flight to a safe landing site, probably due to the fractured link being caught on itself and providing some residual support to the rotor pylon.

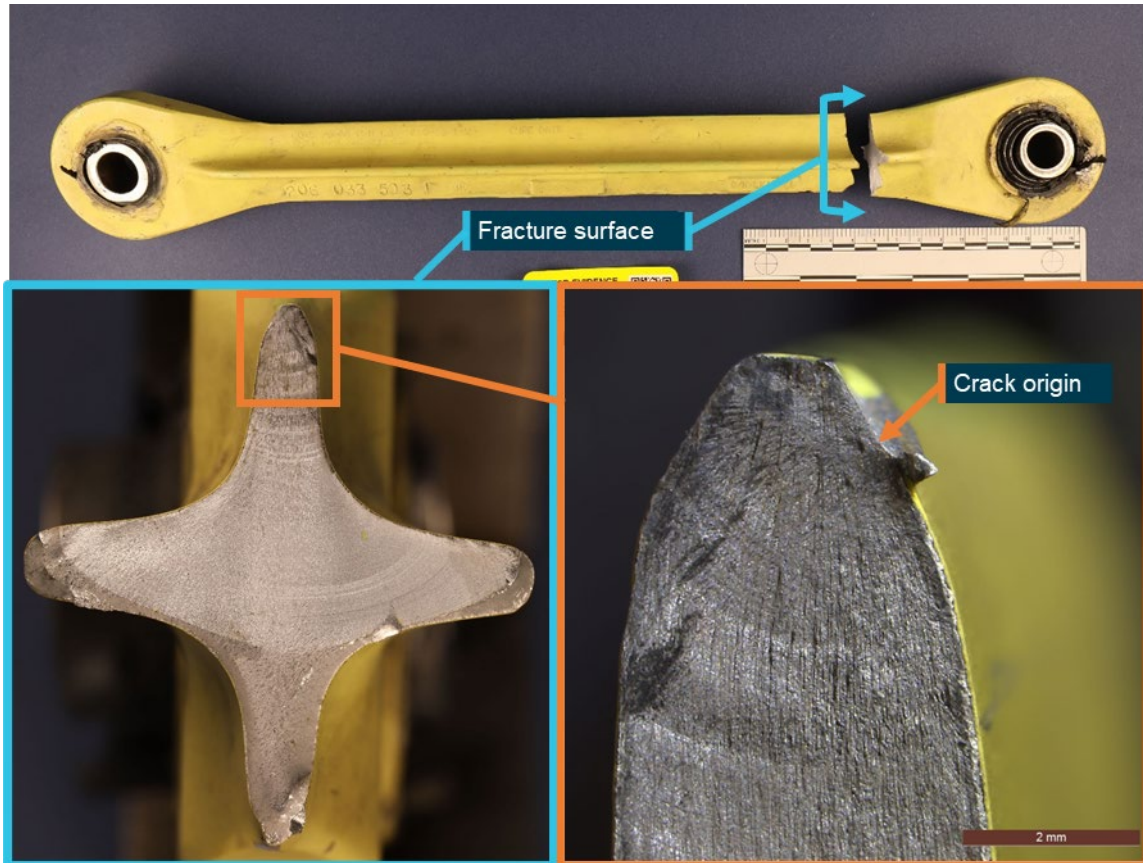
Figure 2: Fractured link assembly and fatigue crack detail

The link fractured approximately 75 mm from the centre of the lower bearing. The fracture surface showed evidence of a high-cycle fatigue crack extending through approximately three-quarters of the cross-sectional area (Figure 2). A shallow area of mechanical deformation was identified at the crack origin, which was estimated to be within the *Bell 206L Component Repair and Overhaul Manual* allowable limits.² Metallographic examination and hardness testing showed that the link was manufactured from a forged, high-strength aluminium alloy. The ATSB identified no material or manufacturing defects within the link that would significantly affect the fatigue life of the part.

The link assembly was shipped to Bell Textron for examination under the supervision of a representative from the United States Federal Aviation Authority. Bell confirmed that the link material and manufacture conformed to drawing requirements, and that the area of mechanical damage at the crack origin was within allowable limits. Bell concluded that the shim fretting damage and wear, and deterioration of the elastomer was consistent with bearing degradation during service and that, as the bearing degraded, loads in the link would have increased.

The degradation and wear of the lower elastomeric bearing would have progressively generated excess clearance and movement in the bearing, ultimately leading to the metal-to-metal shim contact. This would have also resulted in an abnormal loading condition through the link assembly during normal operation. In the absence of any pre-existing defect in the link, the bearing degradation was the most likely reason for initiation and propagation of the fatigue crack.

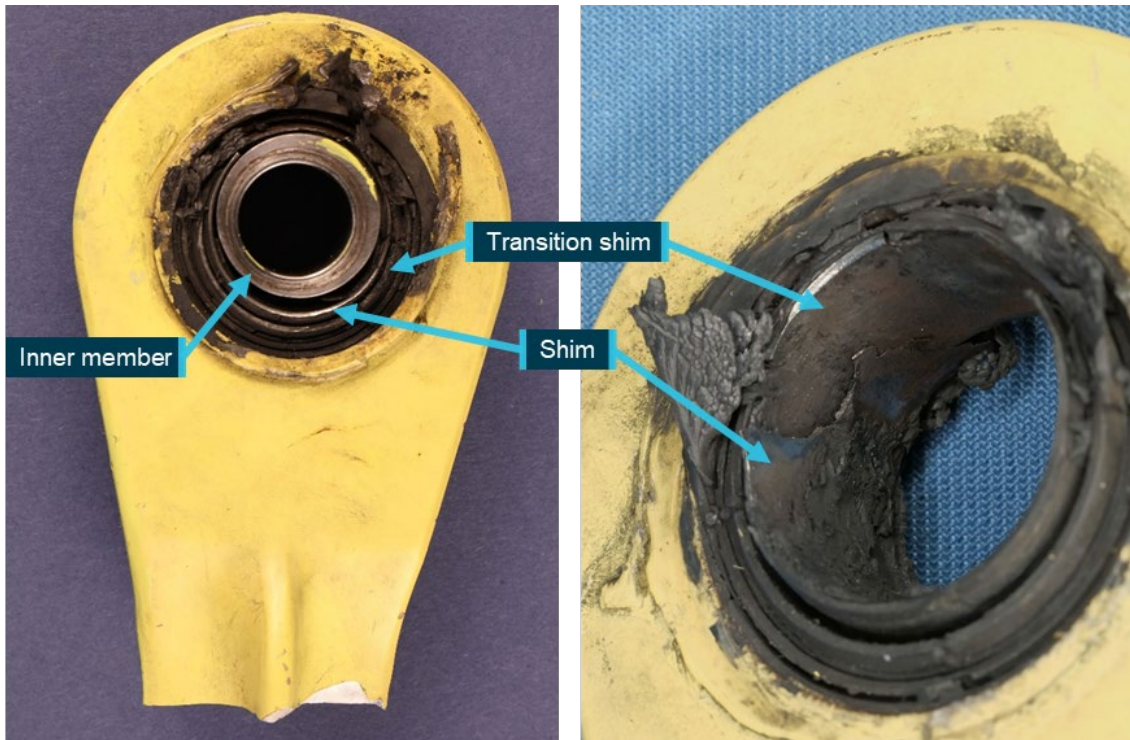
Figure 3: Lower elastomeric bearing

The lower elastomeric bearing exhibited severe wear. The bearing is comprised of 3 concentric steel shims plus an inner member, each separated by elastomer. The innermost shim had completely worn through as a result of metal-to-metal contact with the inner member and the transition shim (Figure 3). The elastomer had been abraded away and/or extruded from between the steel elements. Away from the primary wear, the elastomer showed cracking and cohesive failure. The degree of metal-to-metal shim wear indicated that the bearing had operated for an extended period of time in a degraded state, although the ATSB was unable to more accurately assess the operational period.

A clear polymer coating had previously been applied to the surface of the bearing/elastomer at both ends of the link assembly. This had become loose and largely separated from the elastomer of the lower bearing. The ATSB was unable to visually assess the surface condition of the upper bearing elastomer through the applied coating.

Inner member removed for right hand image to show shim wear. Note: Inner member was designed with non-concentric bore and this was not a feature of the bearing damage.
Source: ATSB

It was not possible to determine with certainty how long the helicopter had operated with visible wear on the bearings. However, the gradual degradation of elastomeric bearings under normal conditions, coupled with the extent of shim wear on the fractured link assembly bearing, indicated that the helicopter had been operating for an extended period with the link assembly bearing in a degraded state. It follows that some elastomeric degradation and shim wear would have been present at the most recent periodic inspection, 12 flight hours prior to the occurrence. However, the most significant degradation was positioned such that it would have been shielded to some extent by the installation in the flexure assembly (Figure 1 and 3). As the maintainer had not identified and applied the maintenance manual requirement to remove the link assemblies for inspection, the likelihood of detection of cracked or degraded bearing elastomer was reduced.

Forest Air Maintenance Engineering updated their maintenance scheduling to include the requirement to remove the link assemblies for detailed examination in accordance with the maintenance manual.

To improve detection of elastomer degradation and in consultation with the helicopter manufacturer, the maintainer has elected to omit the protective silicone adhesive layer from the bearings. The maintainer is instead proactively managing the source of any fluid leaks to limit the likelihood of oil contamination of the bearings.
