Runway incursion involving Diamond Aircraft Industries Inc. DA 40, VH-ERE

Sunshine Coast Airport, Queensland on 7 May 2023

ATSB Transport Safety Report

AO-2023-023

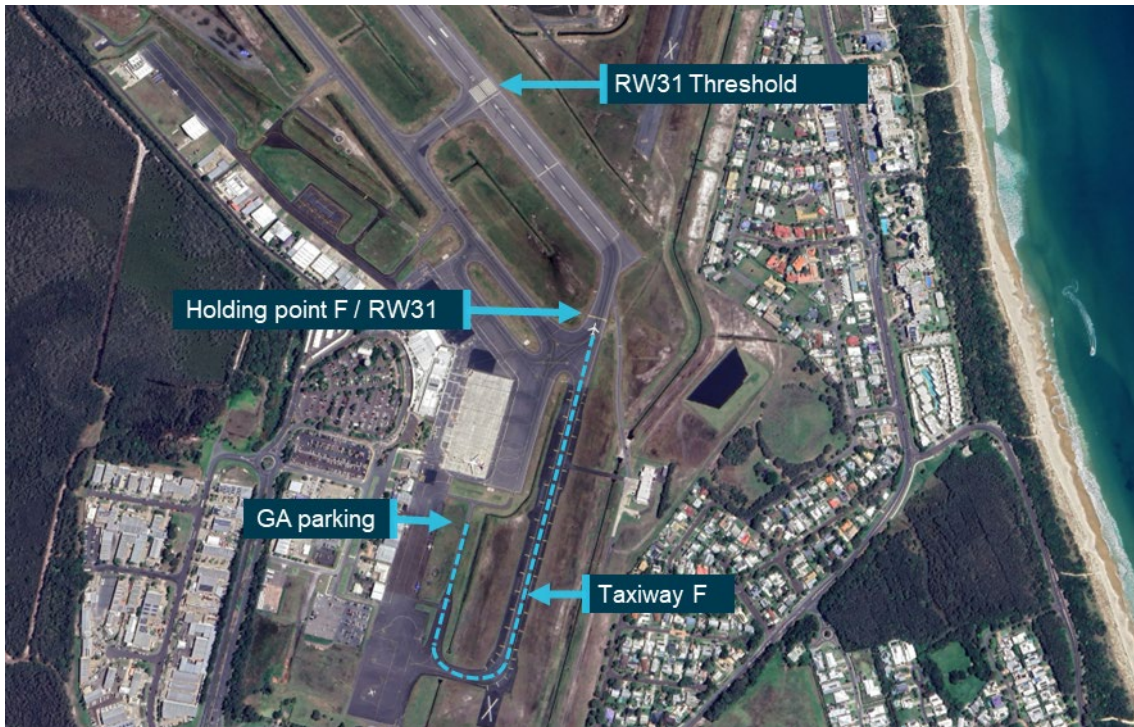
Figure 1: VH-ERE taxi path

At 1322 local time, while parked at the general aviation area on the airport, the pilot contacted air traffic control (ATC) requesting a departure to the south-west. ATC instructed the pilot to 'taxi via Foxtrot to holding point² Foxtrot runway 31'³ (Figure 1) and cleared them to depart for Wellcamp via Esk at 4,500 ft. The pilot readback 'taxi via Foxtrot, use runway 31 and cleared to Esk at 4,500'. ATC reiterated 'taxi to holding point Foxtrot' to which the pilot apologised after reading back 'taxi to holding point Foxtrot'.

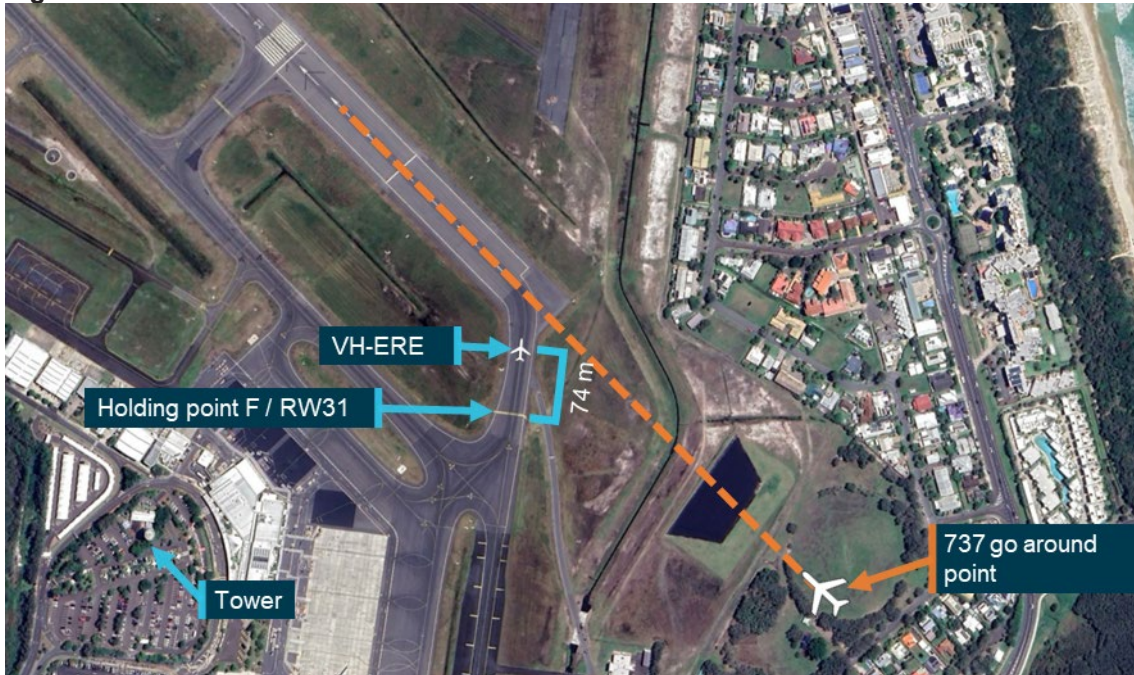
Figure 2: Location of VH-ERE to inbound aircraft

Ten seconds later, while ATC was completing a departure clearance for another aircraft on the ground and updating flight progress strips,⁴ ERE proceeded to cross the holding point without a clearance. The pilot later advised misunderstanding the instruction to hold short of runway 31 as they thought they were holding short of taxiway Foxtrot and that there was a second holding point closer to the runway. The driver of the safety car, who could see ERE and had heard the exchange between the pilot and ATC, notified ATC that ERE had ‘gone onto the runway’ as soon as there was a break on the radio. ERE had travelled approximately 74 m in this time.

The controller immediately instructed the 737, which was now on late final about 250 ft above the runway, to conduct a go around. One second after the go around instruction was given, ERE stopped. The pilot advised that as they were nearing the intersection with the runway and after hearing ATC instruct the approaching aircraft to go around, they stopped as they could not see a second holding point. The crew of the 737 advised that they had seen ERE stationary at holding point Foxtrot, however due to the high nose attitude of the aircraft, they lost sight of it under the aircraft’s nose as they continued the approach.

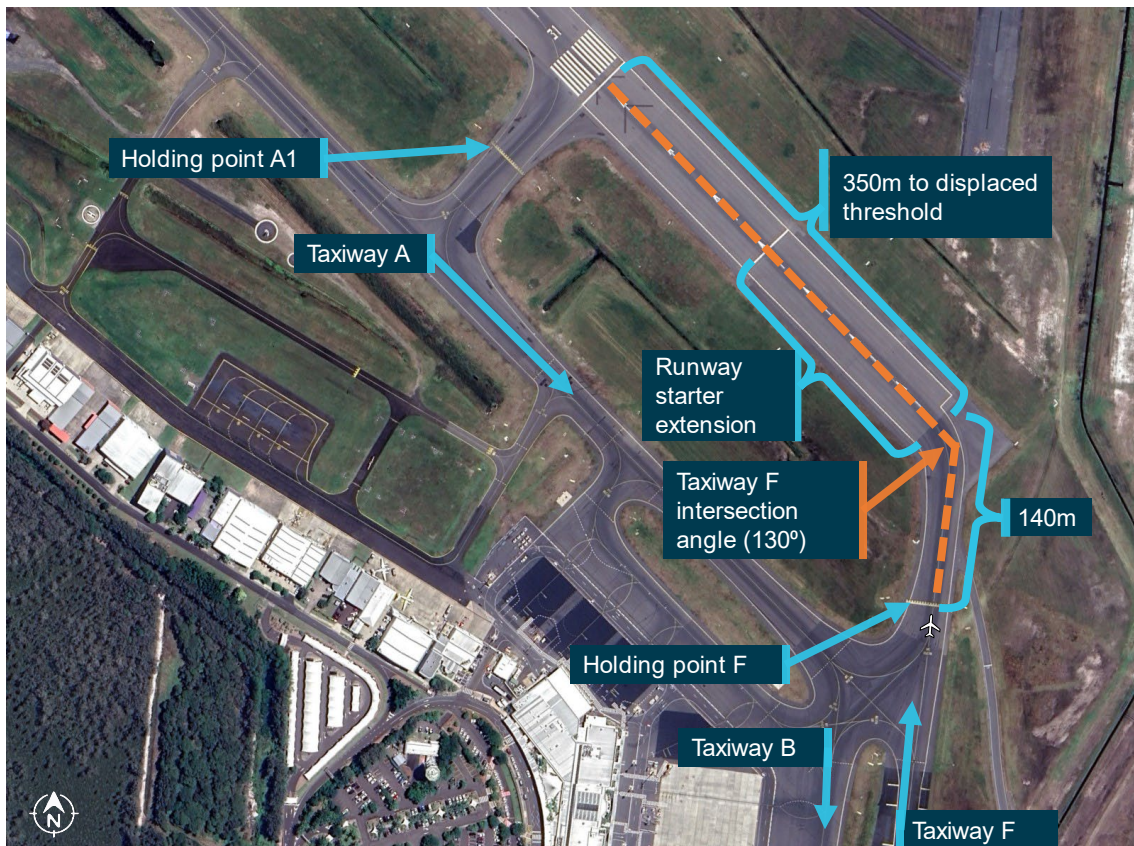
Figure 3: Taxiway Foxtrot in relation to the runway and other taxiways

Taxiway Foxtrot is the repurposed southern end of the decommissioned runway 18/36. Due to the angle between the taxiway and runway 31 (approximately 130° - Figure 3), there is approximately 140 m of taxiway from holding point Foxtrot to the intersection with runway 31 required to ensure that the holding point remained outside of the runway strip. Once reaching the intersection, there is approximately 350 m to the displaced runway threshold.

Due to the angle of taxiway Foxtrot to the runway, a pilot in the left seat of an aircraft would need to scan for landing aircraft at an angle of 125–130° from directly ahead. As explained in ATSB report AS-2022-001, a normal field of view is approximately 190° (95° either side of the forward view). This would have placed the approaching 737 outside the normal field of view of the pilot of ERE. It is also likely that the pilot was concentrating to the front of the aircraft as they were looking for a holding point. In addition, the pilot was sitting on the left side of the aircraft and so their view would also have been blocked by aircraft structure. This would have required them to move forward in the seat to have visibility of an aircraft on final approach.

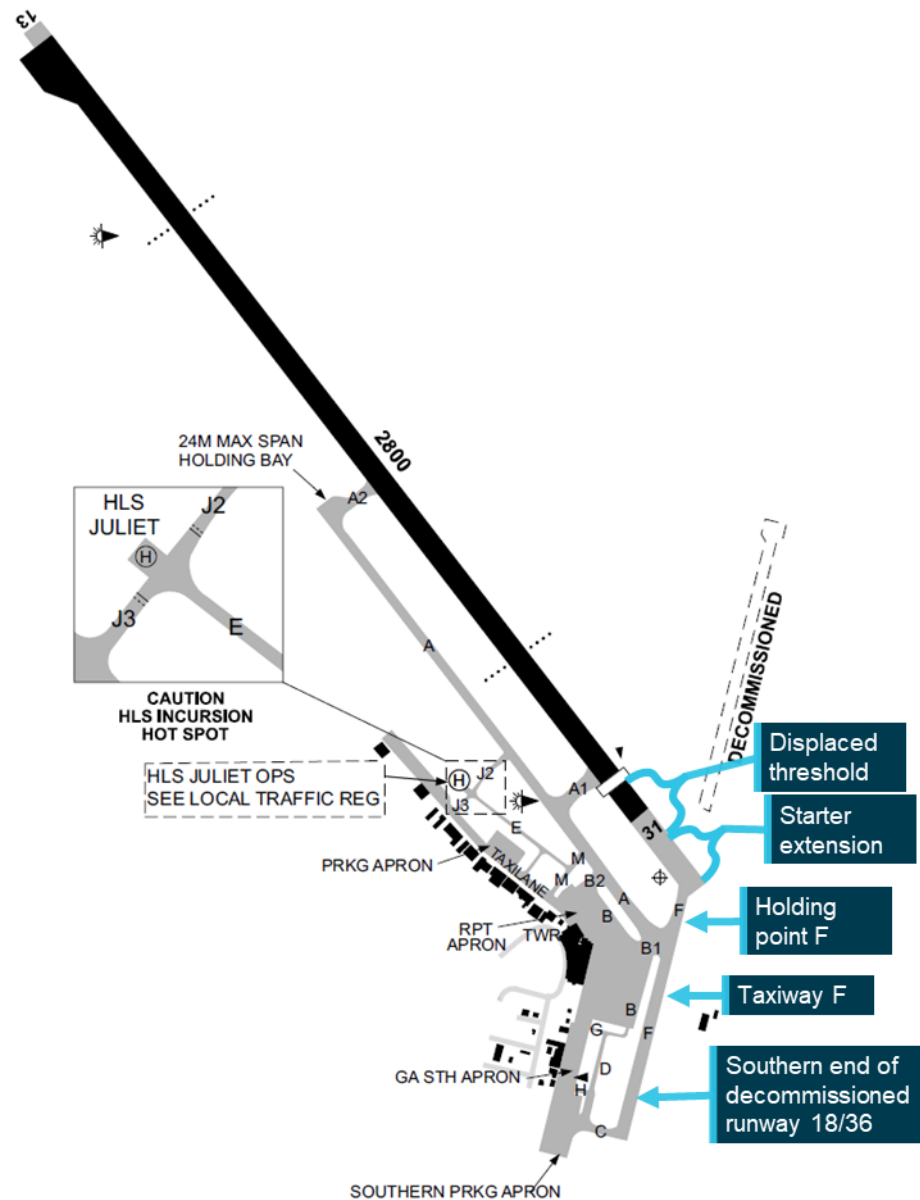
Figure 4: ERSA Sunshine Coast airport diagram

The airport diagram for the Sunshine Coast Airport in the Aeronautical Information Publication (AIP) Enroute Supplement (ERSA) (Figure 4) and the Departure and Approach Procedure (DAP) chart did not indicate any specific holding point locations. In the additional information section in the ERSA, it did not indicate the distance from the holding point to the runway junction. In addition, the ERSA did not indicate the full length of the runway (2800 m) in black shading, which is used to depict the length of runway available for take-off.

The information in these charts is supplied to Airservices Australia as the publishing body, by the Airport owner. The Civil Aviation Safety Regulations [Part 139 Manual of Standards \(MOS\) Chapter 5 Division 2 Standards for information](#) stipulates what information is required to be presented in the AIP documents. This did not require that holding points be depicted in the diagrams. However, International Civil Aviation Organisation Annex 4 Aeronautical charts section 13.6 (g) required that runway holding positions be marked. Australia had filed a difference with ICAO in relation to this requirement.

The ERSA and the DAP diagrams for the Sunshine Coast Airport did not include holding point locations. While the ERSA was not required to show the locations of holding points, inclusion of this information reduces the potential for confusion or ambiguity around their position. Also, the marking used on the runway diagram to depict the take-off distance available was not accurate. Additionally, the CASA aerodrome manoeuvring map for Sunshine Coast Airport did not give an accurate representation of the holding points or the runway and, if compared to the ERSA, would increase confusion for pilots.

- provided clarity around the runway shading on ERSA and DAP diagrams
- upgraded the Sunshine Coast manoeuvring map to accurately reflect the airport layout.
- recommended and supported the addition of a runway hotspot depiction at taxiway Foxtrot at the Sunshine Coast Airport to the ERSA and DAP.

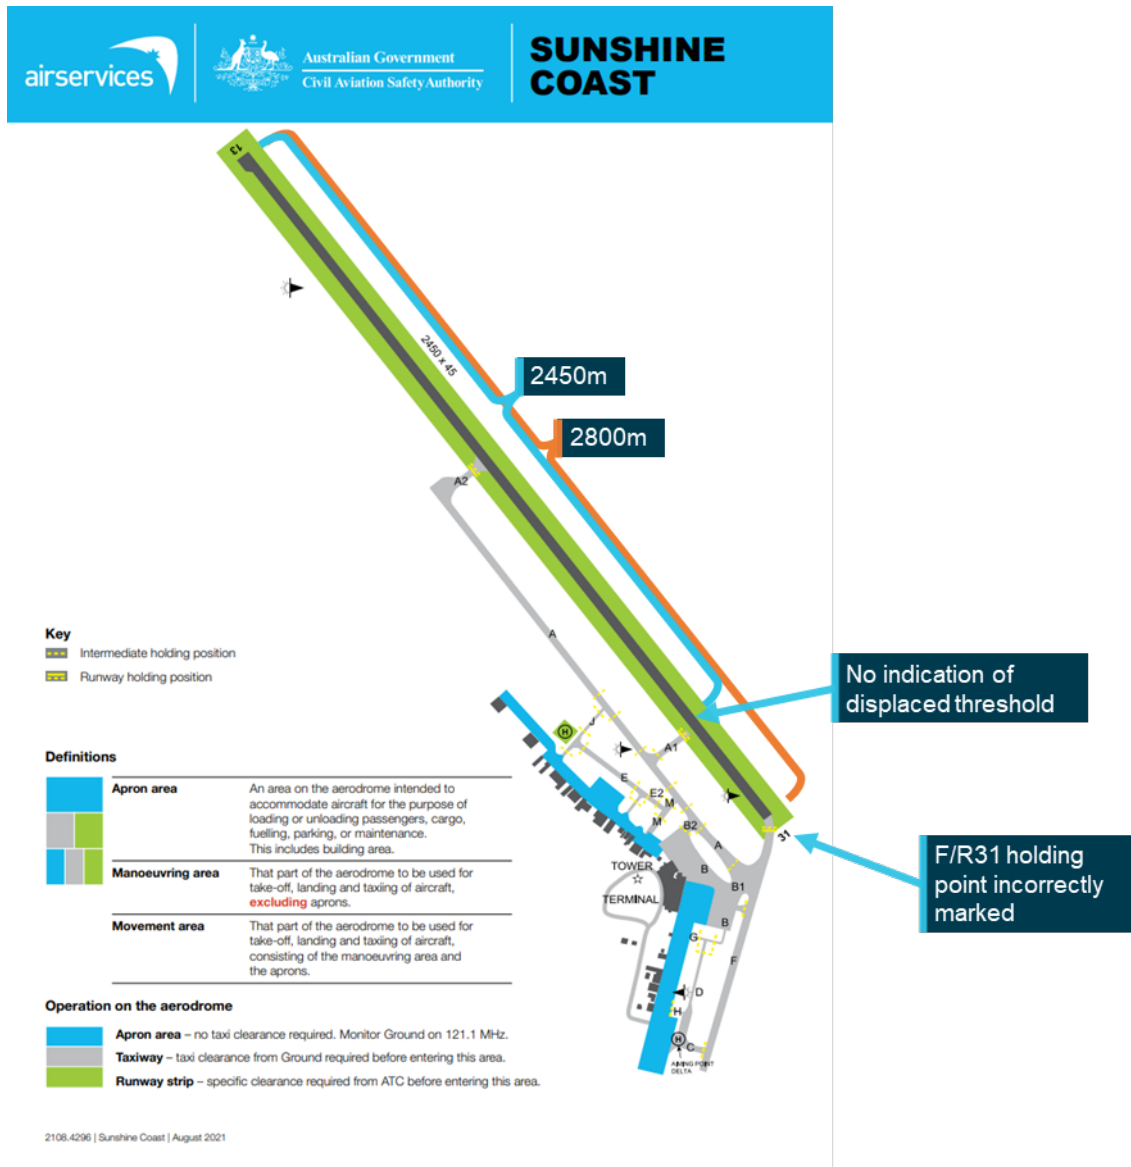
Figure 5: Aerodrome Manoeuvring Map for Sunshine Coast

The Civil Aviation Safety Authority (CASA) aerodrome manoeuvring map for Sunshine Coast Airport (Figure 5) indicated that the entire length of the runway was 2,450 m and did not display the extra 350 m of displaced threshold. Additionally, the placement of holding point Foxtrot was not accurately depicted, with it being shown approximately 110 m closer to the intersection of the taxiway and extended runway. The map did not show the decommissioned runway.

- Requested an update to the CASA manoeuvring map to correctly identify the runway length, location of displaced threshold and holding point Foxtrot.
- Changed the Aeronautical Information Publication (AIP) Enroute Supplement (ERSA) and the Departure and Approach Procedure (DAP) to reflect the full length of runway 31. Additionally, the distance between holding point Foxtrot and the runway has been added to the additional information section in the ERSA.

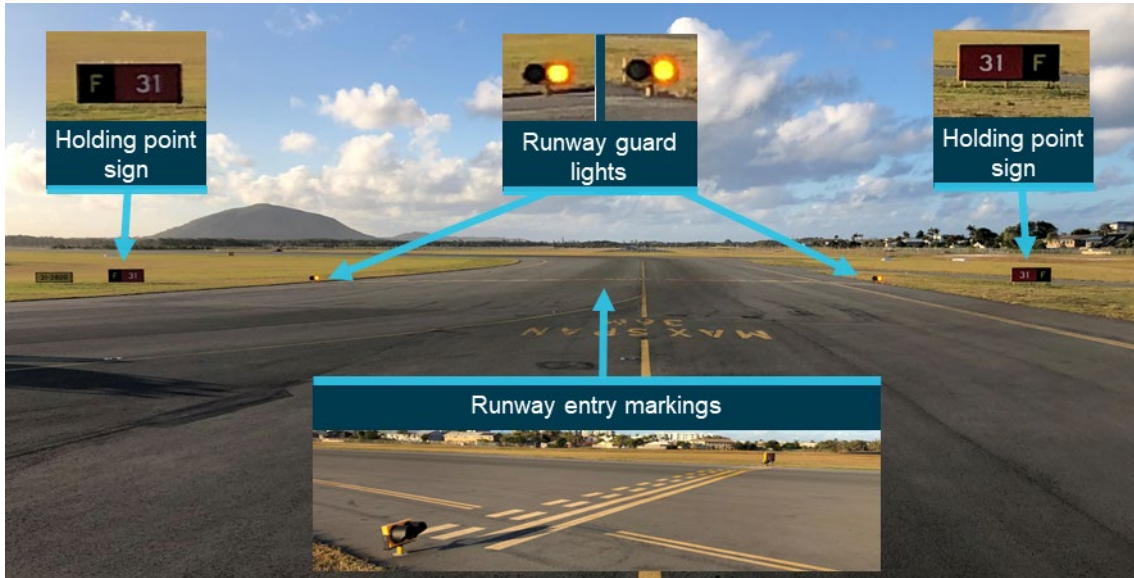
Figure 6: Holding point markings, signage and lights

Holding point Foxtrot was equipped with signage and ground markings to provide flight crews with visual cues indicating their position and proximity to the runway strip (Figure 6). The holding point was also equipped with runway guard lights which sat 30 cm above the ground on either side of the taxiway. These were bright yellow, and flashed when the runway was in operation.

The gable markers at the intersection between taxiway Foxtrot and runway 31 were in an irregular configuration to delineate the extent of the graded runway strip. Due to the location of the taxiway intersecting at the corner of the runway strip, flush rather than raised gables were provided at the taxiway shoulder. The gable that would be within the taxiway has been omitted. These differences were conducted under CASA approval.

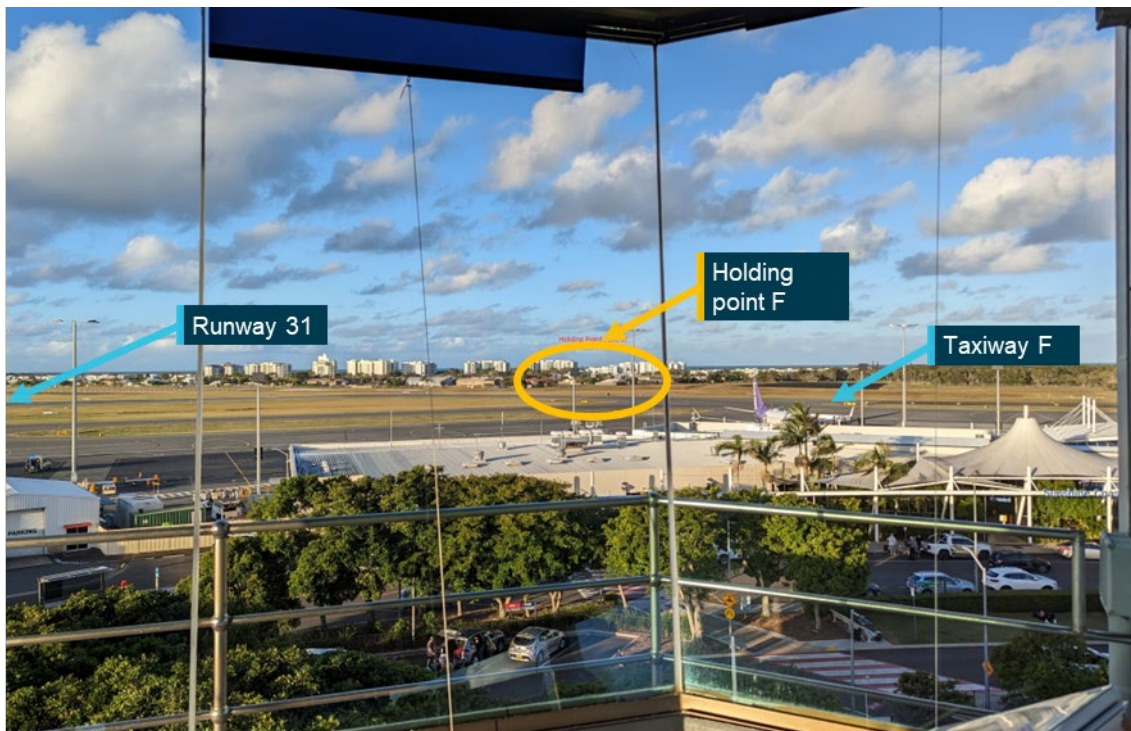
Figure 7: View of holding point Foxtrot from the Sunshine Coast Airport control tower

From the control tower, which is approximately 400 meters from holding point Foxtrot, the entire length of taxiway Foxtrot, the holding point and the displaced threshold of runway 31 are visible.

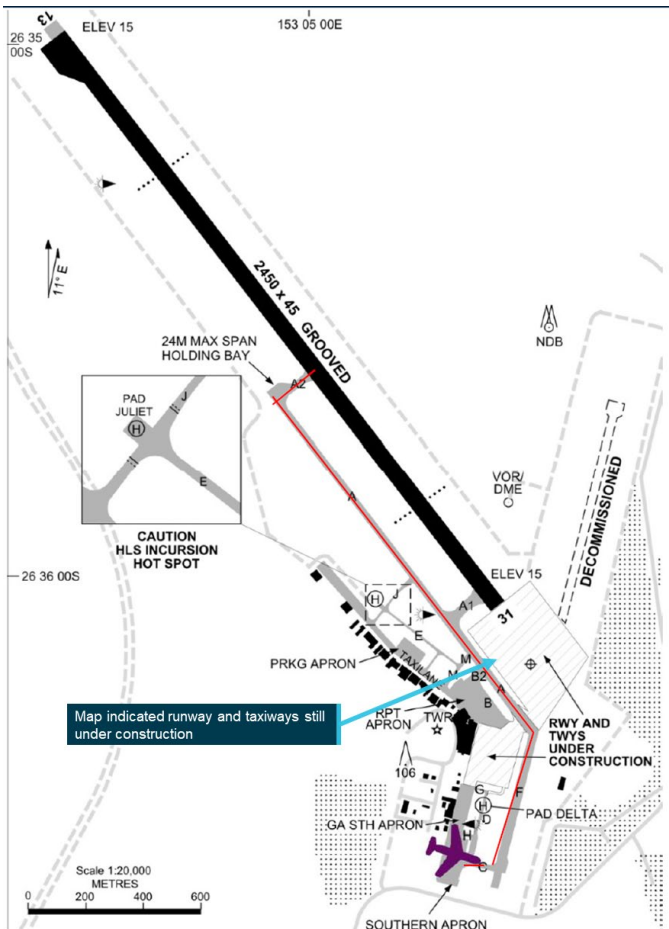
Figure 8: Sunshine Coast Airport map used in the operator airport briefing for students.

The information relating to the runways and taxiways contained a graphic of the runway and taxiways at Sunshine Coast Airport (Figure 8) prior to the runway extension and taxiway Foxtrot completion in 2021. The map showed only 2 runway holding points: A1 and A2.

The operator's briefing documentation on the layout of Sunshine Coast Airport was also not current and did not provide the correct information to students. However, this was found not to have contributed to the pilot's lack of understanding of the airport taxiway layout and markings as the pilot was using the ERSA for pre-flight planning and the DAP as a location reference while at the airport, and so had the latest available information about the runway layout at the airport.

- Existing tutorials for class D, class C, Sunshine Coast Airport, Archerfield Airport, and Gold Coast Airport were reviewed and updated.
- An exam and quiz specifically for Sunshine Coast Airport has been created.
