# Steering failure and contact with navigational beacon involving *CMA CGM Puccini*

Port of Melbourne, Victoria on 25 May 2023

**ATSB Transport Safety Report**

MO-2023-002

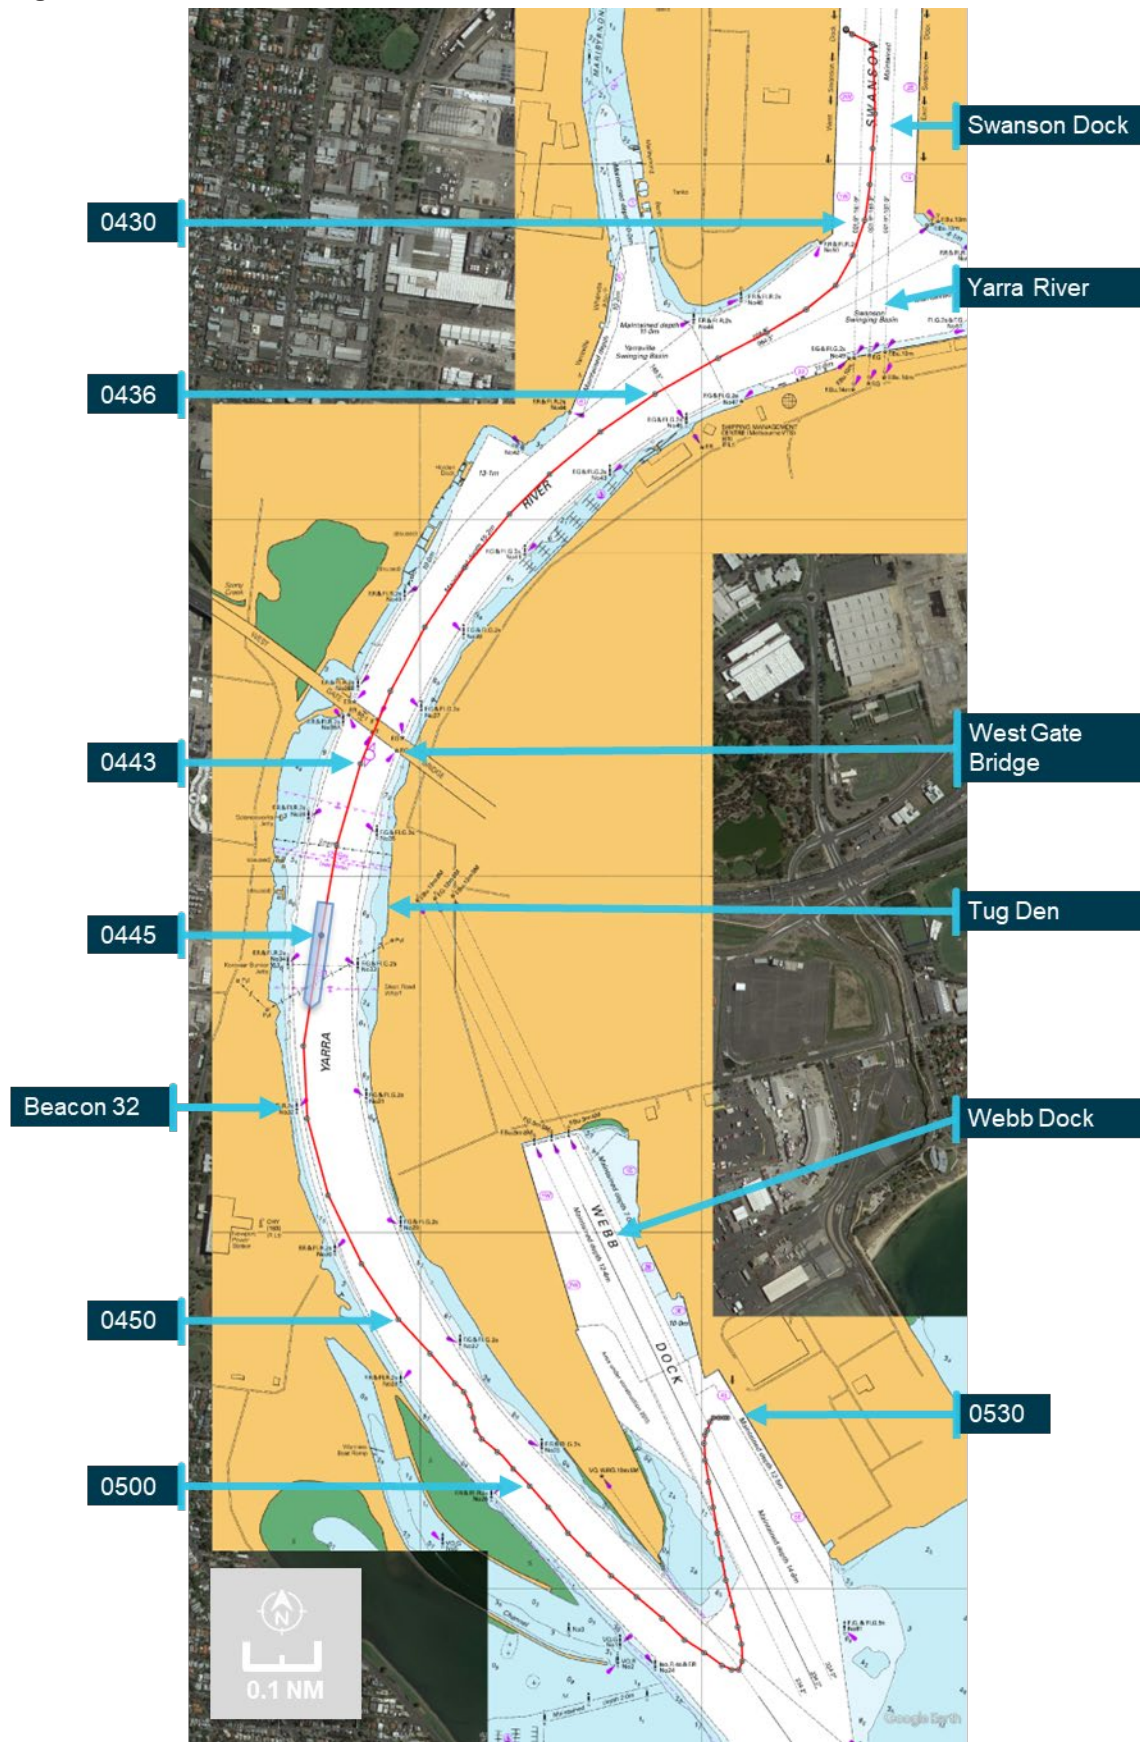
Figure 2: CMA CGM Puccini's track from Swanson Dock to Webb dock

By 0436, the ship was moving along the channel in the river, both tugs had been dismissed and the main engine was increased to slow ahead. At 0442, the ship passed under the Westgate bridge, about 1 mile downriver of Swanson Dock. The ship's speed was 6.6 knots<sup>4</sup> with a rate of turn of 4° per minute to port. At 0443, the main engine was increased to half ahead<sup>5</sup> and more rudder ordered (port 10)<sup>6</sup> to increase the rate of turn. To maintain the turn rate, the pilot then gave helm orders (rudder) of port 5 (0443:34), followed by port 10 (0443:54).

Soon thereafter (0444:03), the pilot noticed that the rudder angle indicator was showing that the rudder was midships and repeated the earlier port 10 order. The able seafarer steering the ship by hand (helmsman) responded that the helm (steering wheel) was at port 10. This exchange drew the attention of the master and chief mate, who both verified that the helmsman had correctly followed the order. The helmsman informed them that the rudder was not responding to the wheel. By that time, the chief mate had moved to the steering console to investigate and observed that the rudder moved to port 5 and then slowly to starboard 5. The ship, with its speed increasing and rate of turn diminishing, tracked toward the western edge of the channel and beacon 32. At the time, the ship's speed was 7.7 knots, it was turning to port at 3° per minute and was 7 m to starboard of its planned track.<sup>7</sup>

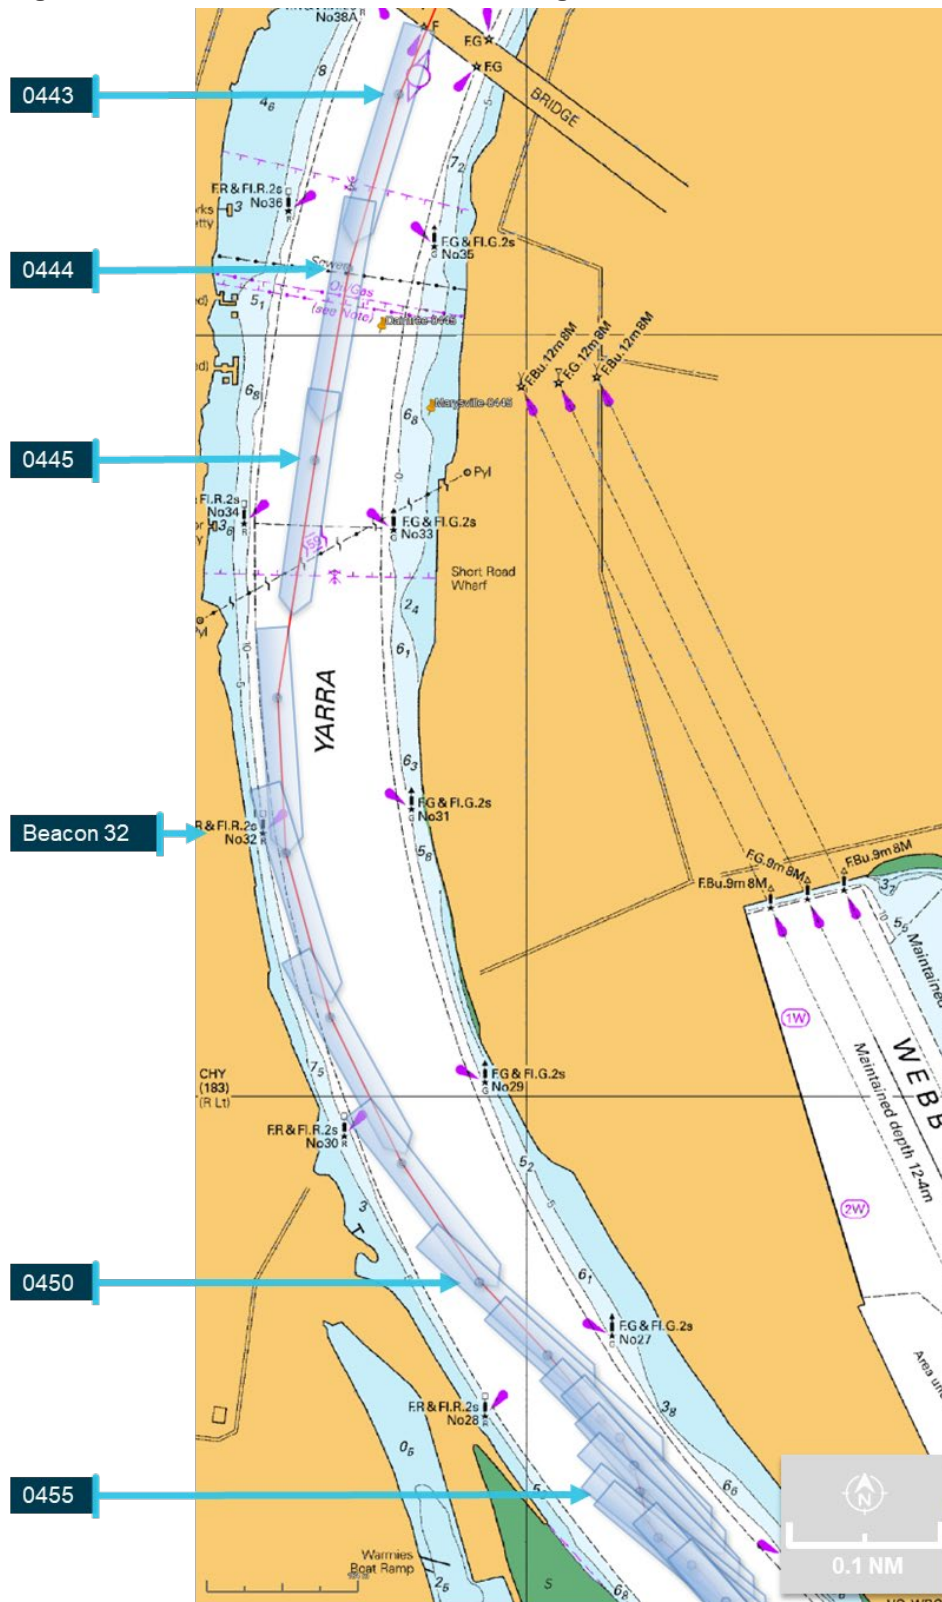
Figure 3: CMA CGM Puccini's track showing contact with Beacon 32

Shortly thereafter, the rudder was observed to move to 35° to port (wheel was hard to port). The main engine was restarted, and the bow thruster set full to port. At 0445:30, the ship's rate of turn to port suddenly increased as its bow closed with the side of the channel. By 0445:44, the ship's speed had reduced marginally (to 7.9 knots) and its swing to port had increased to 13° per minute, with the bow now less than 20 m from channel's edge. The pilot ordered the rudder midships and immediately after to starboard 20 to reduce the increasing swing to port with the aim of avoiding the ship's stern closing and contacting the western bank or shoals (Figure 3).

At 0446:12, the ship was 58 m to starboard of the planned track with significant headway (7.7 knots) and turning rapidly to port (20° per minute) with the bow only about 12 m from the 10 m depth contour and shoal water. Hard starboard rudder and bow thruster full starboard were ordered and the rudder observed to move to about 20° to starboard. However, as *CMA CGM Puccini* was swinging to port, its stern was swinging in the opposite direction (to starboard) and contacted beacon 32. The impact resulted in damage to the beacon, which canted over about 20° from the vertical. The ship's side was scratched due to scraping against the beacon.

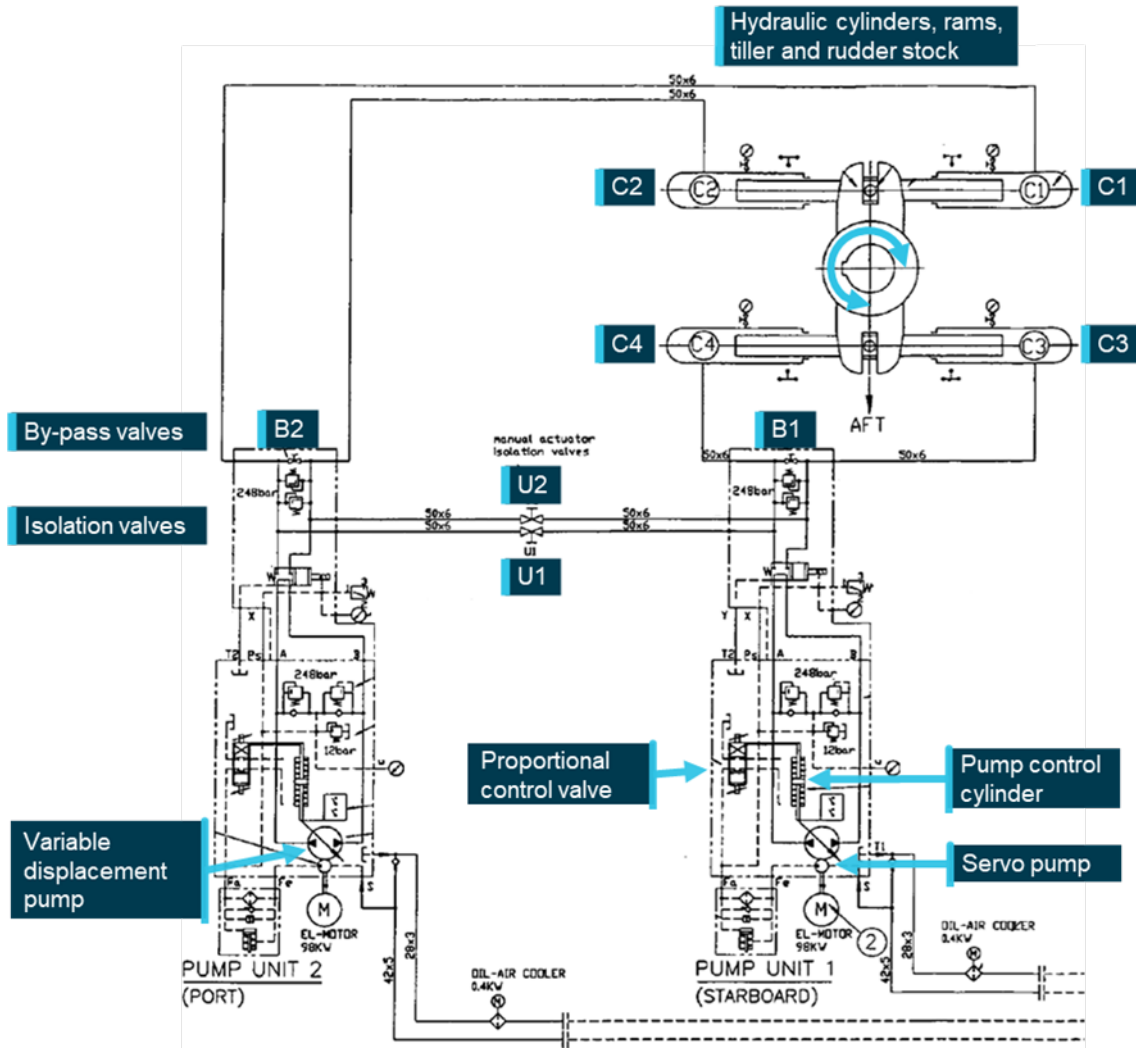
Figure 4: Steering gear hydraulic diagram

Each electric motor also drove a smaller, hydraulic auxiliary servo pump which provided 25 kg/cm<sup>2</sup> pressure control oil to the machinery. An electric solenoid operated hydraulic proportional control valve altered control oil flow to/from either side of the pump control cylinder to adjust the swashplate angle and oil flow rate and direction at the pump, as required. The rudder position was thereby changed by altering the rate and direction of oil flow to or from the cylinders connected to the tiller (Figure 4).
