Fatality on locomotive of train 4MB9

near Cullerin, New South Wales, on 25 August 2022

ATSB Transport Safety Report
Rail Occurrence Investigation (Defined)
RO-2022-011
Interim – 18 October 2023

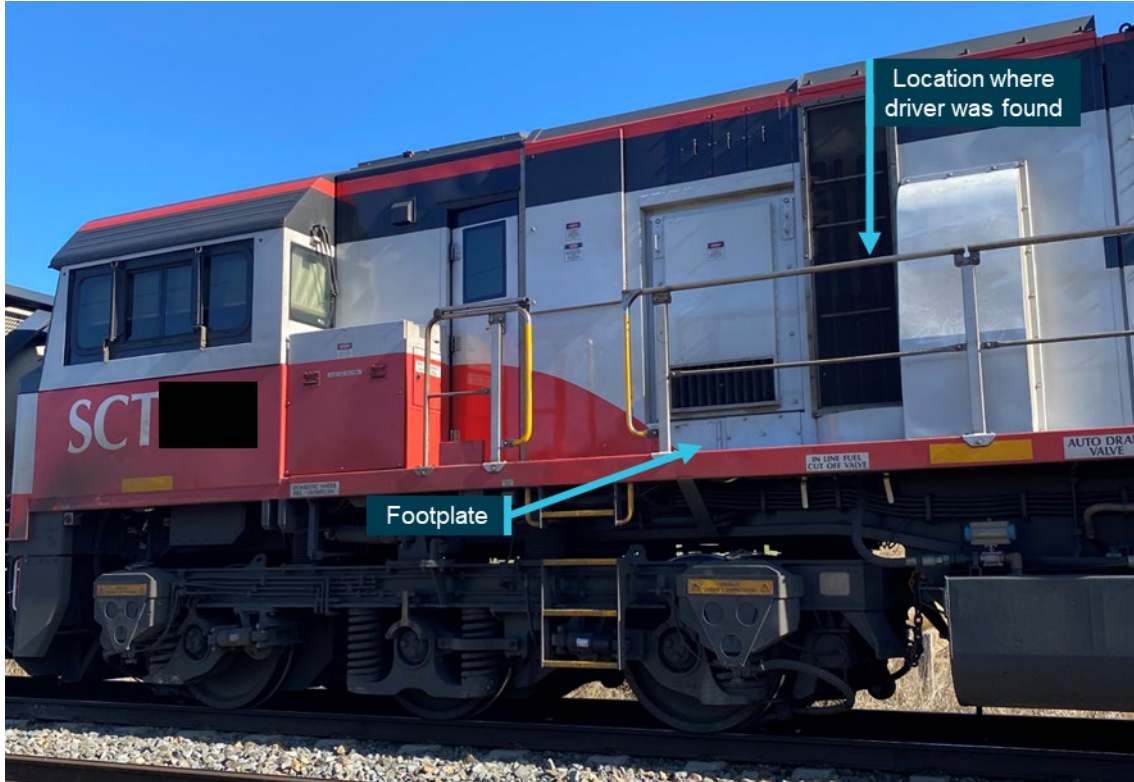
Figure 4: Location of driver (example locomotive)

and then the left-hand side exterior. It was while checking the left-hand side exterior that the driver’s assistant located the driver incapacitated, lying across the top handrail and up against the locomotive traction motor blower shroud (Figure 4). The driver’s assistant moved the driver from the handrail and laid them down onto the footplate, at which point they identified the driver had received a fatal head injury.

*Note: the image is of an example locomotive, not the actual locomotive involved in the accident.
Source: NSW Police, annotated by OTSI*

- issued an updated instruction regarding in-line fuelling operational modes and procedures, including restrictions for their use
- issued an updated procedure prohibiting the exit of the locomotive cabin onto the external footplate or, being located outside the profile of the locomotive while it is in motion
- the placement of warning stickers on doors leading from the locomotive vestibule onto the external footplate.

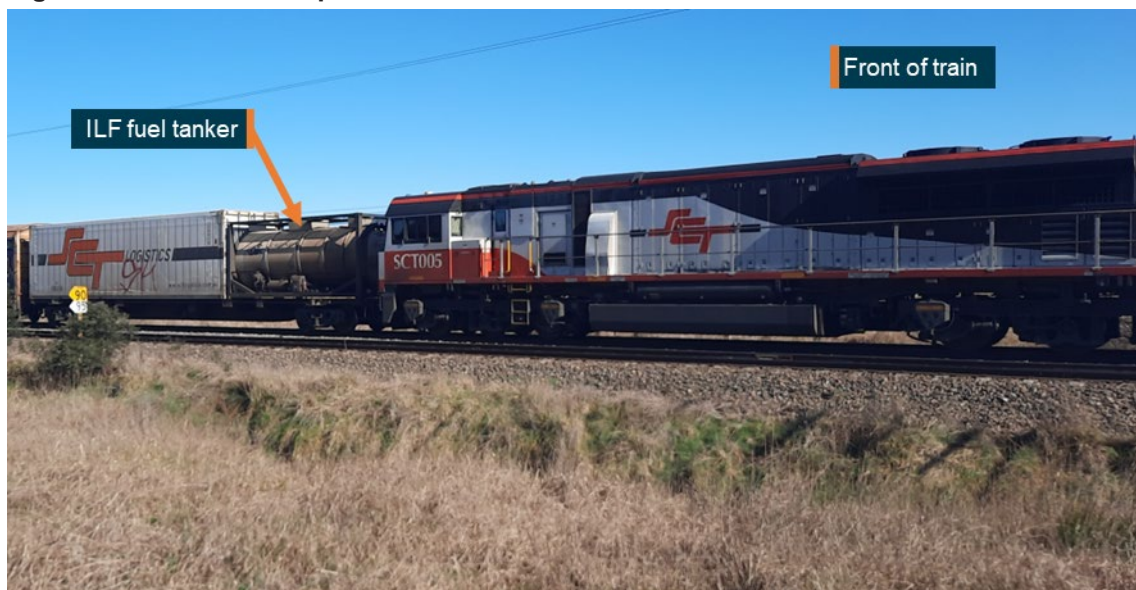
Figure 5: ILF fuel tanker placement

SCT Logistics operated ILF on the east-west corridor between Adelaide (Penfield), SA and Perth (Forrestfield), WA and, on the north-south corridor between Melbourne (Altona), Vic. and Bromelton, Qld. ILF required the placement of a fuel tanker on a flat container wagon immediately behind the locomotives (Figure 5).

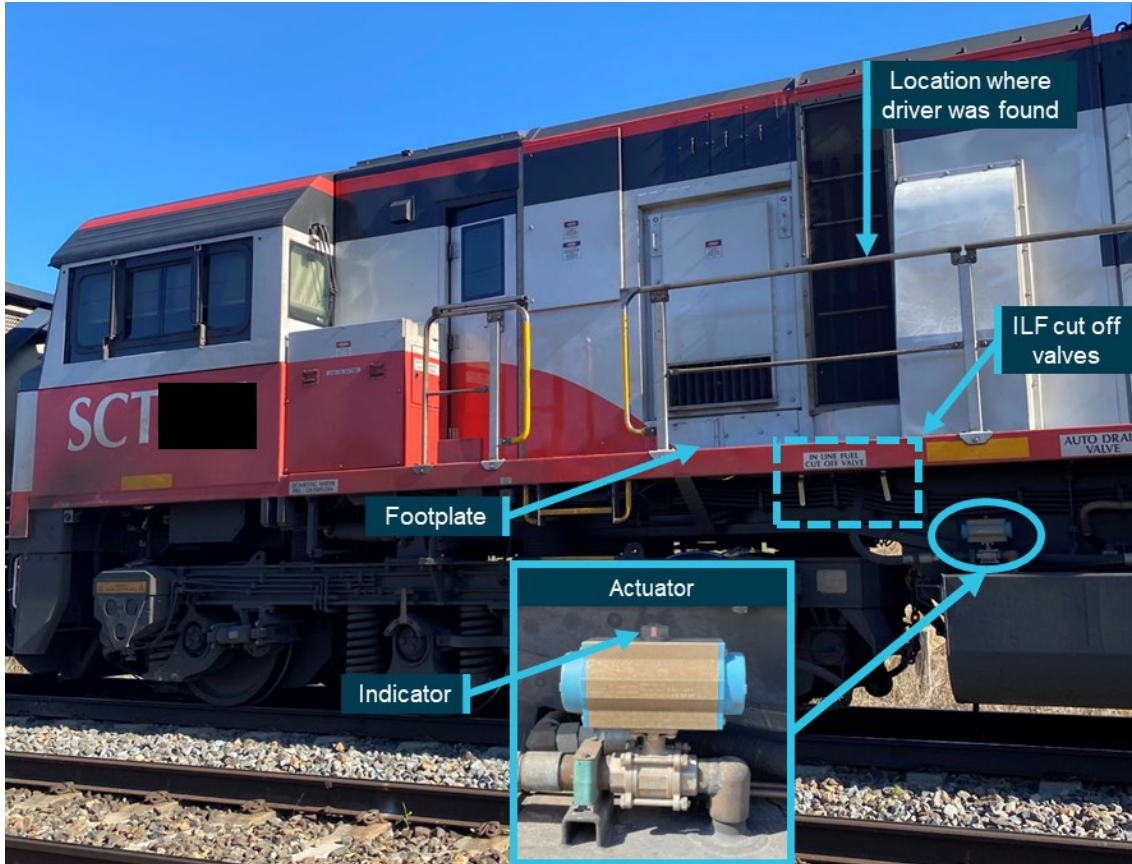
Figure 6: Location of the driver in relation to ILF equipment (example locomotive)

At the time of the accident, the driver's assistant advised the network control centre that the driver had been outside on the locomotive's footplate checking a 'fuel switch'. It was observed that the location where the driver's assistant found the driver in an incapacitated state was directly above:

- two ILF cut off valves, which isolated either the locomotive's fuel tank from the ILF fuel line or, isolated the ILF fuel line from the front locomotive headstock¹¹
- the locomotive's actuator valve (Figure 6).

Note: the image is of an example locomotive, not the actual locomotive involved in the accident. In this example image, the locomotive's ILF cut off valves (dotted box) and actuator (inset image) are depicted in the 'closed' position however, these were verified to be 'open', consistent with gravity feed mode, on the day of the accident.
 Source: NSW Police, annotated by OTSI

After the accident, OTSI investigators attended SCT Logistics' depot at Altona, Vic. to inspect an exemplar SCT class locomotive and the ILF system. During this inspection, it was found that when standing on the locomotive's external footplate it was not possible to observe the position of the locomotive's ILF cut off valves. However, it was found that by leaning hard up against the top handrail and leaning out past the locomotive's profile, it was possible to observe the indicator located on the top of the locomotive's actuator.
