# Weather-related event involving Super Puma helicopter, VH BHK

Barrow Island area, WA | 15 February 2013

**ATSB Transport Safety Report**  
Aviation Occurrence Investigation  
AO-2013-034  
Final – 12 December 2013

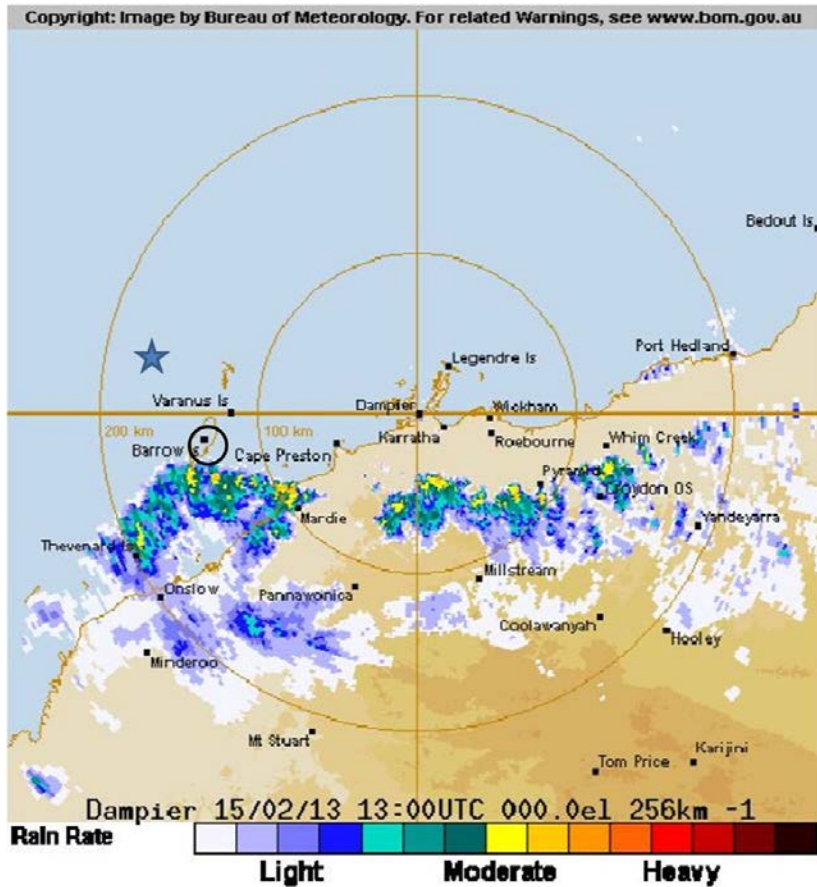
At about 2000 the line of thunderstorms moved over the coast south of Barrow Island. These thunderstorms developed further over the ocean and continued to move north-west, producing wind gusts at Barrow Island aerodrome from 2054 (Figure1).

Figure 1: Ground-based weather radar image at 2100, soon after departure 'Lorelay' (Helicopter position represented by star and destination circled)

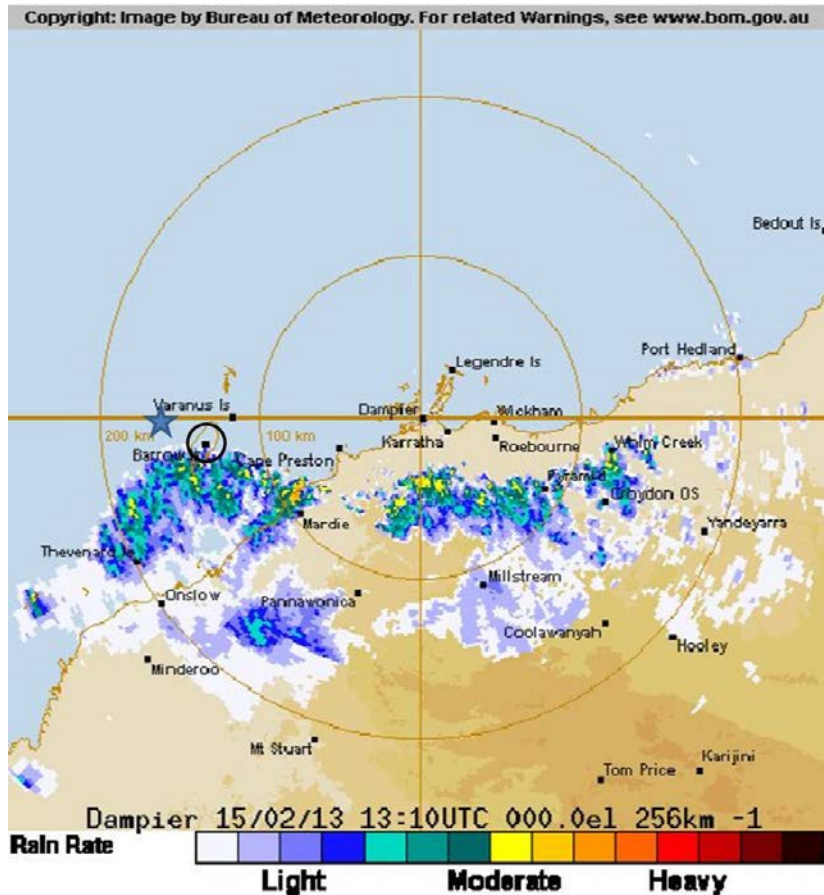
Nearly halfway to the approach fix, the crew noticed the weather radar returns were changing from light to heavy before the helicopter entered cloud and was subject to severe turbulence and significant ambient lightning (Figure 2). The crew turned to the west (away from Barrow Island) soon after 2110 and descended to the lowest safe altitude of 2,000 ft, seeking to get around or under the weather. They tracked generally westward for 10 minutes in continuing severe turbulence and lightning activity.

**Figure 2: Ground-based weather radar image at 2110, when the crew turned west (Helicopter position represented by star and destination circled)**

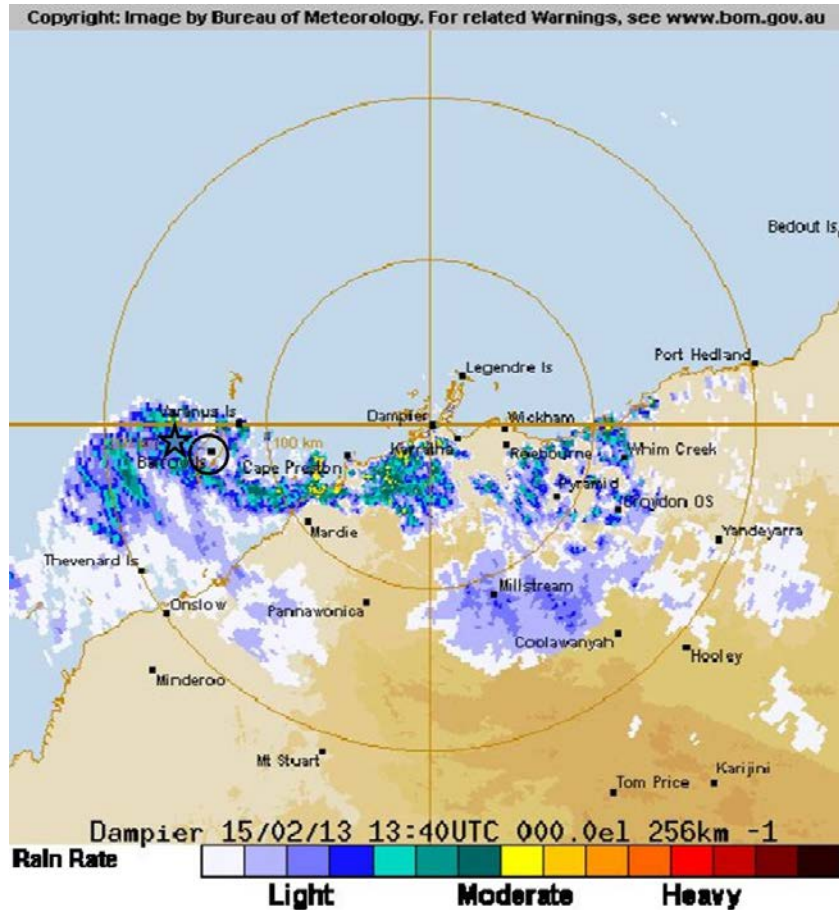
**Figure 3: Ground-based weather radar image at 2140, at about the time the crew became visual (Helicopter position represented by star and destination circled)**
