Engine failure involving de Havilland Canada DHC-2 Beaver, VH-AAX

Moruya Airport, New South Wales, on 4 April 2022

ATSB Transport Safety Report

AO-2022-025

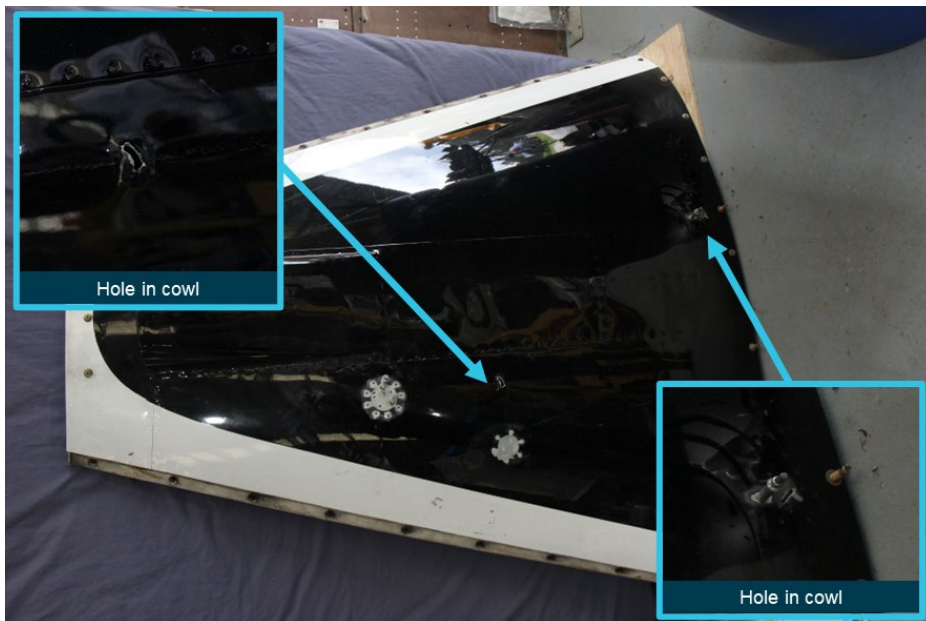
Figure 2: Damage to upper engine cowl of VH-AAX

A post-flight examination of the aircraft revealed holes in the cowling above the engine compartment (Figure 2). Examination of the engine identified a perforation of the external wall of the combustion chamber, holes through the exhaust assembly, failure of the main shaft and the torsion shaft,⁵ damage to the turbine section, and loss of the 2nd and 3rd-stage turbine wheels (Figure 3).

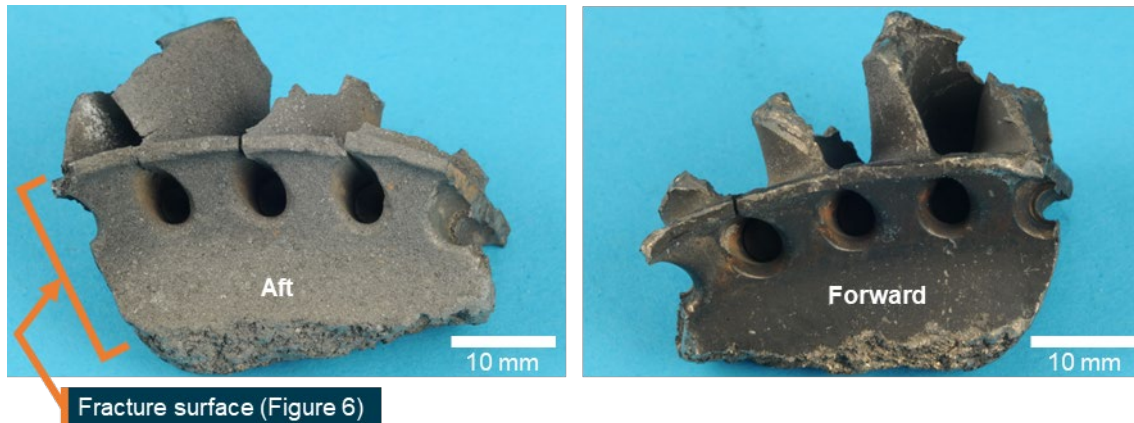
Figure 5: Recovered fragment of 3rd-stage turbine wheel found lodged in the combustion case viewed from the aft (left) and forward sides (right)

- there was evidence of rotational instability in the engine while the engine was running
- the main shaft and the torsion shaft had fractured
- a fragment of turbine wheel was lodged in the outwards rupture of the combustion case; this fragment (Figure 5) was consistent with the specified material of the 3rd-stage turbine wheel. No other parts of the 3rd stage turbine wheels were found in the engine
- evidence of low-cycle fatigue cracking⁷ was identified on the fragment of the 3rd-stage turbine wheel found lodged in the combustion case (Figure 5 and Figure 6)
- the 2nd stage turbine wheel was not present
- the aft turbine bearing and bearing support, aft sump scavenge pump, aft bearing support struts, turbine nut, and tail cone were missing
- there was ‘no uncontainment’ of the combustion case.⁸

Both Honeywell and the National Transportation Safety Board concluded that the most likely reason for the engine failure was a low-cycle fatigue failure of the 3rd-stage turbine wheel.

When a low-cycle fatigue crack on the 3rd-stage turbine wheel, grew to a critical size, a fragment of the wheel was liberated under load, which initiated the engine failure. The fragment impacted the combustion case and became lodged. The separation of this wheel fragment resulted in significant rotational imbalance, which led to fracturing of the main and torsion shafts. Detached turbine section components then exited the engine, damaging the exhaust assembly. There was no evidence that any turbine wheel fragments exited through the combustion case with sufficient energy to cause a hazard to the aircraft. As such, the failure was deemed to be contained.

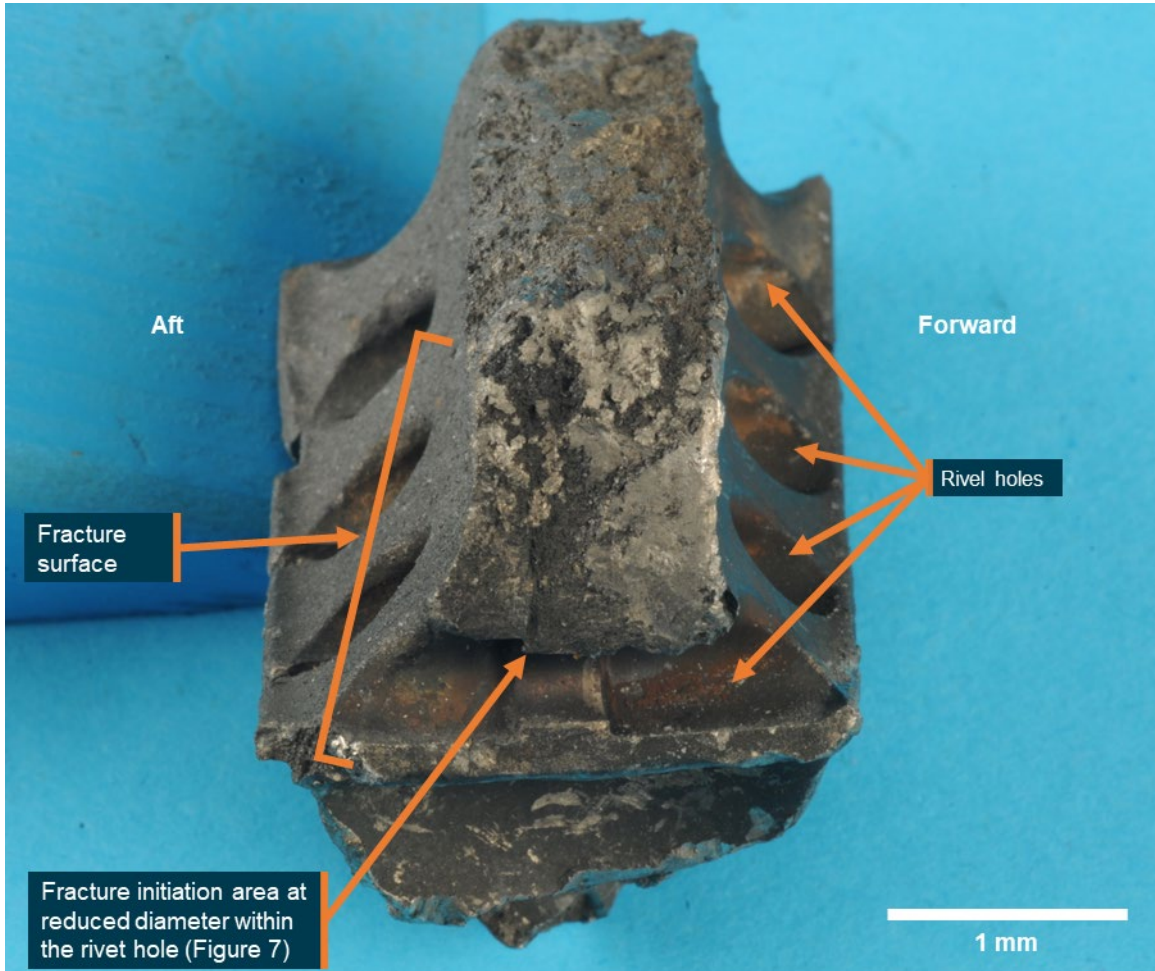
Figure 6: Fracture surface on the 3rd-stage turbine wheel fragment

The photograph in Figure 6 shows the fracture surface on the 3rd-stage turbine wheel fragment. The fracture surface is in the radial plane located at a rivet hole. The crack initiation area has been indicated.

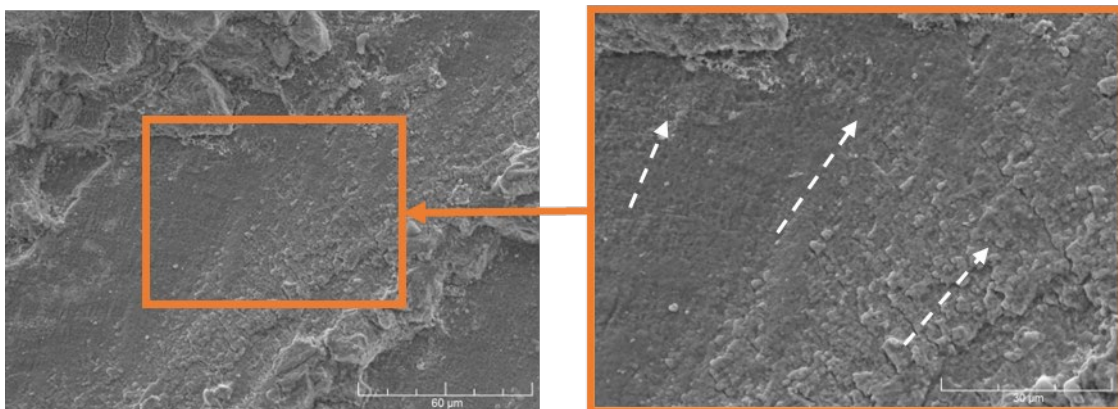
Figure 7: Microscopic fracture surface features adjacent to the fracture initiation area indicating fatigue crack growth

The scanning electron microscope image in Figure 7 taken of the fracture surface, showed features consistent with fatigue cracking. The direction of crack growth (white dash arrows), informed by the striations, indicated that the crack originated from the reduction in diameter of the rivet hole.
