Flight instrumentation failure and descent below glideslope involving SAAB 340, VH-VEQ

9 km south of Sydney Airport, New South Wales, on 24 October 2022

ATSB Transport Safety Report
Aviation Occurrence Investigation
AO-2022-050
Interim – 23 November 2023

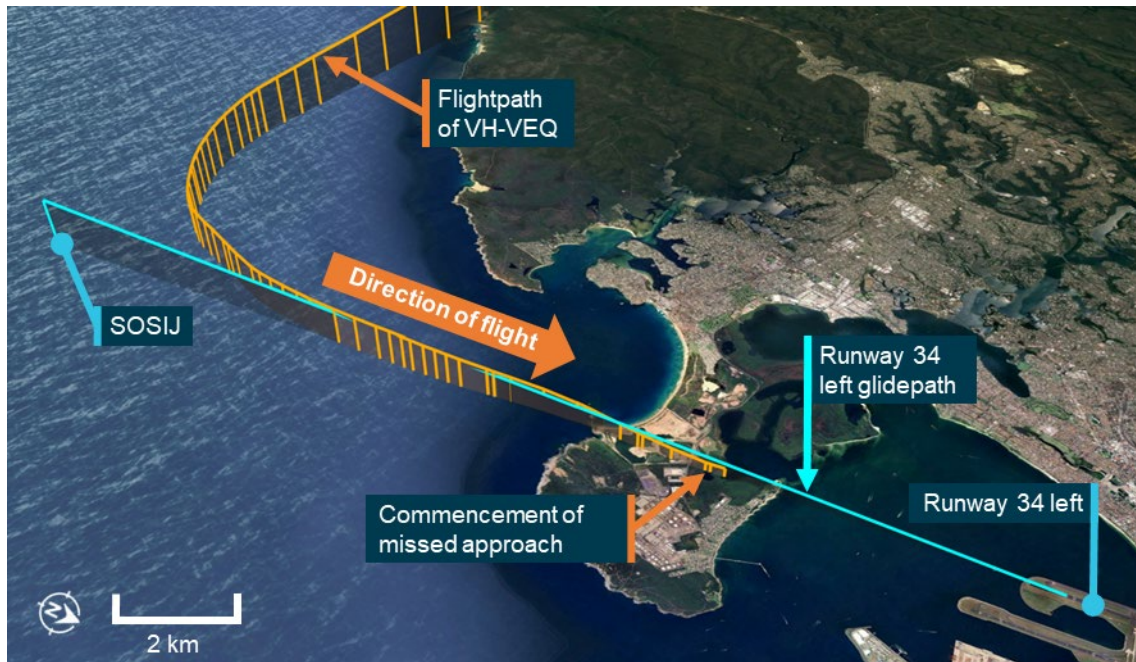
Figure 1: Flight path of approach

As the aircraft approached SOSIJ in cloud, at night and with the autopilot engaged, the crew commenced a 90° left turn to intercept the localiser (Figure 1). The aircraft subsequently intercepted the localiser at an altitude and distance from the runway that positioned it close to being on the glideslope for the runway 34 ILS approach. The crew continued the approach using the autopilot and observed that the aircraft did not commence descending as expected to maintain the glidepath. In response, the captain disconnected the autopilot and manually increased the descent rate to that expected for the approach.

When the aircraft was about 5 nm from the runway, the crew conducted an altitude and distance check which showed that the aircraft was close to the glideslope. As the aircraft descended below 1,373 ft above mean sea level (AMSL) at 1,920 feet per minute, and with the erroneous 'on-gldeslope' indication still present, the captain re-engaged the autopilot. The autopilot maintained this descent rate, resulting in the aircraft deviating significantly below the glideslope.
