Wirestrike and collision with terrain involving Robinson R44 II, VH-WLH

Bingegang, Queensland on 4 April 2023

ATSB Transport Safety Report

AO-2023-014

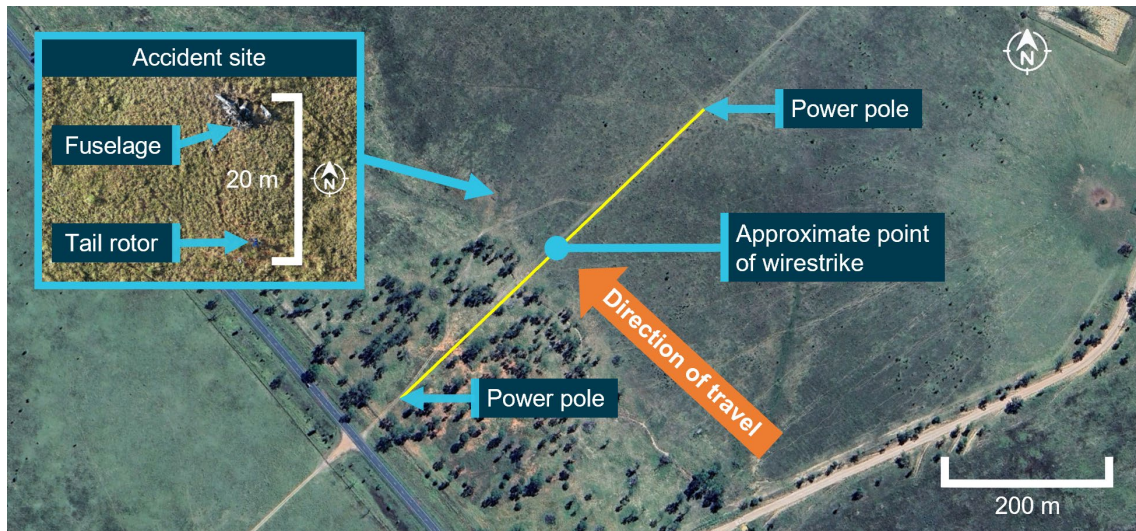
Figure 1: Accident site

Figure 1 shows an overview of the accident site. The powerline, a single-wire earth return (SWER) wire that ran across the property, was not marked and there was no requirement within the applicable aviation regulations, Australian Standards or elsewhere to do so. The wire was estimated to be at a height of 5.6 m at the point of impact.

The terrain was clear to the right of the helicopter's flightpath, and there were trees taller than the wire height that would have obscured the wire and pole on the left side.

The helicopter impacted terrain left side down and yawing to the right about 90 m beyond the point of contact with the wire and facing back towards the wire. There was insufficient evidence available to determine the angle and speed of impact with the ground.

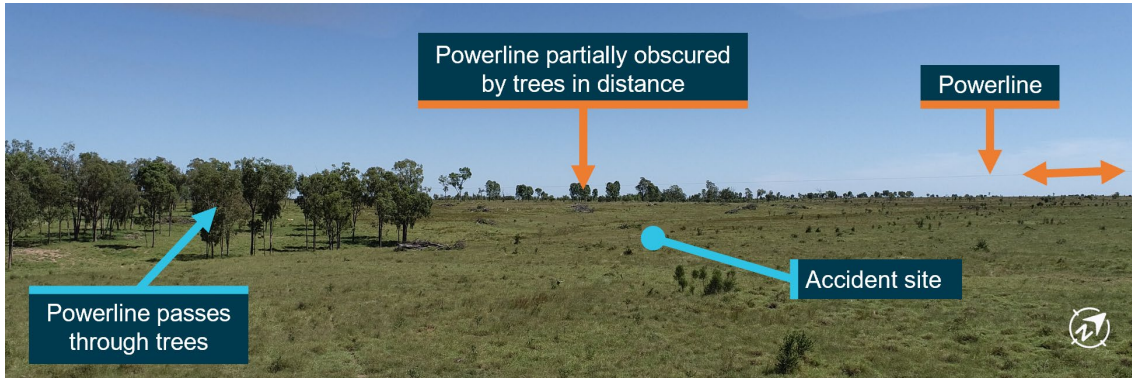
Figure 2: RPAS simulation of flight path

Queensland Police officers later returned to the accident site to conduct a simulation using a remotely piloted aircraft system (RPAS) of the helicopter's approximate flight path and height prior to striking the powerline assuming that it had not turned. The simulation was conducted in conditions similar to those on the day of the accident. Images from the RPAS simulating what the pilot would have seen when approaching the wire showed the wire was difficult to distinguish from the background and the left pole was obscured by trees (Figure 2).

- The powerline was partially obscured by trees and terrain, depriving the pilot of critical visual cues as to its presence.
