# Misaligned take-off involving Piper PA-31, VH-XMM

Essendon Fields Airport, Victoria on 21 July 2023

## **ATSB Transport Safety Report**

AO-2023-035

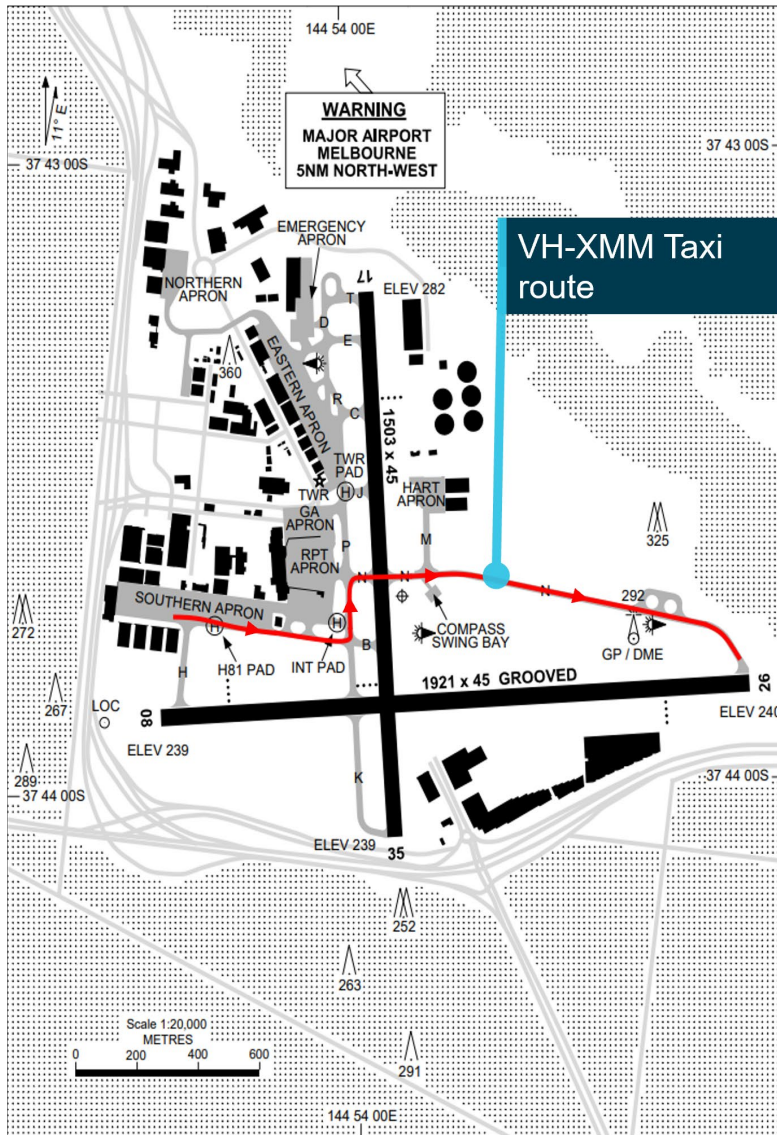
Figure 1: Aircraft taxi route

At 0109 local time, VH-XMM taxied from the southern apron where they had been parked, with the airport lighting energised. The pilot contacted Melbourne Centre air traffic control (ATC) and relayed their taxi intentions, to which the controller responded asking if they could accept runway 26<sup>1</sup> for departure. The pilot accepted and over the next 10 minutes taxied the aircraft via taxiway Papa and November, crossing runway 17, (Figure 1). They completed their pre-departure checklists, engine run-up checks<sup>2</sup> and obtained an airways clearance during the taxi. After they arrived at the holding point of runway 26, the pilot reported ready for departure and received departure instructions from the controller.

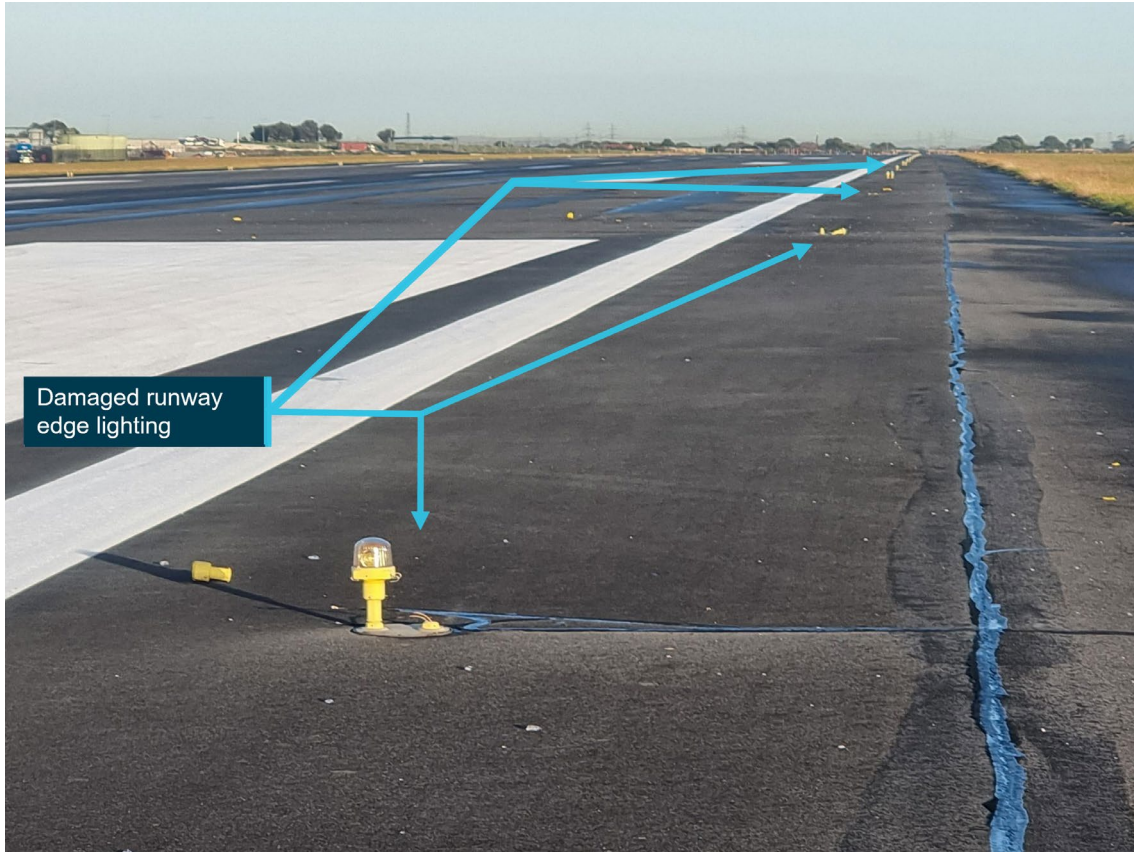
**Figure 2: Damaged runway lights**

During a subsequent inspection of the runway, damage to multiple runway lights was detected and foreign object debris was found scattered across the runway.

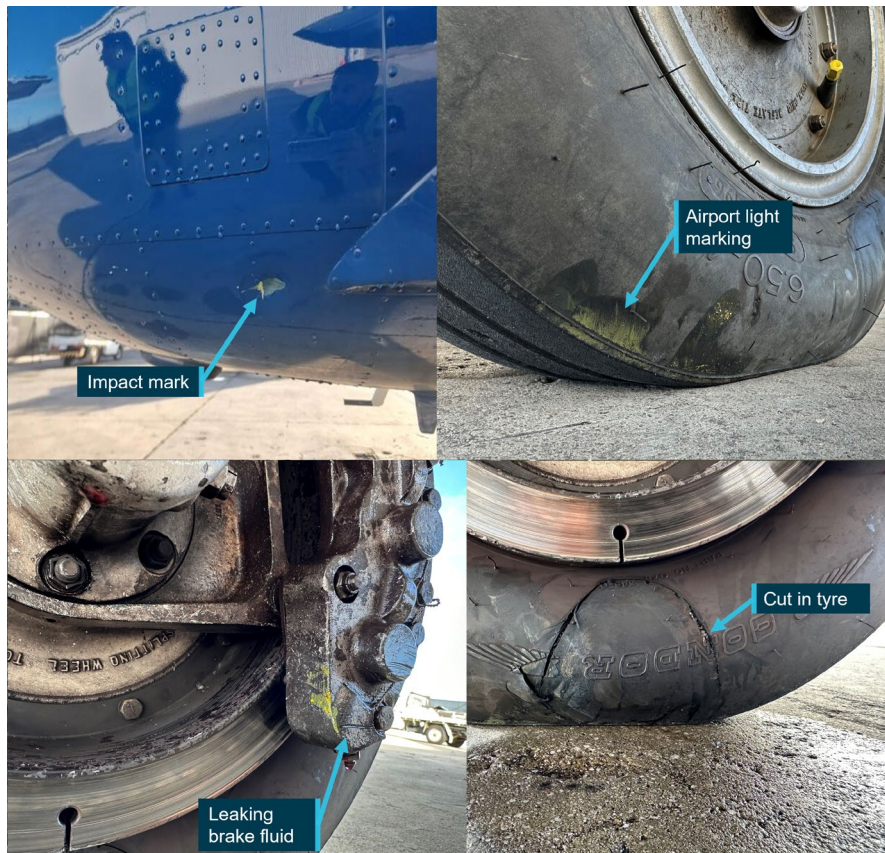
**Figure 3: Damaged sustained by VH-XMM**

On inspection of the aircraft, the pilot determined that the right main landing gear brake caliper was leaking fluid and a cut in the tyre was observed. The pilot sought the advice of a senior base pilot who was on site at the time however, it was not clear at this time exactly how the aircraft came to be damaged. The pilot entered a defect into the aircraft maintenance release and arranged another aircraft to complete the flight.

After the occurrence, the aircraft was inspected by engineers. Further damage was found to the main fuselage which was consistent with the aircraft striking the runway lights (Figure 3).

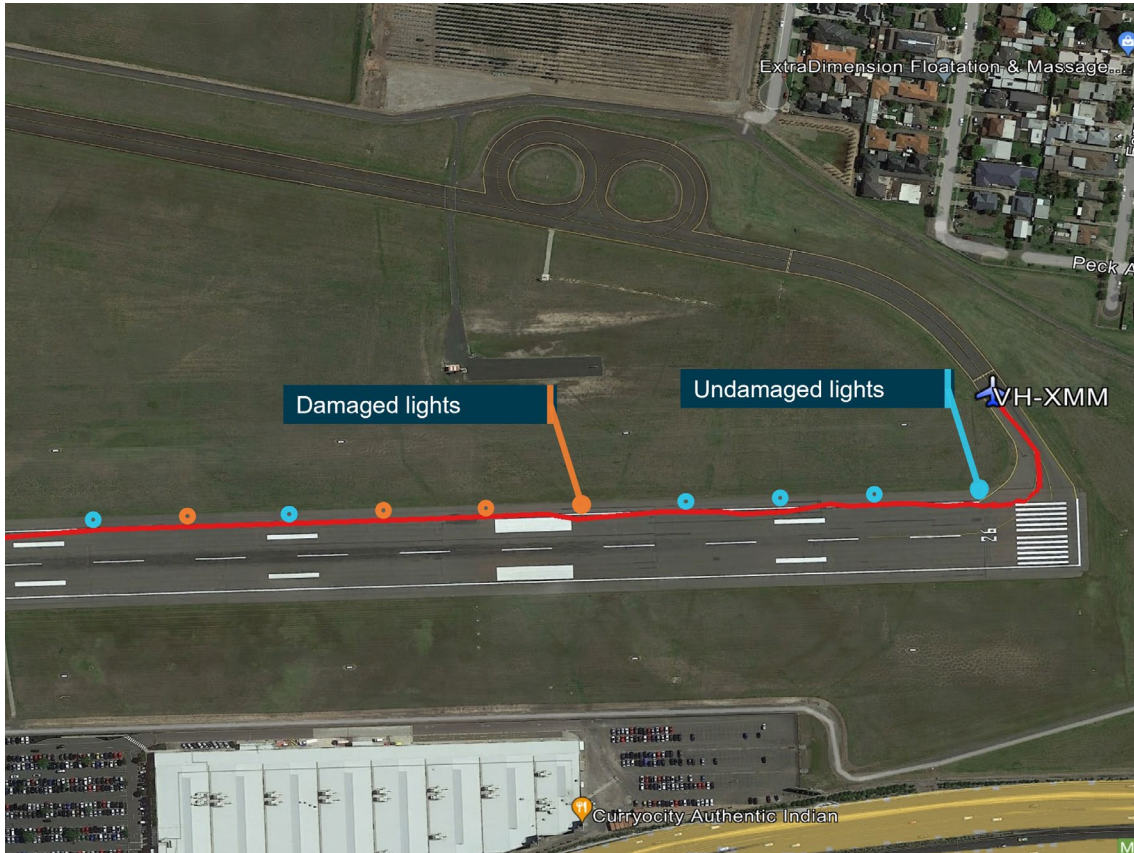
**Figure 5: VH-XMM take-off path with damaged light positions**

The airport operator provided the ATSB with ADS-B movement data which showed the position of the aircraft, and further ADS-B data was obtained from publicly-available, third-party websites (Figure 5).

The pilot of VH-XMM was conducting a flight from Essendon to Bankstown and taxied to runway 26. Recorded position data from the aircraft confirmed that the aircraft was aligned with the runway edge lighting during the line-up.

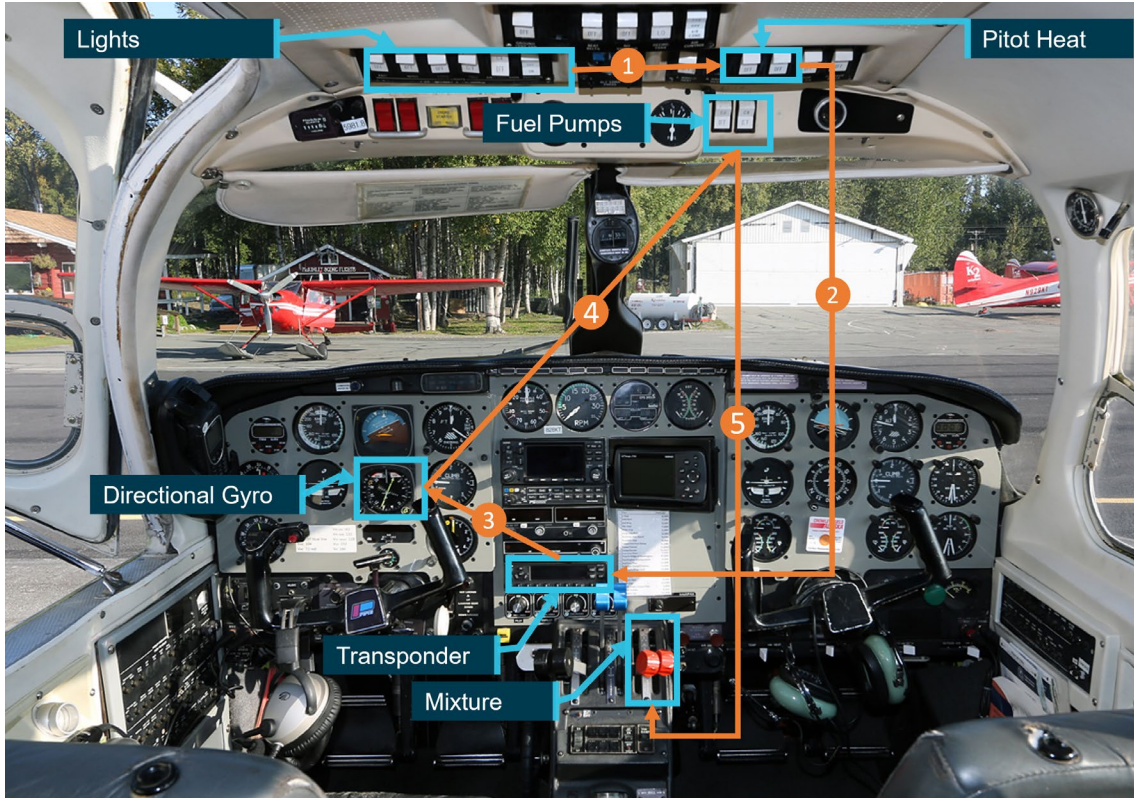
Figure 6: Exemplar aircraft showing the line-up checklist flow

As the pilot was lining up, they were also completing the line-up checklist. The Air Link standard operating procedure was for pilots to complete the checklist from memory via a flow method and then confirm by referring to a checklist. The line-up checklist required the pilot’s attention to ensure the correct position of multiple items. Figure 6 shows the required checklist flow of an exemplar aircraft, which highlighted the pilot’s attention being drawn from outside the aircraft into the cockpit to identify and confirm specific switches. In addition to the checklist, the pilot also reported checking the extended runway 26 approach for traffic.

During the interview, the pilot confirmed that while entering the runway, they checked the runway approach for traffic, filled out flight departure times and confirmed the line-up checklist was completed by using a physical checklist. These actions diverted the pilot's attention from outside into the cockpit. In addition to the refocusing of attention, the pilot also advised that runway 26 was not a frequently used runway for operations. A combination of the high workload, unfamiliarity with the runway and night operations increased the risk of runway misalignment.

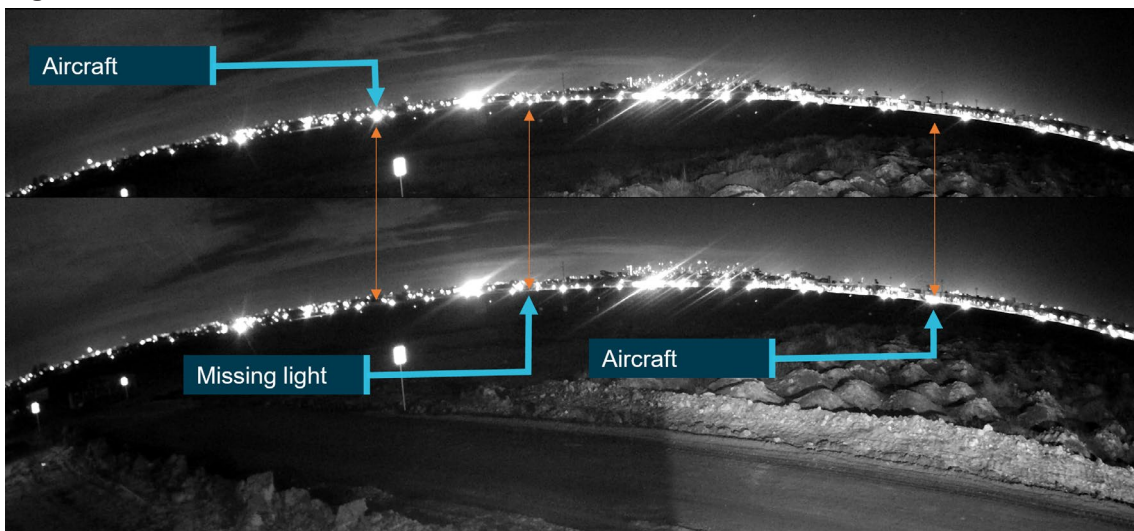
Figure 6: CCTV before and after take-off run

CCTV footage showing the runway was obtained to confirm if the runway lights were energised during the take-off. From the footage, an aircraft could be seen conducting a take-off run from runway 26 at 0119 and during the take-off, one of the runway lights extinguished as the aircraft passed over it.

CCTV footage confirmed that the aerodrome lights were energised and an aircraft was observed to conduct a take-off run along runway 26 at the time of VH-XMM's departure. As the aircraft moved along the northern runway edge lights were observed to extinguish. In addition, after the aircraft returned to the apron, the damage was detected, which was consistent with striking the runway lights.
