Collision with terrain involving Robinson R44, registration VH-HRB

95 km west-north-west of Borroloola, Northern Territory on 7 August 2023

ATSB Transport Safety Report

AO-2023-037

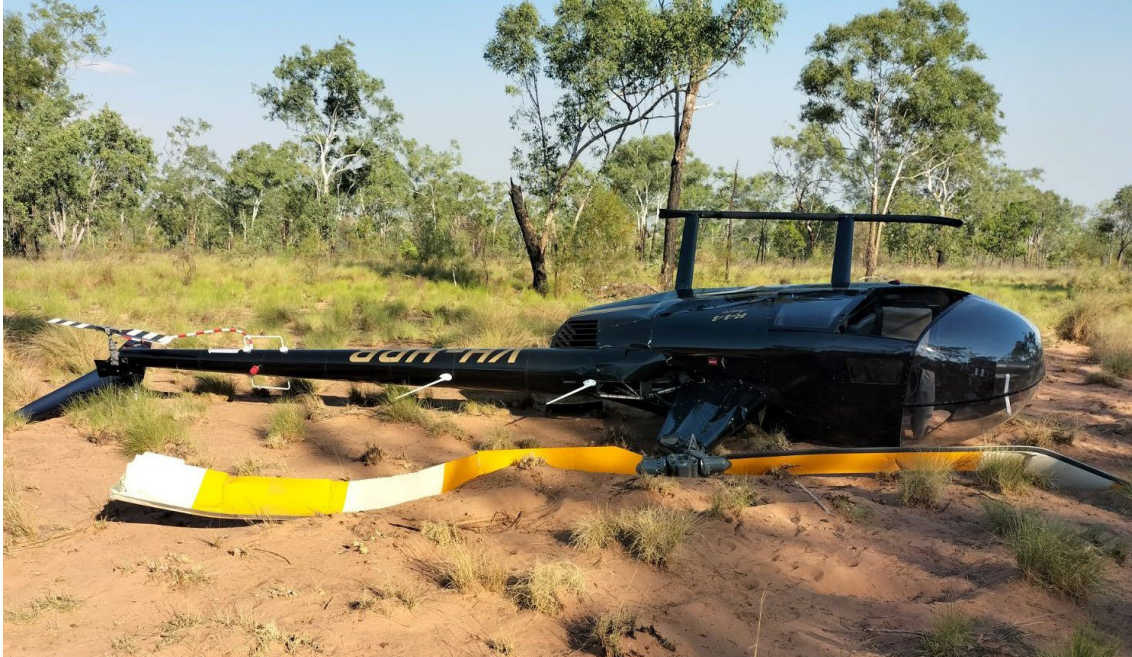
The helicopter subsequently started drifting right, which the pilot later advised they did not recognise, instead believing that the right skid was still on the ground. They lowered the collective² in an attempt to settle the helicopter resulting in the helicopter rolling onto its right side (Figure 1).

Figure 1: VH-HRB post-accident

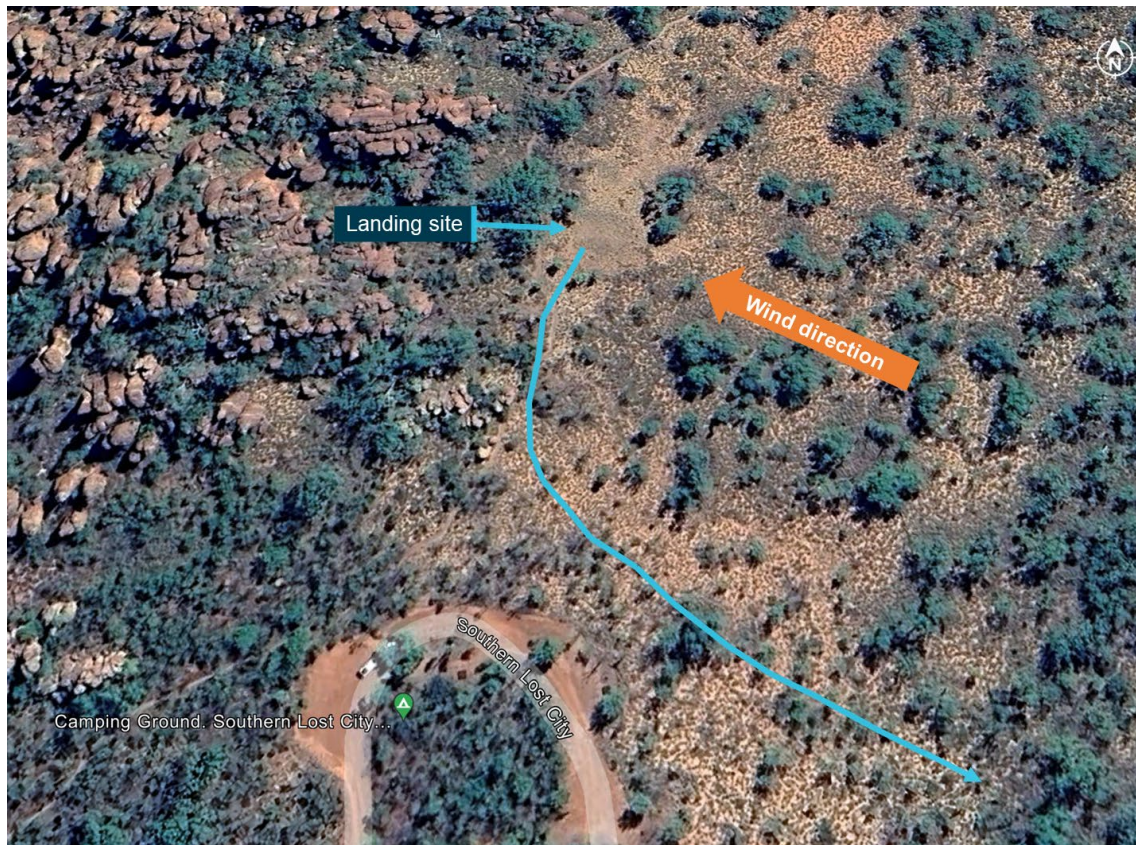
The operator’s procedure for the landing site was to follow a curved departure to the south-east when easterly winds prevailed (Figure 2).

Figure 2: Intended direction of travel

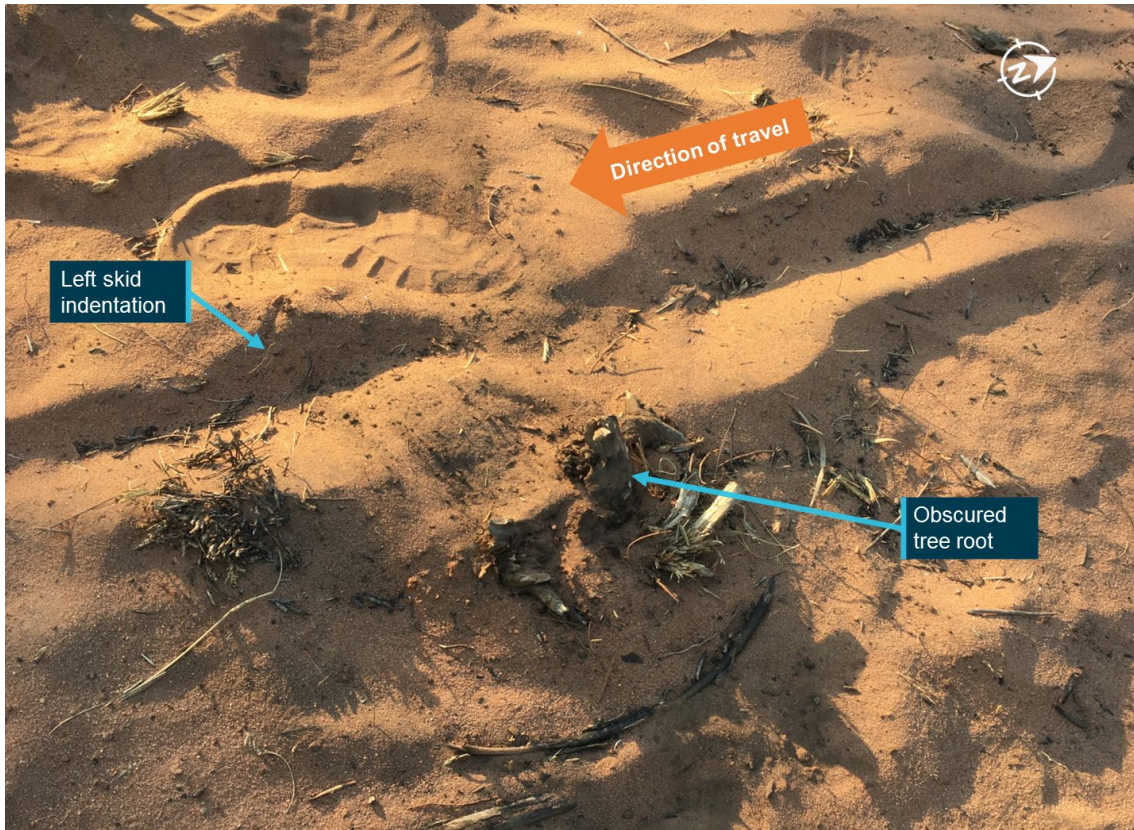
Photographs provided by the operator post-accident (Figure 3) depicted a tree root protruding from the sand in close proximity, or pressed against, the helicopter’s left skid.

Figure 3: Left skid indentation against tree root

Prior to departing, the pilot was unaware that the helicopter's left skid was pressed against a tree root, which was not obvious as it was partially obscured by sand. During take-off with prevailing east-south-easterly winds, the pilot applied slight left cyclic to manoeuvre the helicopter into a hover. These inputs pushed the left skid into the tree root, which in turn resulted in the helicopter initially rolling around the left skid.

- The pilot was unaware that the helicopter's left skid was pushed against a tree root during the take-off, leading to an uncommanded left roll and subsequent dynamic rollover during the attempted recovery.

Operators and pilots are also reminded to conduct a thorough visual inspection of landing sites to identify potential hazards prior to take-off. While uncertified aerodromes, bush landing sites and paddocks can be suitable landing areas, they are also prone to concealed hazards.
