Runway excursions on take-off involving Airbus A330-323, 9M-MTL, and Boeing 787-9, VN-A819

Melbourne Airport, Victoria, on 7 and 18 September 2023

ATSB Transport Safety Report
Aviation Occurrence Investigation
AO-2023-043
Preliminary – 1 December 2023

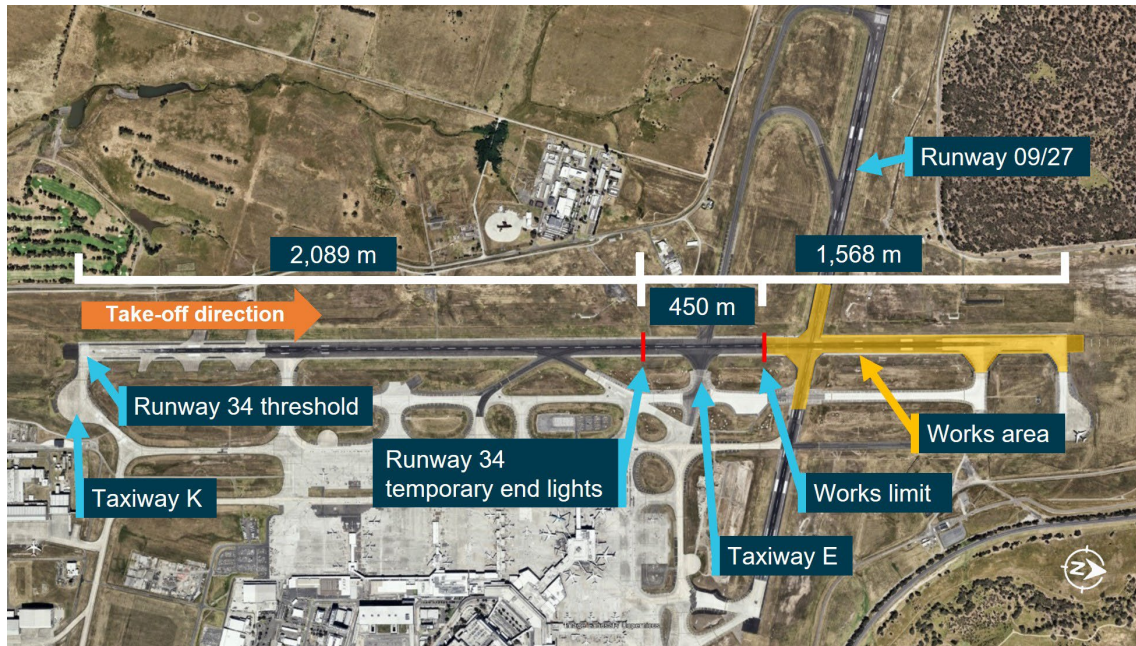
Figure 1: Melbourne Airport arrangement relating to the occurrences

Within an 11-day period in September 2023, the ATSB received two notifications of runway excursions during take-off at night from runway 34 at Melbourne Airport, Victoria. Runway 34, which was normally 3,657 m long, had been temporarily shortened by 1,568 m from the northern end, due to runway resurfacing works in progress (WIP) (Figure 1).

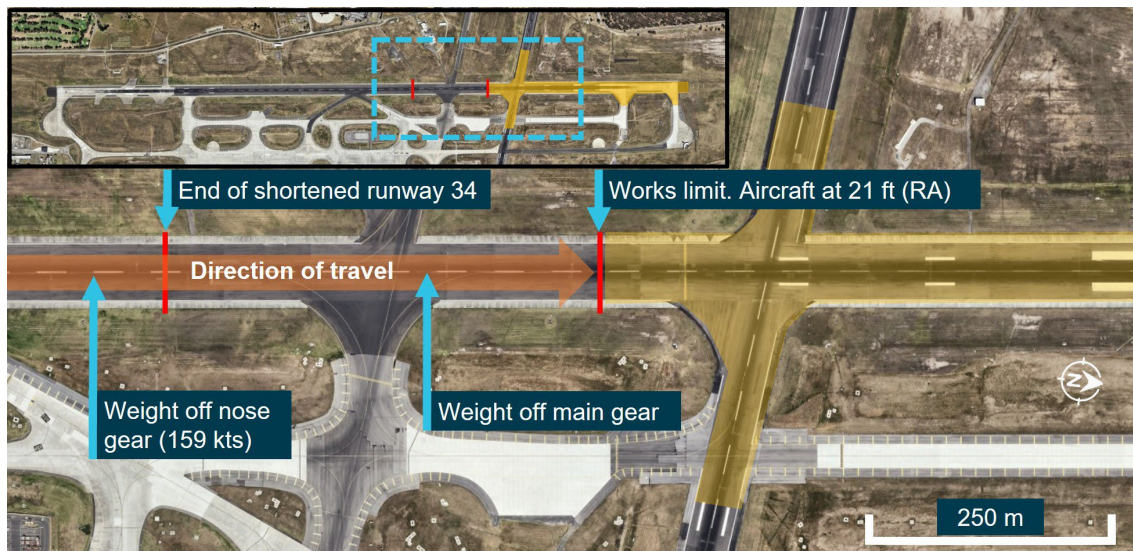
Figure 3: 9M-MTL take-off relative to runway works

Aircraft flight data showed that upon reaching the calculated rotation speed (V_R) of 159 kt, approximately 75 m before the runway end, the aircraft rotated (weight off the nose landing gear), (Figure 3). Both crew recalled that the initial rate of rotation was slow¹⁴ and was subsequently corrected. The data recorded weight off the main landing gear, after the end of the runway, approximately 170 m before the works limit line. The data recorded 21 ft (6.4 m) radio altitude (RA) as the aircraft crossed the works limit.

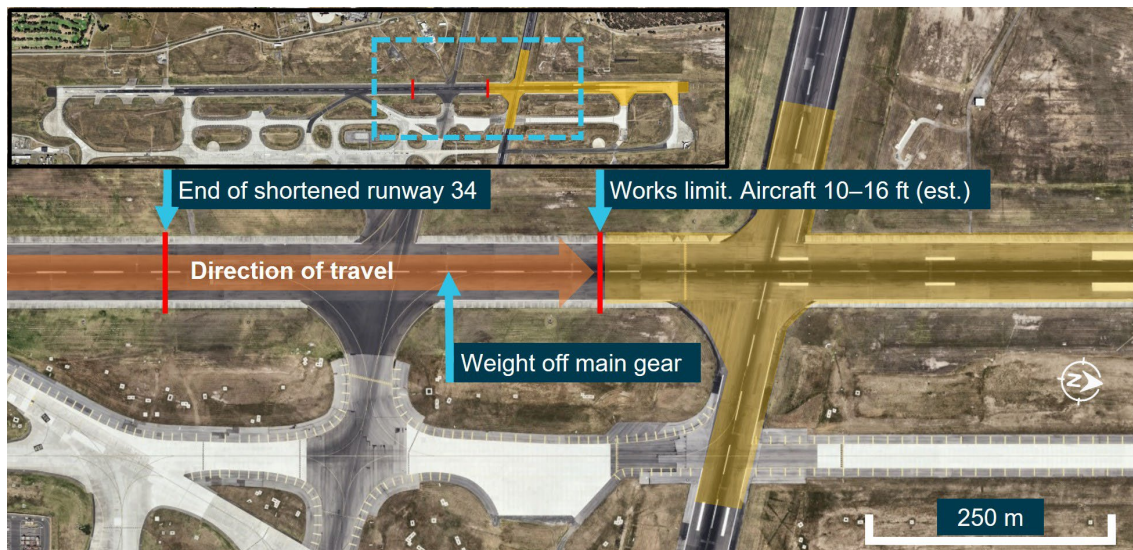
Figure 4: VN-A819 take-off relative to runway works

Flight path data provided by Bamboo Airways identified the point of weight off the main landing gear as just past taxiway E (Figure 4). Based on witness reports and review of CCTV footage, Melbourne airport estimated the height over the works limit to be 3–5 m (10–16 ft).

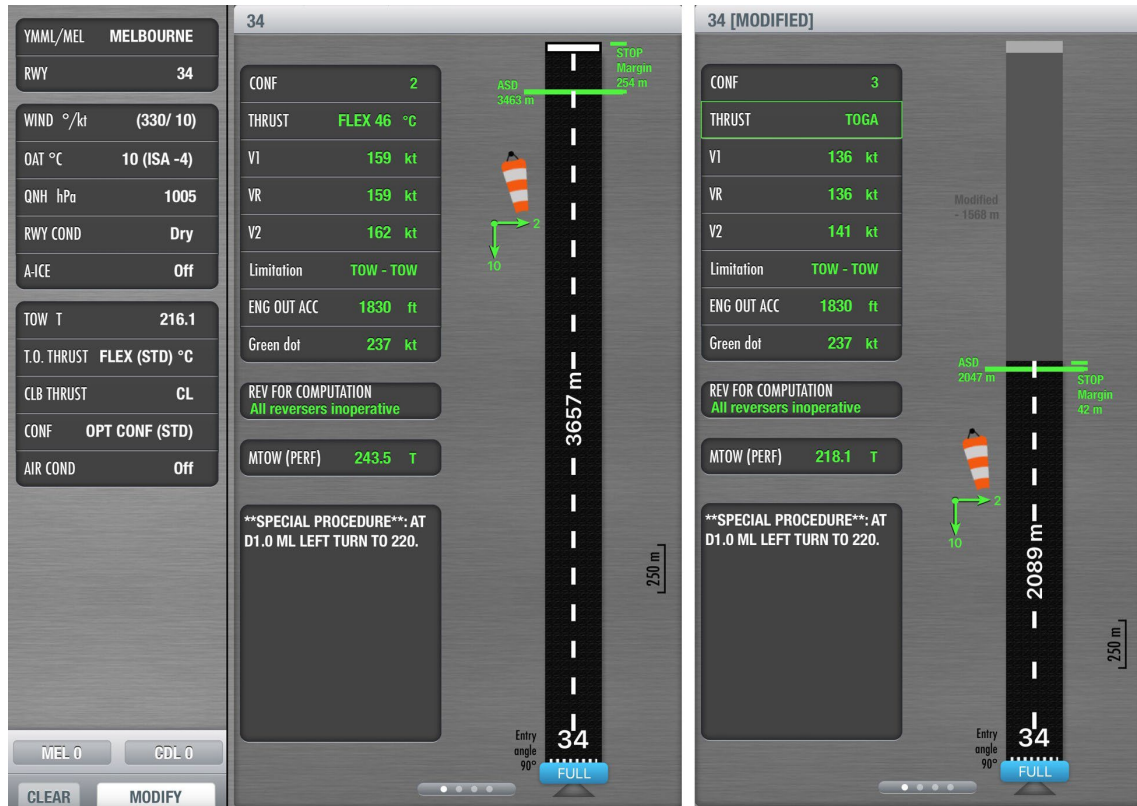
Figure 5: 9M-MTL Airbus *Flysmart* performance comparison between Melbourne runway 34 full-length (centre of image) and reduced-length (right) under otherwise identical conditions.

A comparison of the calculations made by the systems for a full-length and reduced-length runway applicable to each occurrence is shown in Table 1 (9M-MTL) and Table 2 (VN-A819). Using the full-length runway in the calculations resulted in a reduced thrust setting, reduced flaps setting and higher V speeds.¹⁸
