Engine room fire on board *MPV Everest*

Southern Ocean on 5 April 2021

ATSB Transport Safety Report

MO-2021-003

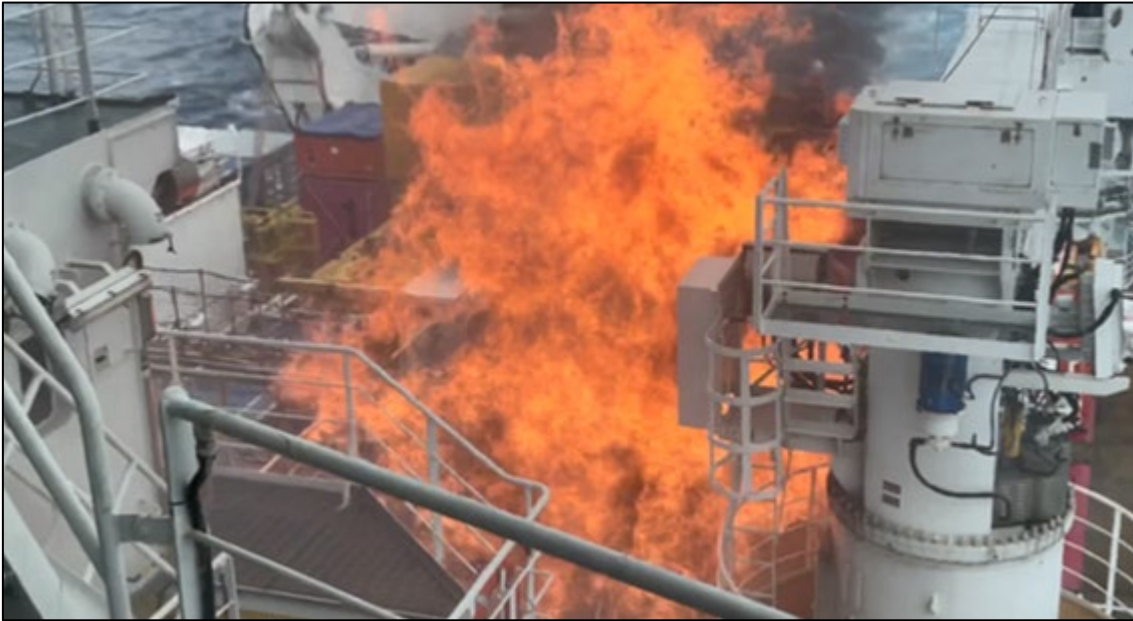
Figure 4: Flames from the port engine room exhaust ventilation casing

Outside the exhaust casing, the flames quickly engulfed 2 rubber watercraft and other equipment stowed inboard of the casing and set them alight (Figure 4). Meanwhile, the chief engineer, who was working on DG4 and DG5 (in the starboard engine room) heard the fire detector alarm and other alarms and went to the ECR. There, the chief engineer observed that the IAS indicated active fire detectors in the port engine room. Soon after, the chief engineer, accompanied by the third engineer, went to investigate and, on opening the watertight door to the port engine room, they saw thick smoke and burning material. The chief engineer also noted that the water mist fixed fire-extinguishing system was active. They retreated, shut the watertight door, and returned to the ECR.

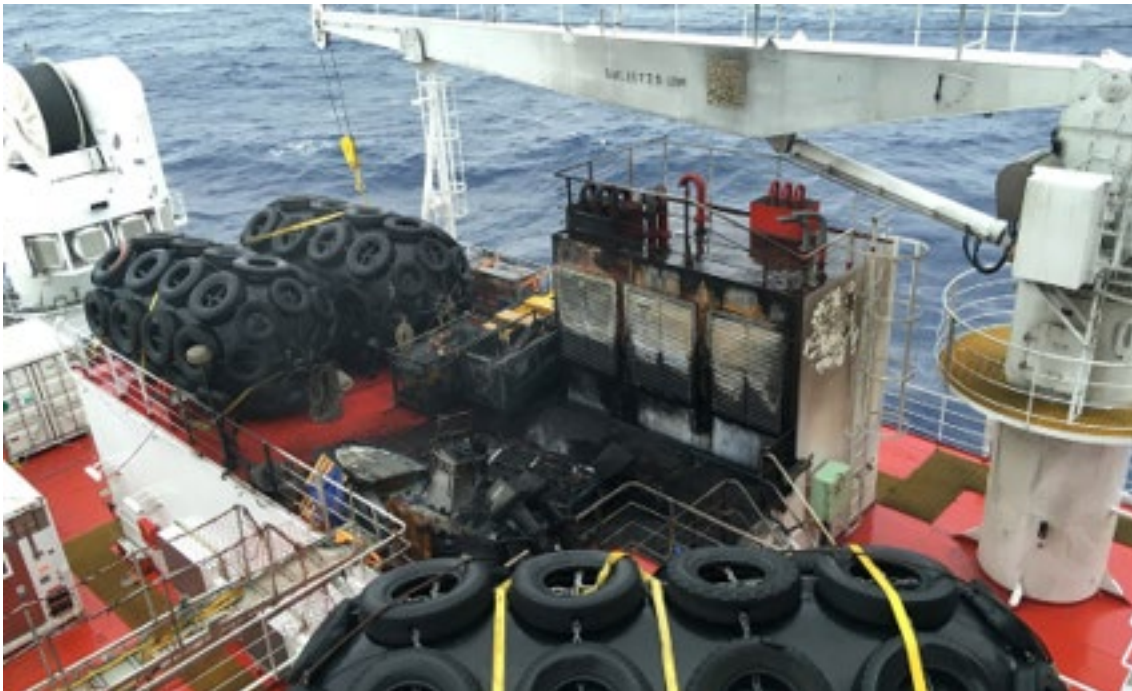
Figure 7: Fire damage on deck including the burnt-out watercraft adjacent to the casing

The fire resulted in 2 AAD watercraft being destroyed on deck along with some other associated equipment in the vicinity (Figure 7).

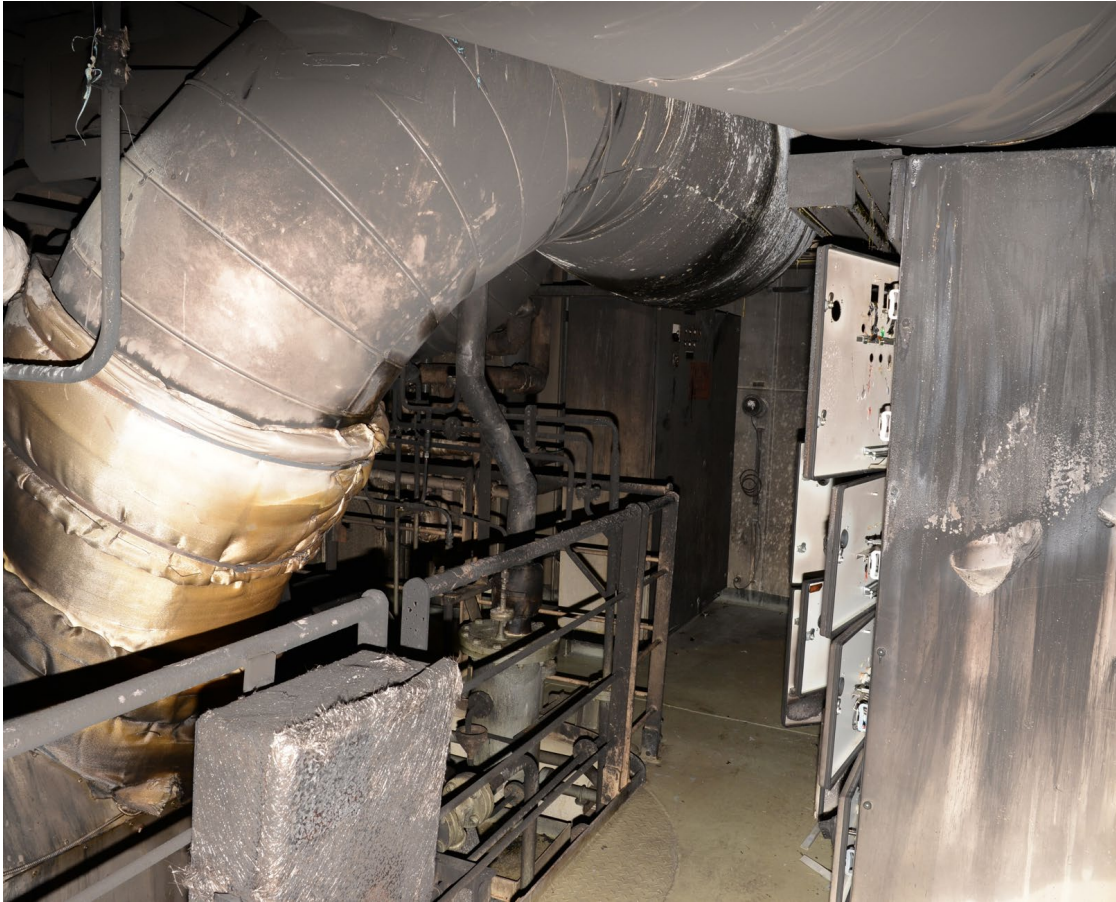
Figure 8: Fire damage inside the port engine room

The fire also resulted in substantial damage to the port engine room including to machinery, fixtures, wiring, and electrical enclosures (Figure 8).

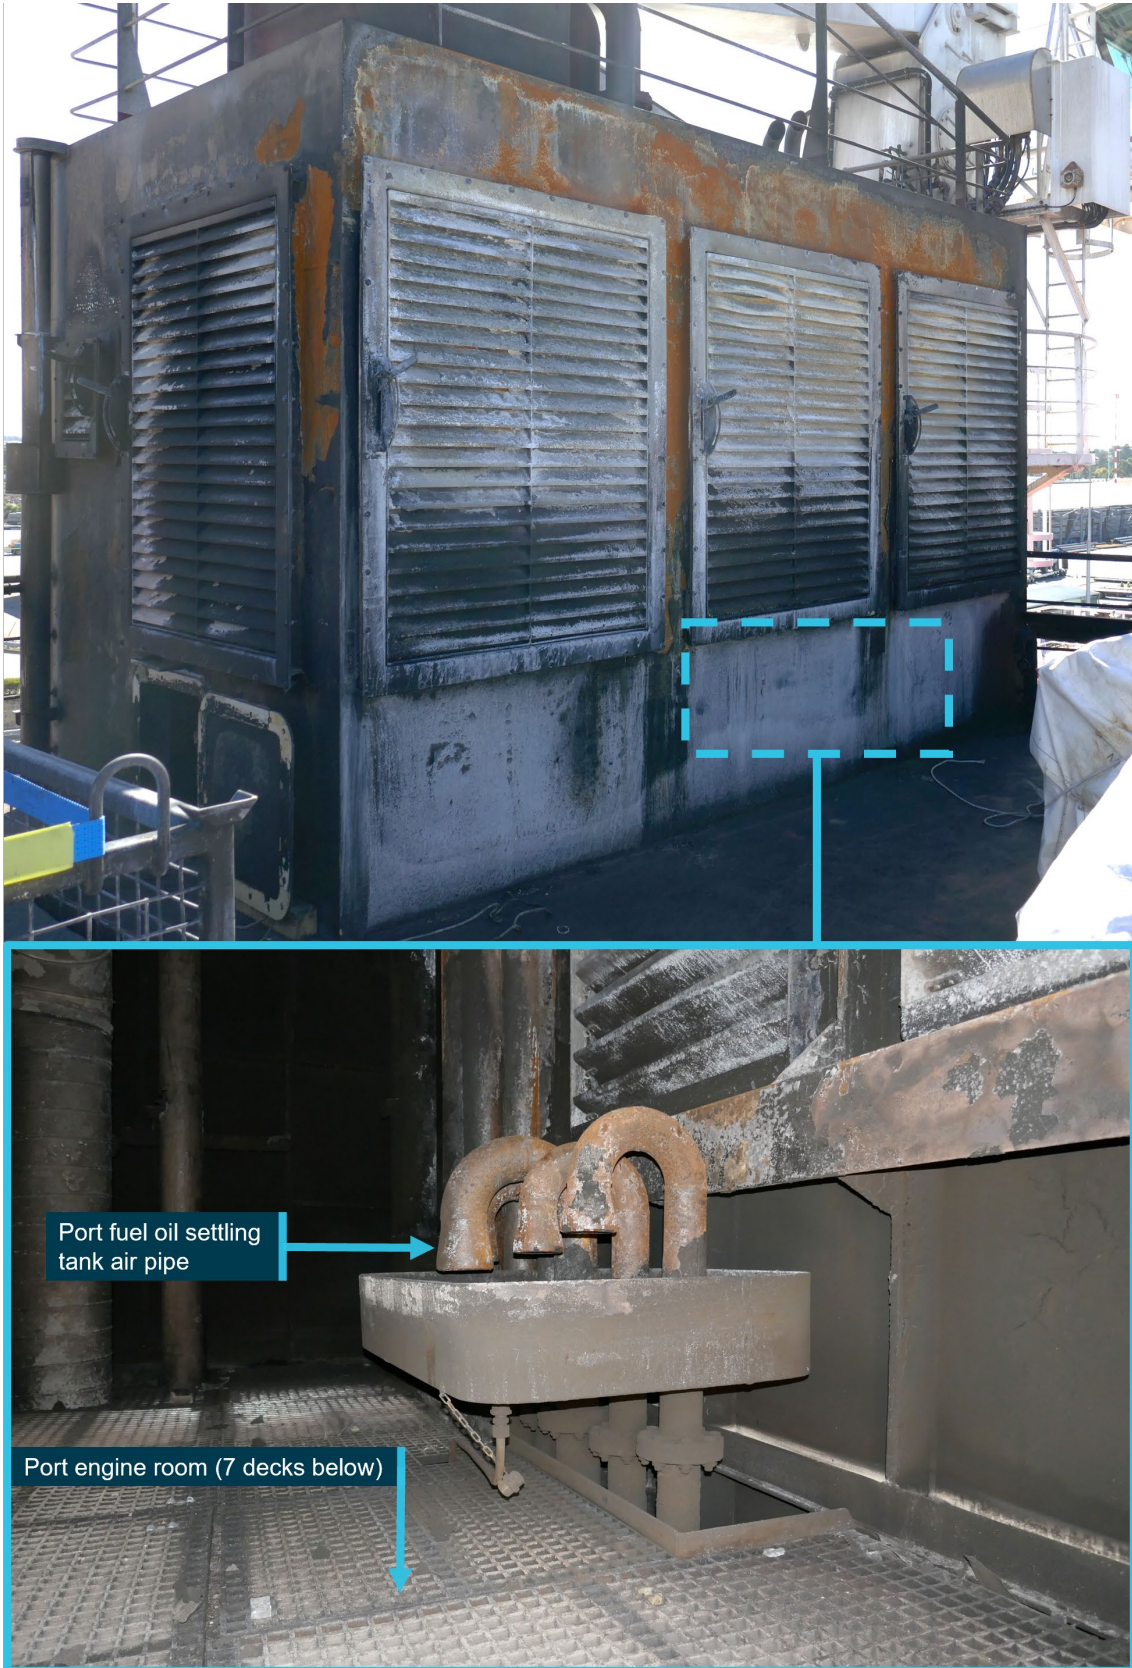
Figure 9: Port engine room exhaust ventilation casing (inset photo: close-up of internal vent pipes)

After the fire was extinguished, the fire-damaged port engine room was ventilated, and inspected by the chief engineer and second engineer, among others. During these early inspections, the engineers observed fuel oil pooled in the port engine room as well as fuel dripping down into the engine room from within the exhaust ventilation casing above. On further investigation, the chief engineer identified several pipes passing through the exhaust ventilation casing, with some terminating externally on top of the casing while others terminated internally within the casing (Figure 9). One of the pipes that terminated inside the casing was identified as an air pipe for the port fuel oil settling tank that was being filled prior to the fire.

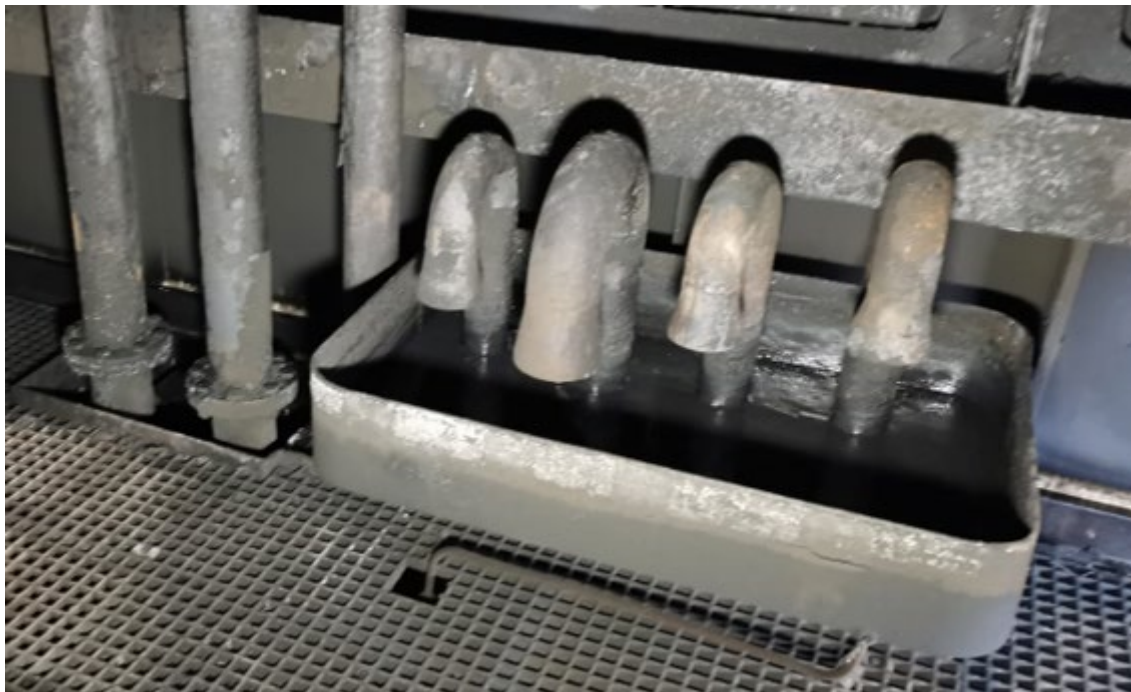
Figure 10: Fuel in port settling tank air pipe save-all

The inspections also found quantities of liquid fuel pooled in the save-all around the port settling tank's goose neck vent pipe termination (Figure 10). The chief engineer's investigation concluded

that the port settling tank that was being filled had overflowed from the tank's goose neck air pipe termination in the upper level of the port engine room exhaust ventilation casing and that the fire had resulted from the ignition of this overflowing fuel.

Photo taken by shipboard staff following the fire showing liquid fuel in the port settling tank air pipe save-all.
Source: Fox Offshore

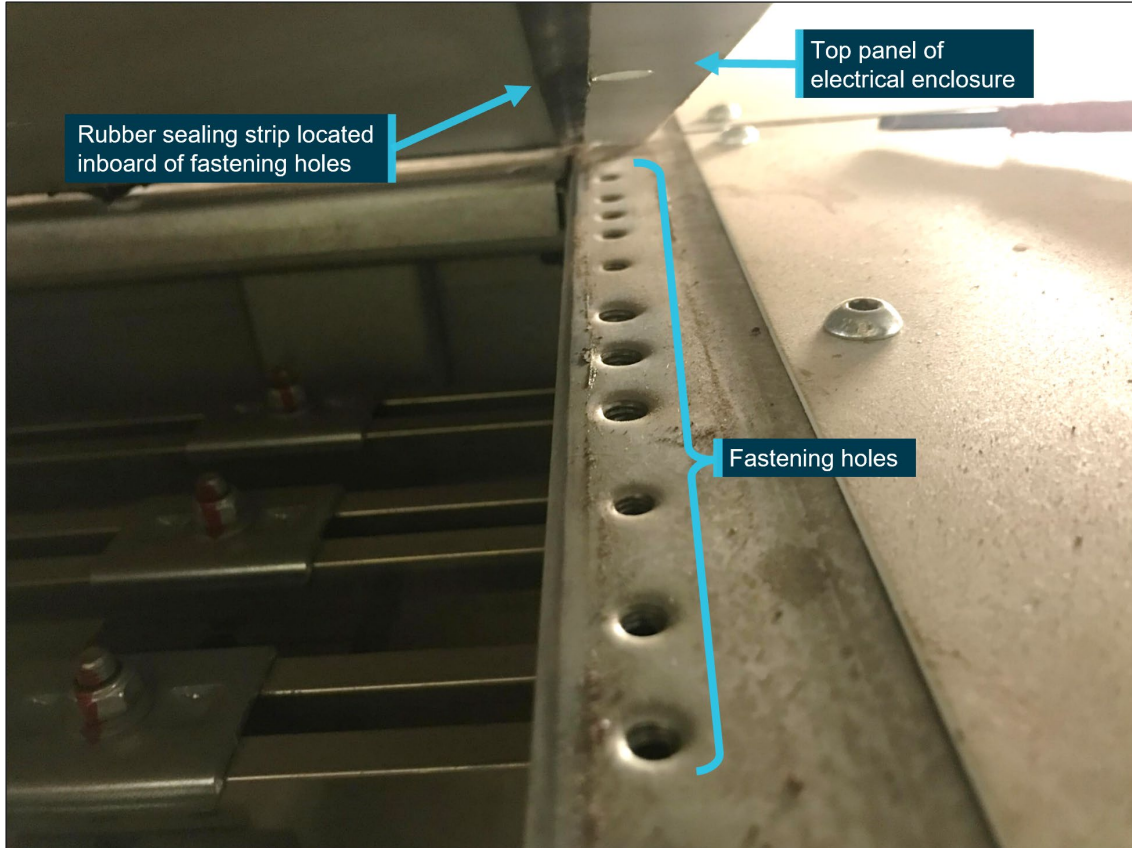
Figure 11: Top of pump room electrical enclosure

The shipboard investigation found that the enclosures were incorrectly constructed, that the top panels were not adequately sealed and that there were gaps between adjacent panels. Sealing gaskets intended to prevent the entry of fluids were located inboard of fastening holes thereby providing an unimpeded path for fluid ingress (Figure 11).

Note that only about 3 fastening holes on each side of the top panel are used to secure the panel to the enclosure leaving the remaining fastening holes empty.

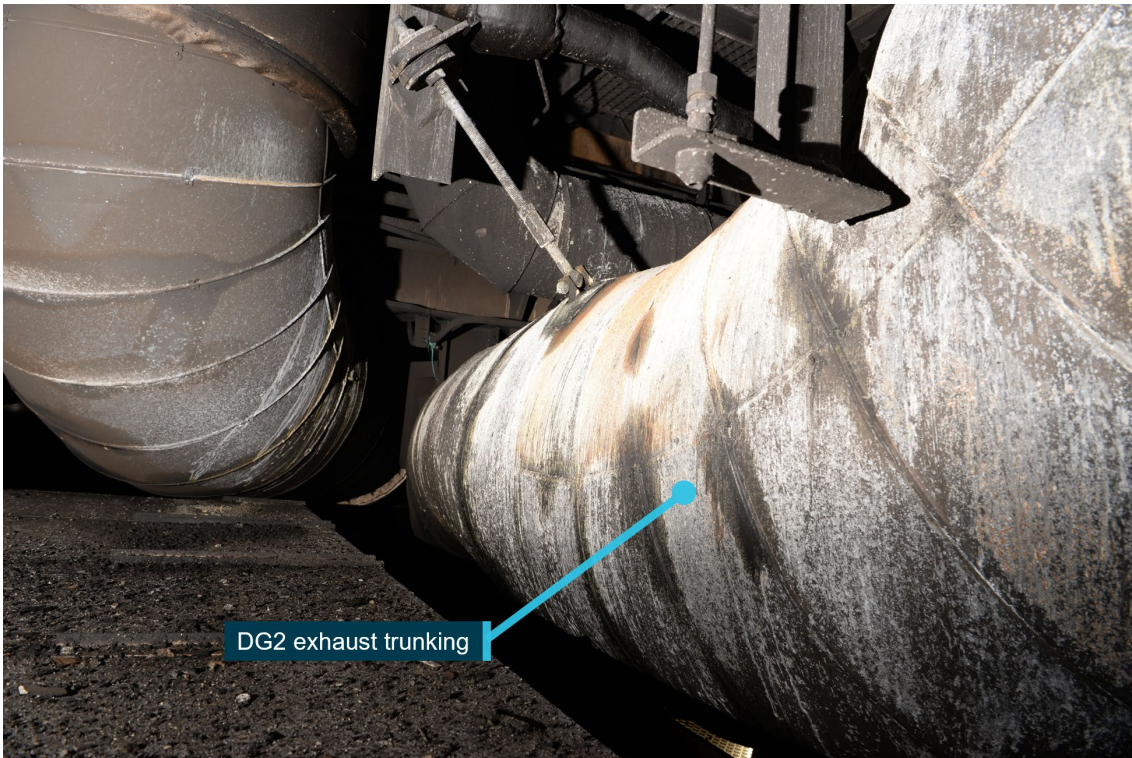
Figure 19: Upper surfaces of DG2 exhaust trunking

All 3 exhaust trunkings showed heavy sooting. The underneath of the trunking for all 3 generators had zinc oxide trails, particularly where the trunking bent upwards to enter the exhaust ventilation casing indicating localised surface temperatures above 450° C. The upper surfaces of DG2's trunking showed evidence of increased oxidisation, presenting as orange oxides, indicating that the surface temperature was above 750° C, particularly around the location of the brace securing (Figure 19).

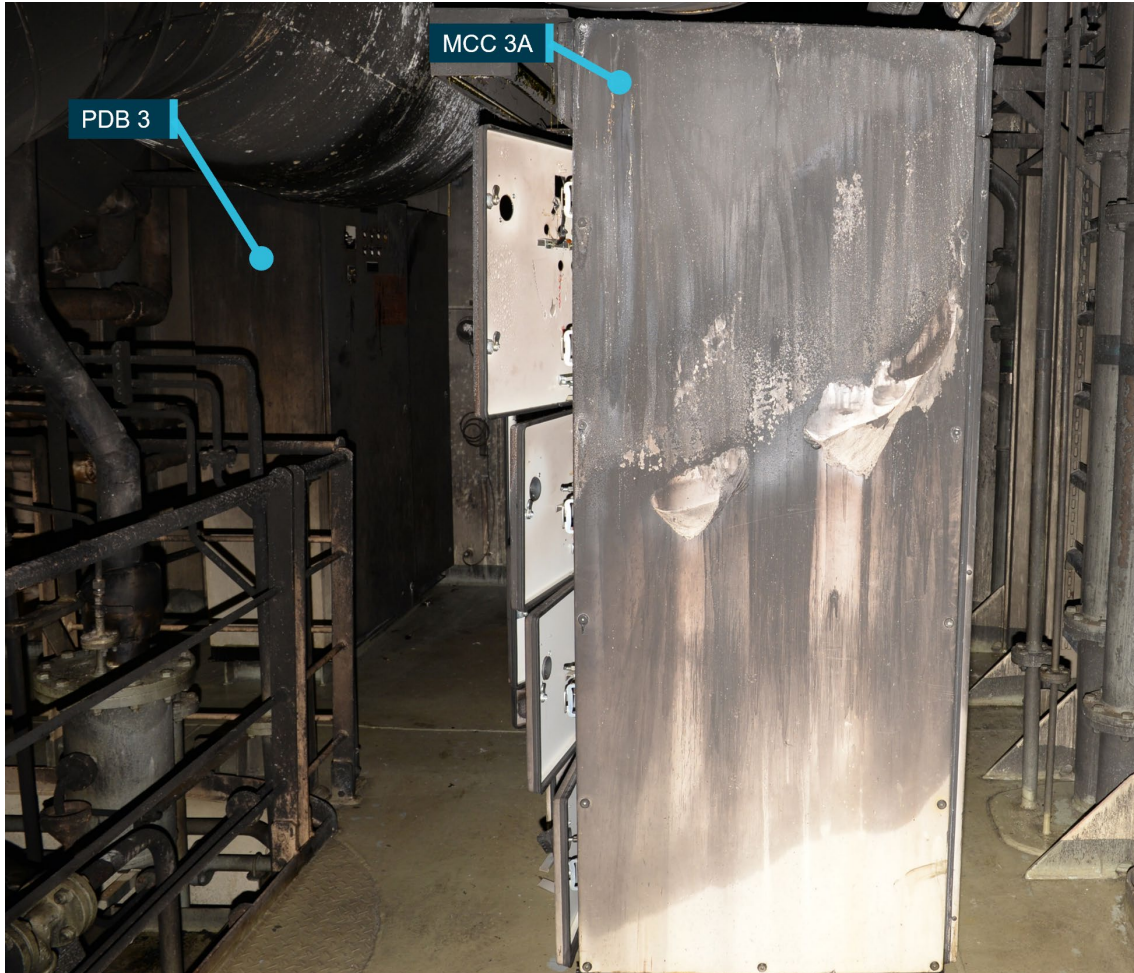
Figure 20: Electrical enclosures at forward end of B-Deck

combustion at deck level, while the starboard doors showed even thermal damage to both upper and lower door surfaces indicating combustion occurring above the cabinet and at deck level. The starboard end of the MCC presented with increased thermal damage radiating from lower to higher surfaces (Figure 20).

The interior of the MCC had mild sooting throughout with intact door seals showing minor thermal damage. There was melting and charring of switches and indicator lights but no evidence of arcing. A bank of indicator lights in the third column showed deeper charring than others and was removed by the ATSB for analysis. However, further examination did not identify any obvious signs of arcing or short circuiting. There was liquid diesel at the bottom of the MCC enclosure.

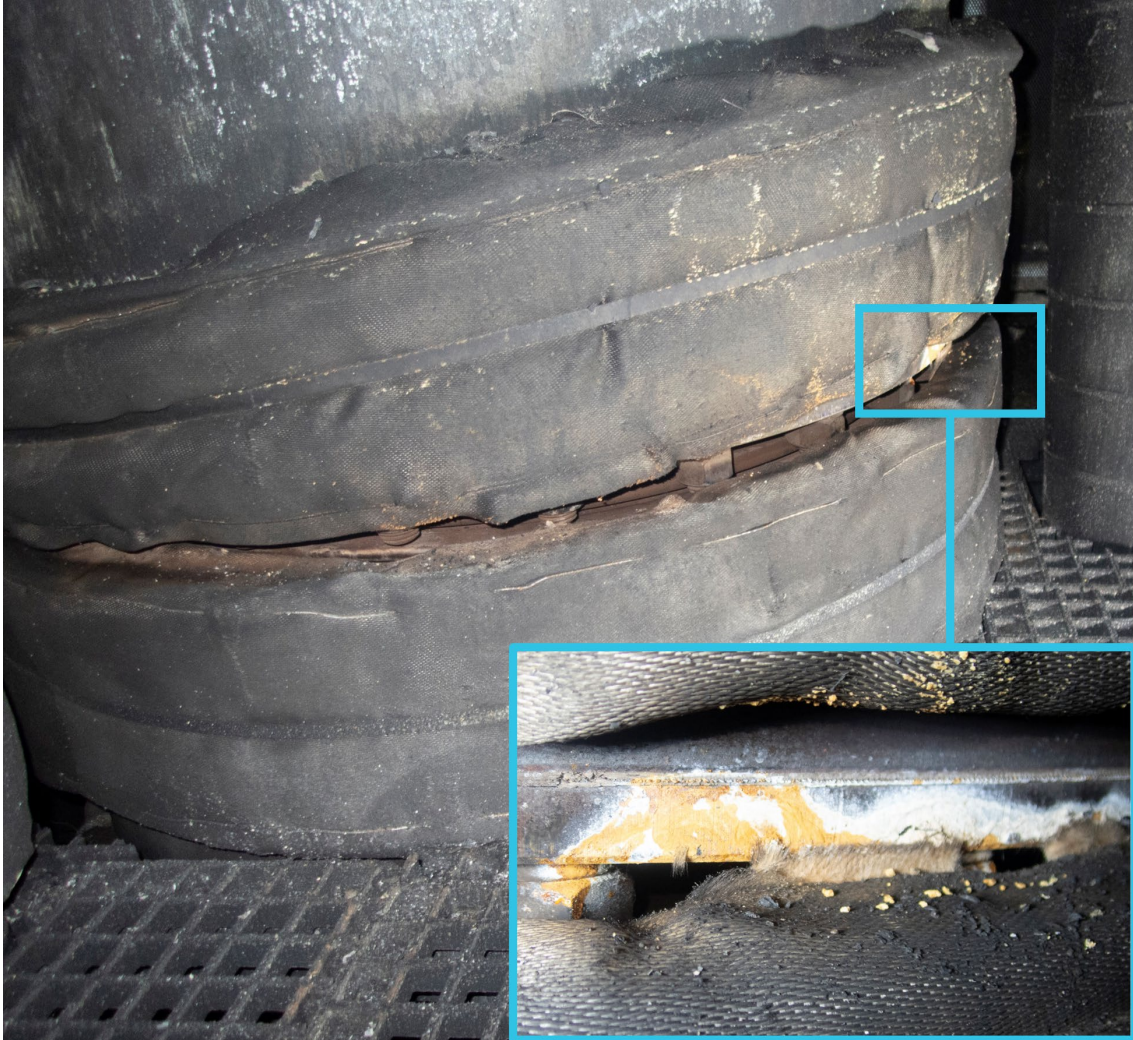
Figure 21: Gap in sections of insulation on exhaust trunking of DG3

exposing a flanged joint where 2 sections of the trunking were bolted together (Figure 21). There was oxidation present on the exposed section of the flange with the burn pattern indicative of being affected by airflow from right to left. The section of insulation located above the exposed flange showed signs of combustion with oxidation and burn patterns radiating upwards and outwards indicative of an upwards airflow.

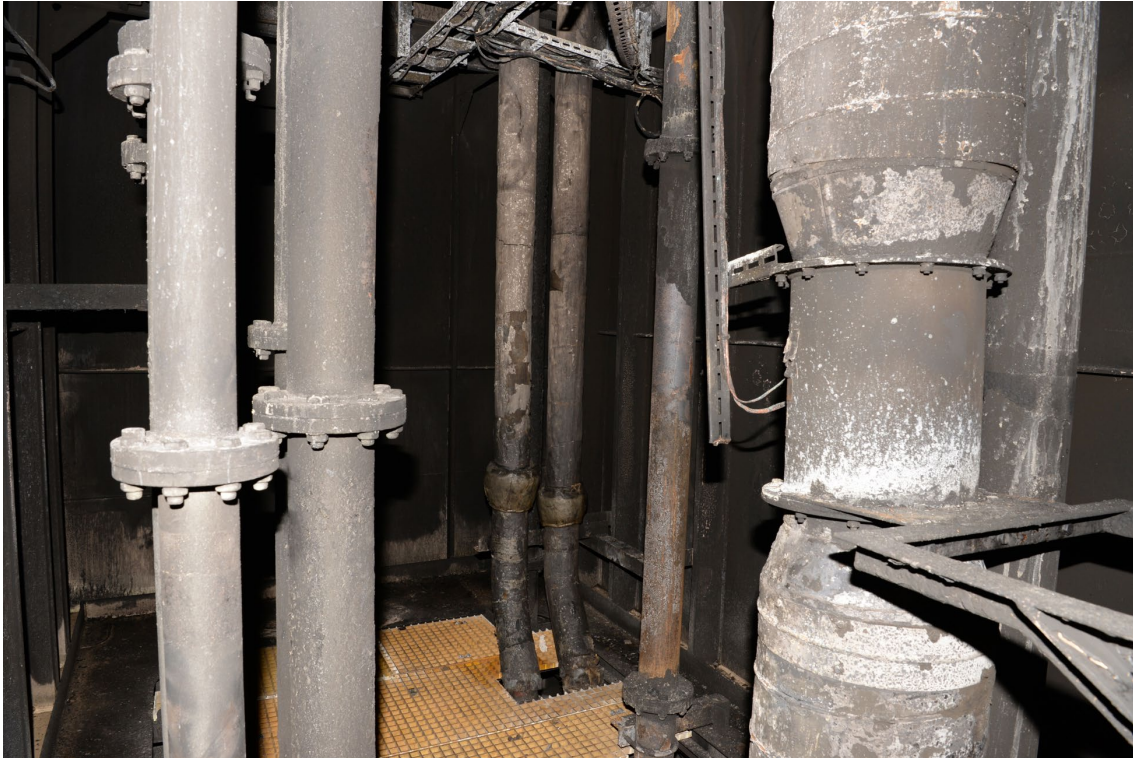
Figure 22: Interior of exhaust ventilation casing at lower forecastle deck level

Cable trays located in the upper area of this space showed more combustion damage in the centre of the space (in the path of the airflow upwards) than near the bulkheads. Cables at the forward end of the space were the most fire-affected with the clean burning of the cable inner and outer sheath indicative of direct flame contact and surface temperatures exceeding 650° C.

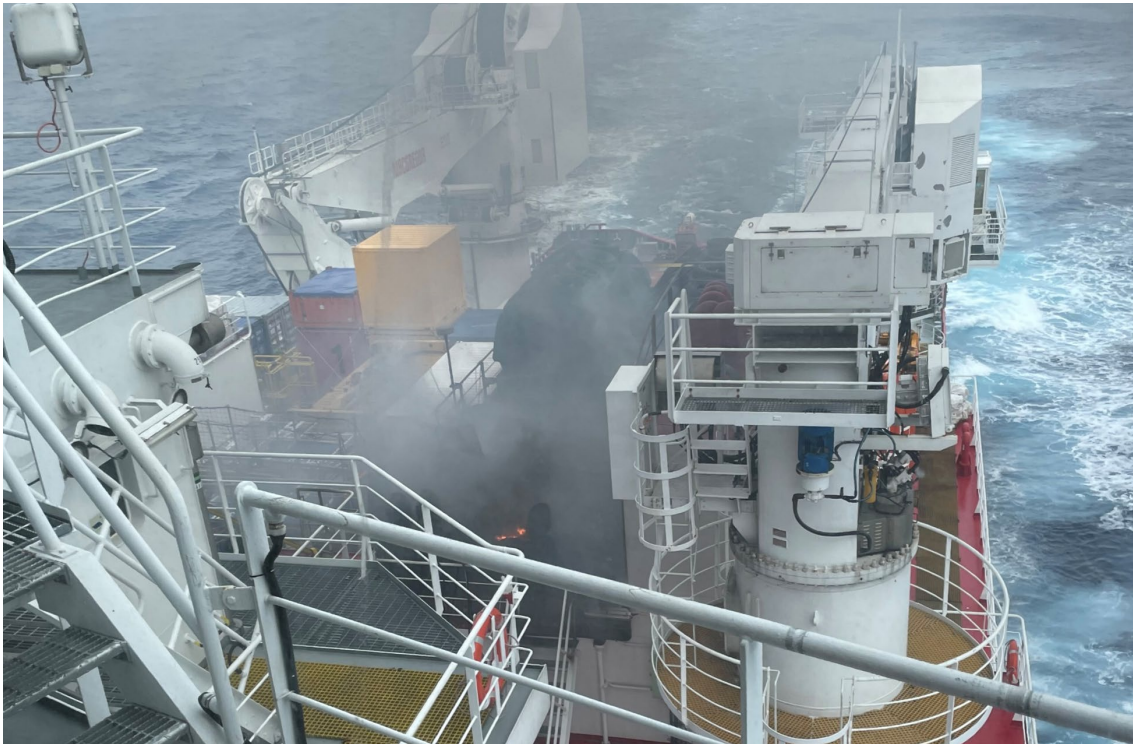
Figure 27: Photo taken just after initial deflagration

Footage captured about 35 seconds later showed a further deflagration event with large flames issuing from the ventilation louvres. Based on the above evidence, it was estimated that the initial deflagration occurred at about 1058:17 and the second deflagration occurred about 40 seconds later, at about 1058:57 (Figure 4).

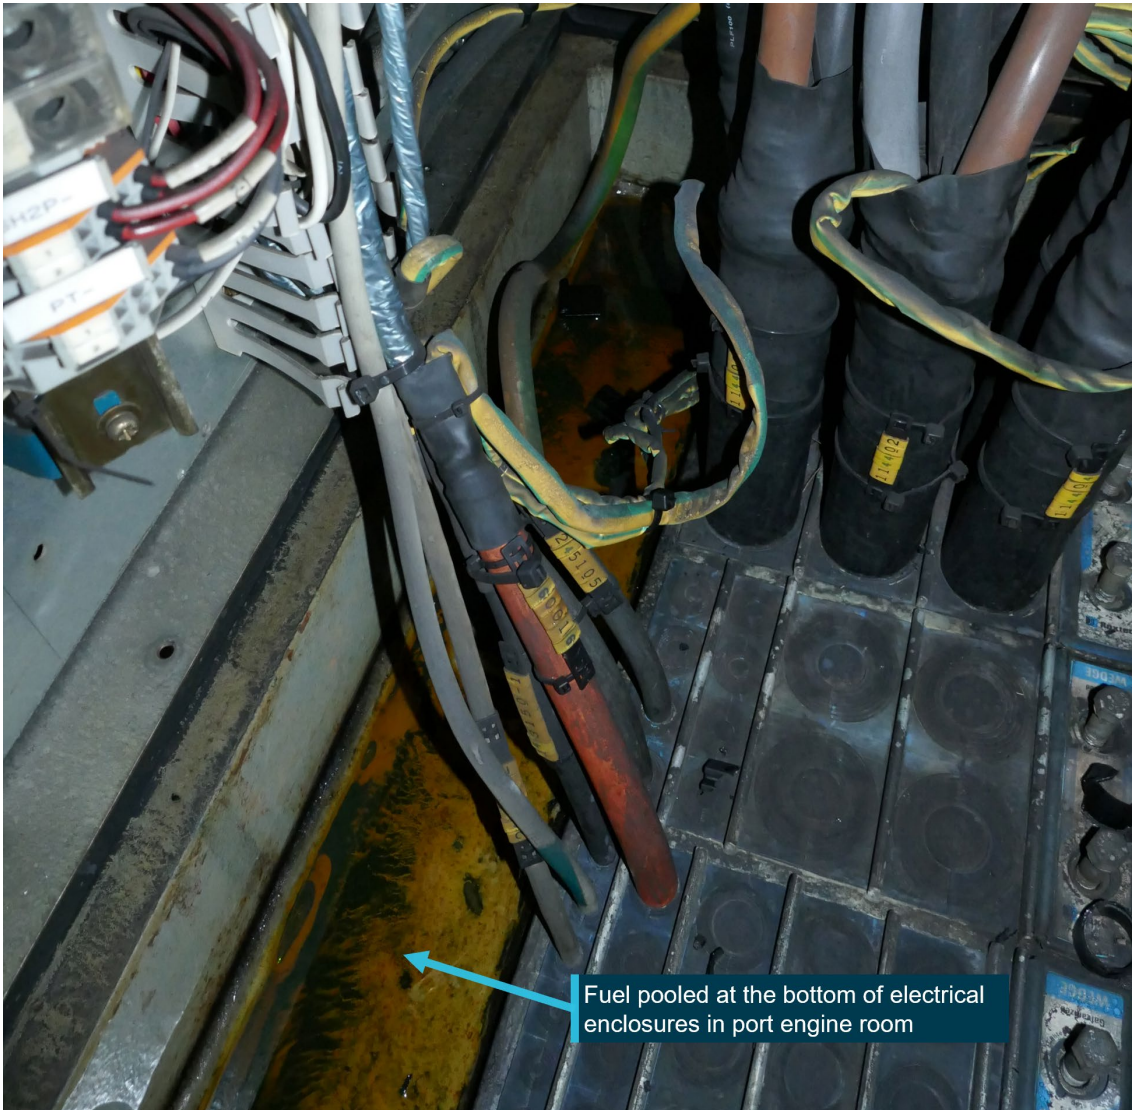
Figure 28: Fuel pooled inside electrical enclosures on B-Deck in the port engine room

The MCC and PDB enclosures on board *MPV Everest* were designed, manufactured and installed by Z-Power in Singapore. The fire-affected electrical enclosures in the port engine room and the seawater affected cabinet in the starboard pump room were replaced and repaired respectively in the repair yard in Singapore. Subsequently, Z-Power was engaged to carry out a detailed inspection of other electrical switchboards and enclosures on board to ensure they were properly sealed against water ingress. The inspection identified 7 other MCCs and PDBs that required remedial work to ensure they were appropriately sealed.
