# Descent below minimum altitude involving British Aerospace BAE 146, VH-SFV

15 km south of Rockhampton Airport, Queensland on 5 January 2023

**ATSB Transport Safety Report**

AO-2023-004

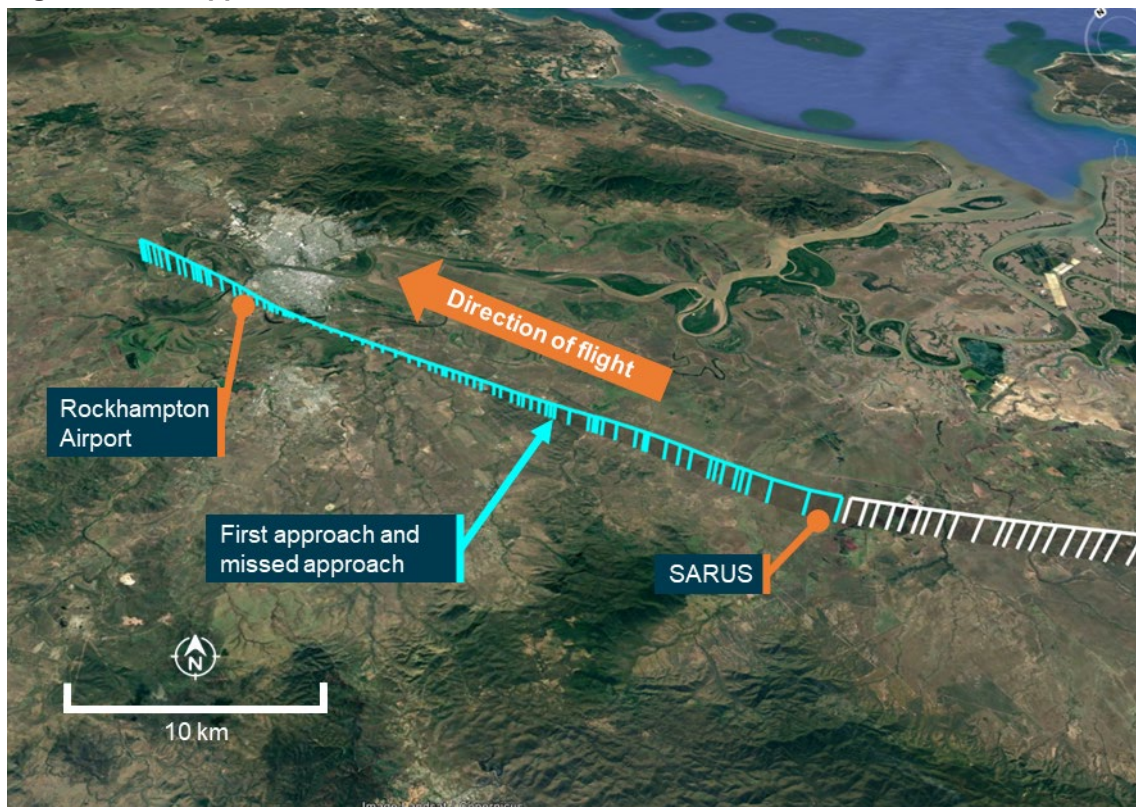
**Figure 1: First approach**

At 0300, as the aircraft climbed through flight level 220,<sup>3</sup> air traffic control cleared the flight to track to the waypoint SARUS. This waypoint was the initial approach fix for the required navigation performance (RNP) approach for runway 33 at Rockhampton and the tracking allowed the crew to proceed directly from the cruise and descent to a straight-in RNP approach (Figure 1).

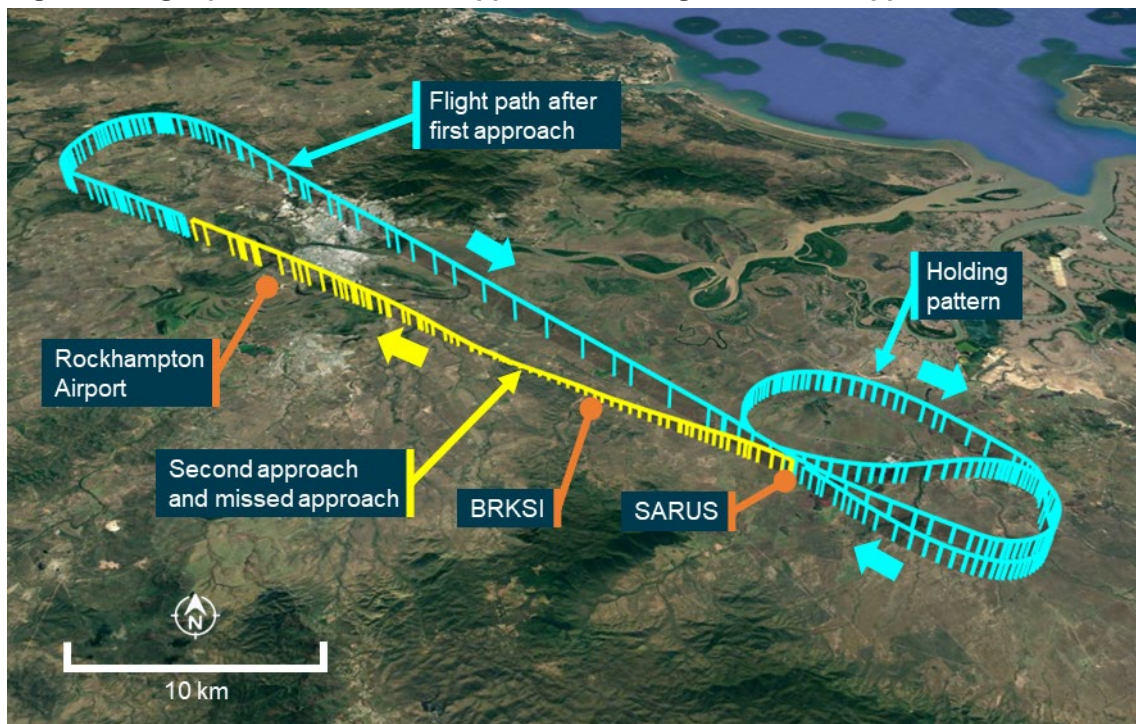
**Figure 2: Flight path of first missed approach, holding and second approach**

The crew carried out the missed approach, climbed to 4,500 ft and returned to the waypoint SARUS to prepare for a second approach (Figure 2). At SARUS, the crew conducted a holding pattern and descended to the minimum holding altitude of 3,500 ft. While conducting the holding pattern, the crew obtained updated weather information from ATC, reactivated the pilot-activated runway lights, completed an approach briefing and readied the aircraft for the second approach.

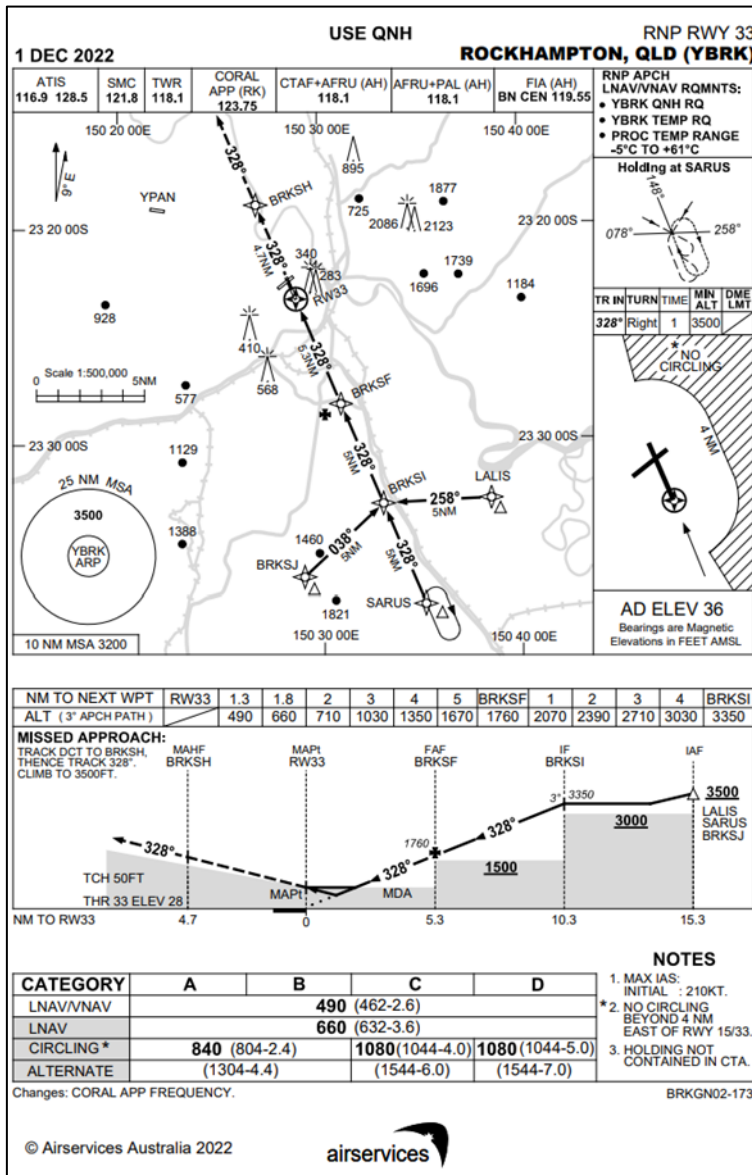
Figure 3: Rockhampton RNP runway 33 approach chart

At 0358:55, prior to crossing BRKSI, the aircraft descended below the 3,000 ft segment minimum safe altitude (SMSA) (Figure 3). The aircraft continued descending on about a 3° approach profile and crossed BRKSI at 1,705 ft (1,295 ft below the SMSA) before then descending below the next SMSA of 1,500 ft, 24 seconds later at 04:00:56.

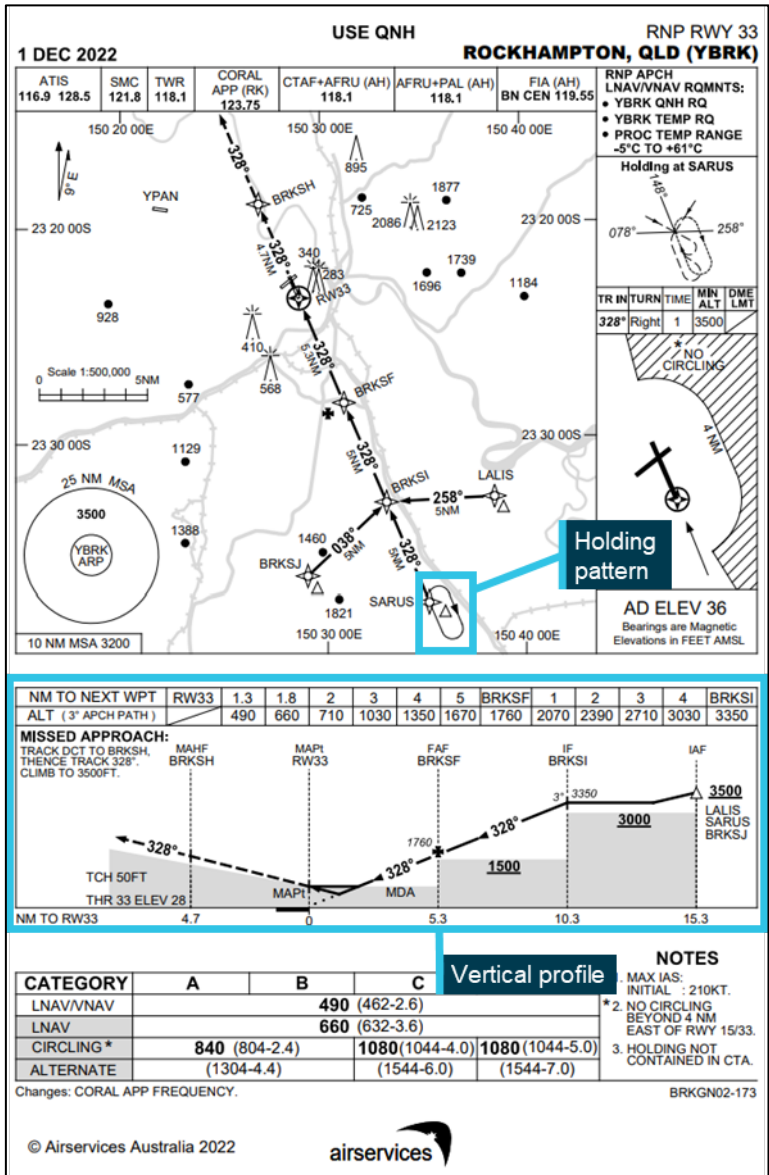
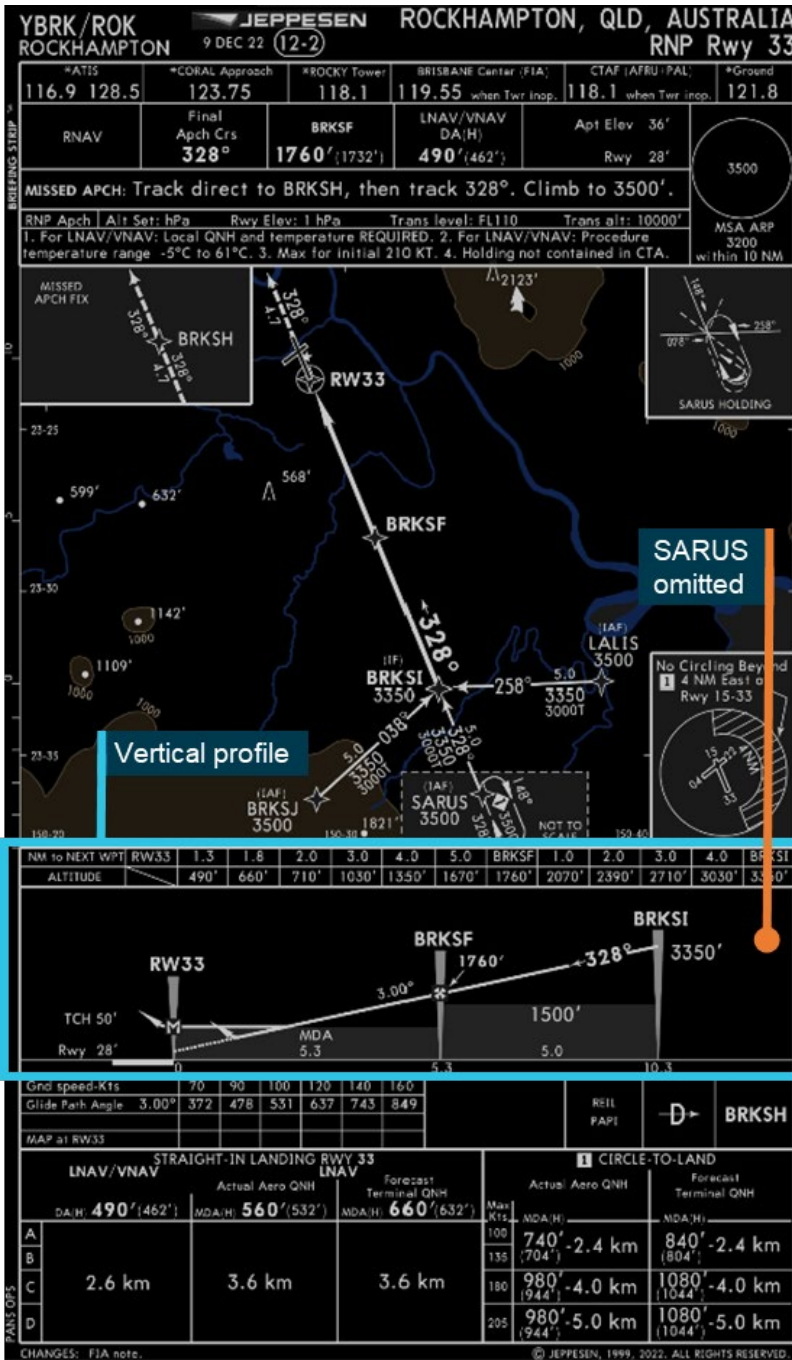
Airservices Australia and Jeppesen (an approved data service provider) published charts for the RNP runway 33 procedure. The charts produced by both organisations were designed and published in accordance with International Civil Aviation Organisation (ICAO) guidance.<sup>6</sup> The crew of VH-SFV used an electronic approach chart provided by Jeppesen, which was presented in dark mode for the night approach.

The Airservices Australia chart vertical profile presentation included the full approach, including the waypoint SARUS. This chart also included the minimum altitude of 3,500 ft at SARUS, the distance to the missed approach point of 15.3 nm (Figure 8) and the segment minimum safe altitude (SMSA) of 3,000 ft between SARUS and BRKSI. The Jeppesen chart (Figure 9) vertical profile commenced at waypoint BRKSI and did not include the waypoint SARUS, nor the SMSA between SARUS and BRKSI.

To provide a standardised presentation of aeronautical data for Jeppesen charts worldwide, Jeppesen chart design specifications directed that the vertical profile commence at the intermediate fix (IF) when an approach has multiple transitions. Jeppesen noted that this was the most common worldwide depiction of profile information. As the Rockhampton RNP approach had multiple transitions leading to the BRKSI IF, the vertical profile commenced at that waypoint.

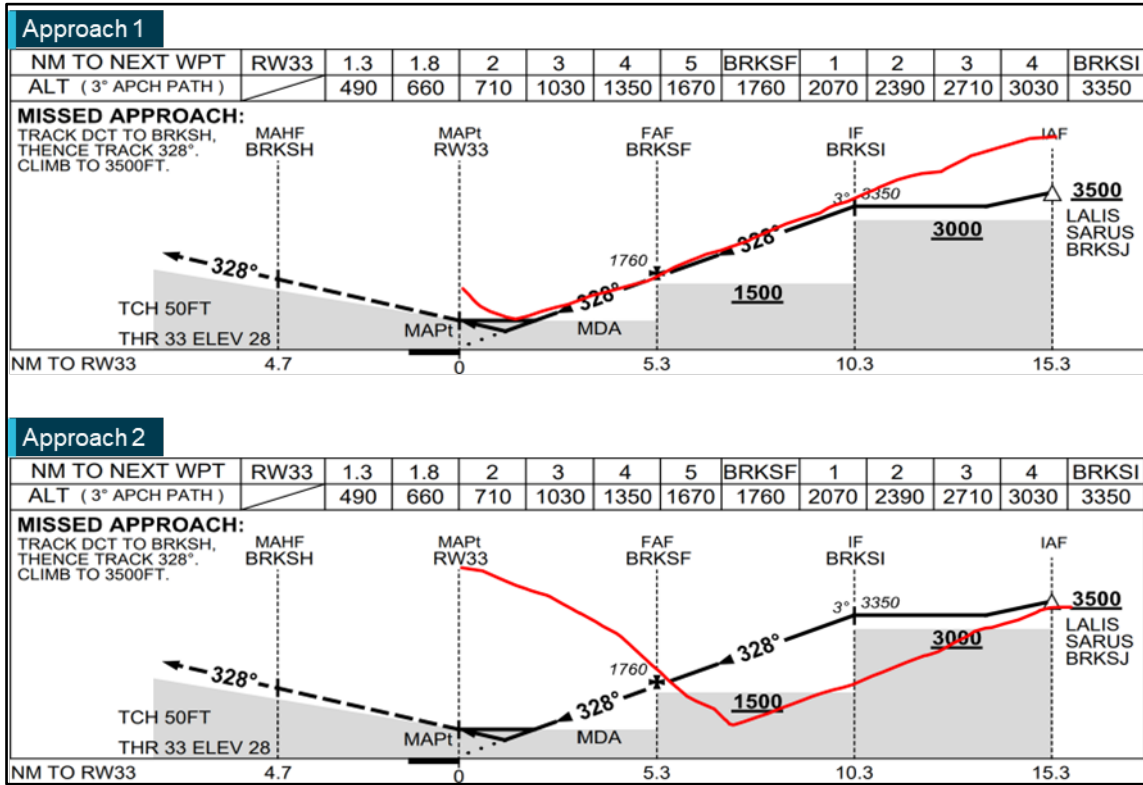
**Figure 10: RNP approach procedure showing the descent profiles of the 2 approaches**

Analysis of flight data from VH-SFV’s flight data recorder showed the descent profiles of the 2 approaches (Figure 10). The profiles show a similar descent angle, but with the second approach displaced by about 5 nm (1 approach segment).

On this occasion, following the missed approach and holding pattern, the aircraft crossed SARUS, and the captain immediately commenced descending as per their normal practice, but from the minimum holding altitude of 3,500 ft rather than their accustomed crossing altitude of 5,000 ft during a straight-in approach. This resulted in the aircraft incorrectly descending along a profile consistent with being one approach segment further along than its actual position.

As the aircraft descended along a normal descent angle, but one segment early, it twice descended below SMSAs. In dark night and cloudy conditions, this removed terrain and obstacle separation protections.
