Runway incursion involving Piper PA-28, VH-SFA, and Saab 340, VH-VED

Shellharbour, New South Wales on 6 July 2023

ATSB Transport Safety Report

AO-2023-032

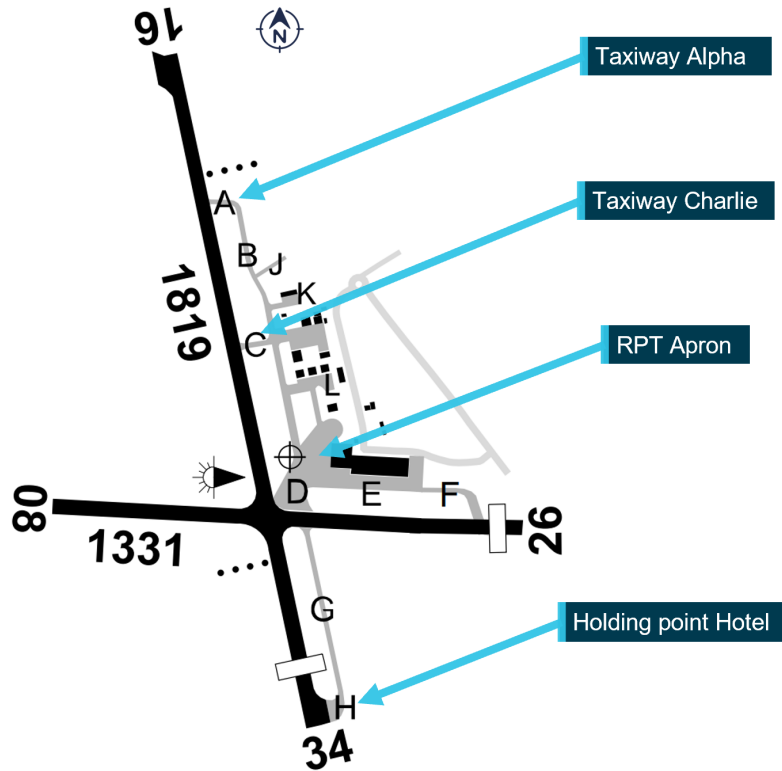
Figure 1: Shellharbour Airport layout

The PA-28 pilot taxied to, and held, at holding point Hotel (Figure 1) where they observed the Saab land and commence a turn to the right. Being unaware of the intended backtrack, they incorrectly assumed that the Saab would exit the runway on taxiway Alpha and taxi to the RPT apron. They then diverted their attention to other traffic in the circuit.

Student records indicated the PA-28 pilot was familiar with Shellharbour circuit procedures, having previously flown there with instructors and on a solo navigation exercise. However, as these previous flights did not include full-stop landings, it is reasonable that taxiways not intended to be used as part of this exercise were not discussed during the pre-flight briefing. However it also meant that the pilot was unaware that larger aircraft, such as the Saab, could only access the apron by backtracking along the runway.

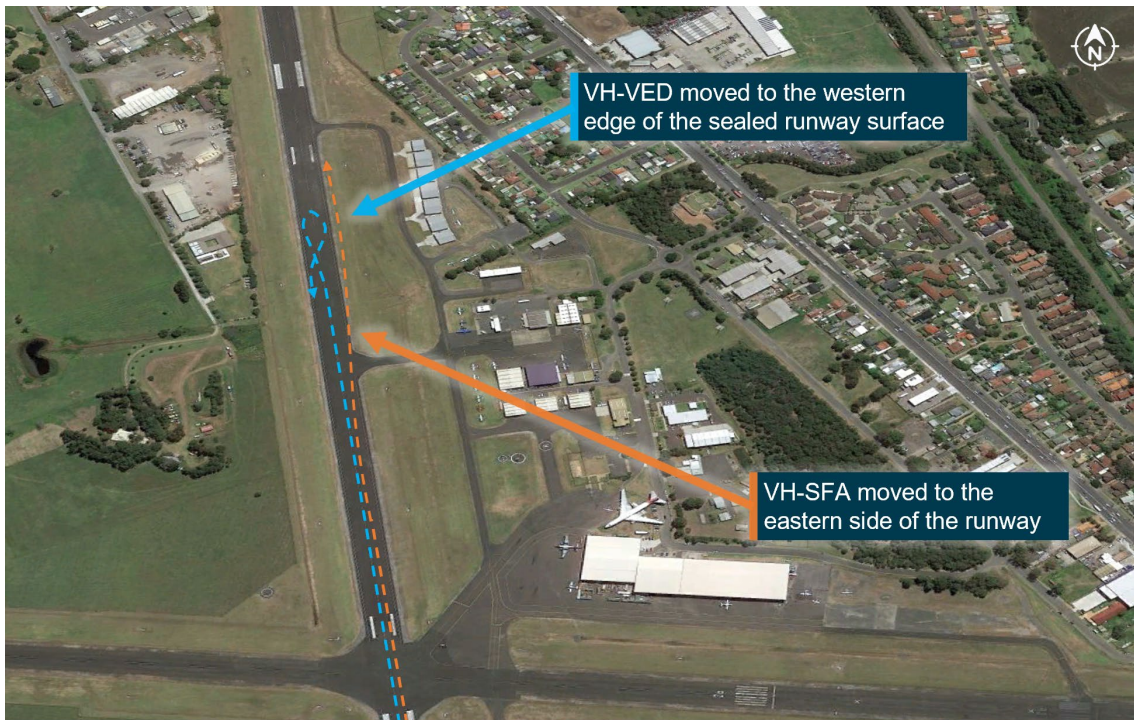
Figure 2: Aircraft avoiding action

The pilot flying (PF) in the Saab advised that they ensured the landing lights were left on to aid in detection while on the runway. They also stated that, as right circuits were required when using runway 34, they made the reversal turn to the right on the runway to enable them to view the traffic in the circuit. As they realigned with the runway centreline to commence the backtrack, the PF noticed the PA-28 appeared to be rolling on the runway towards them. The PM attempted to contact the pilot of the PA-28, however, other aircraft in the circuit made broadcasts about this time, possibly over transmitting the call by the PM, and the transmission from the Saab was not heard by the pilot of the PA-28. In order to minimise the risk of collision with the approaching aircraft, the PF taxied the Saab to the western side of the sealed runway surface (Figure 2).

*The dashed lines show the approximate paths over the ground of each aircraft. The track of VED is based on recorded ADS-B data. The track of SFA is based on pilots' statements.
Source: Google Earth, annotated by the ATSB*

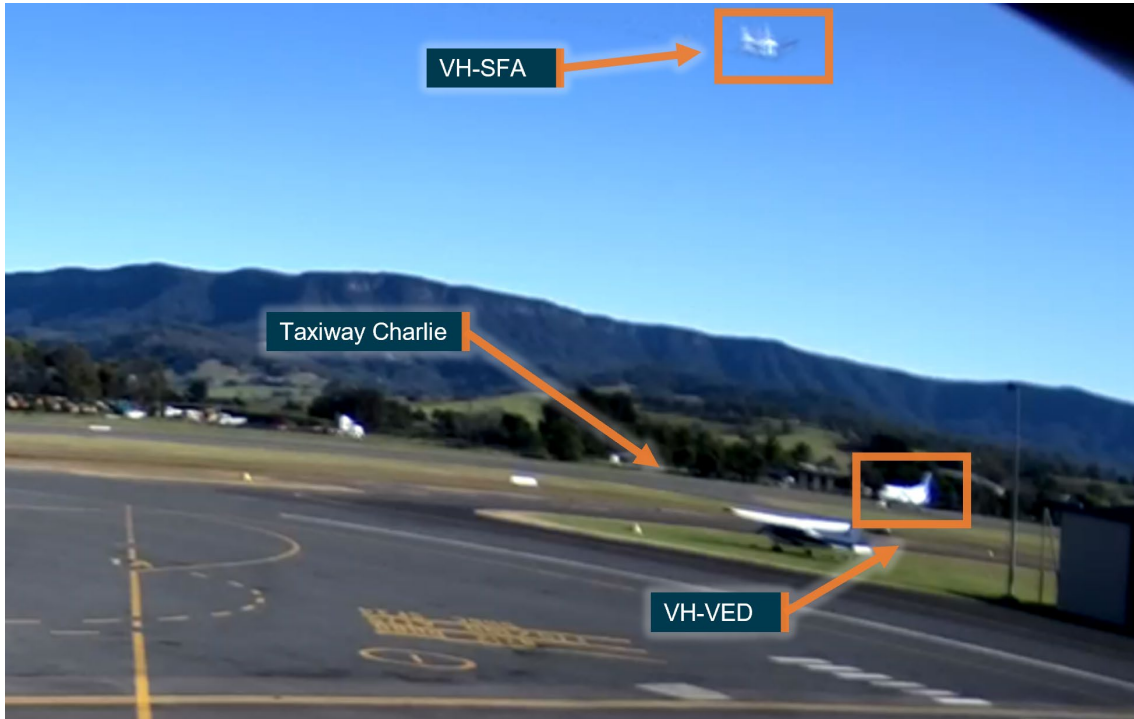
Figure 3: CCTV footage

During the period of hesitation, the aircraft continued to accelerate towards the rotation speed of 60 kt. The pilot then assessed that the distance between the 2 aircraft was sufficient to continue the take-off. Additionally, they perceived that any attempt to stop the aircraft on the runway remaining was not assured and may have resulted in a ground collision. Based on the avoiding action taken by the Saab crew, they continued the take-off and rotated prior to the runway intersection, before slowly veering to the eastern side of the runway (Figure 2) and passing approximately 150 ft over the left wing of the Saab (Figure 3).

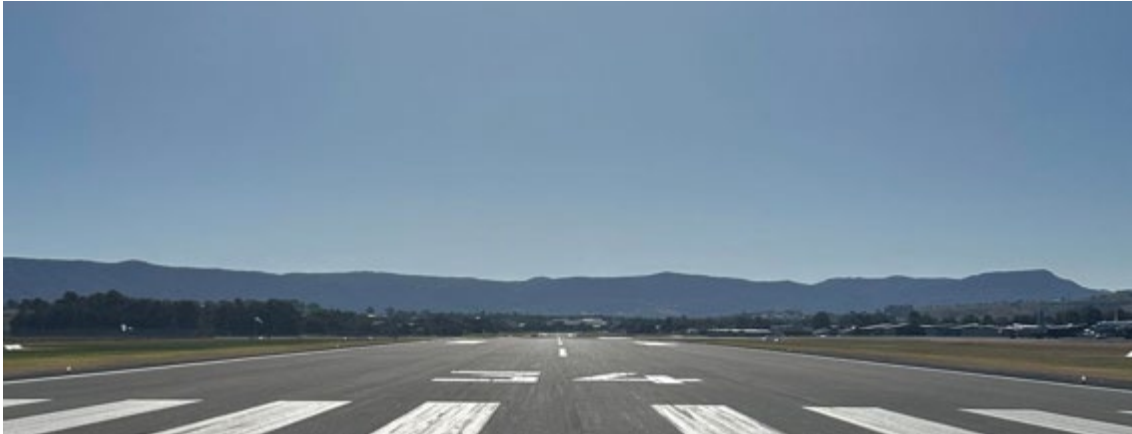
Figure 4: View from the runway 34 threshold

Shellharbour Airport (Figure 1) has two intersecting sealed runways 16/34 and 08/26. Runway 34 was in use at the time of the occurrence and had a 0.1% down slope to the north. The view of the entire runway from the threshold marker was clear of obstructions with good visibility (Figure 4).

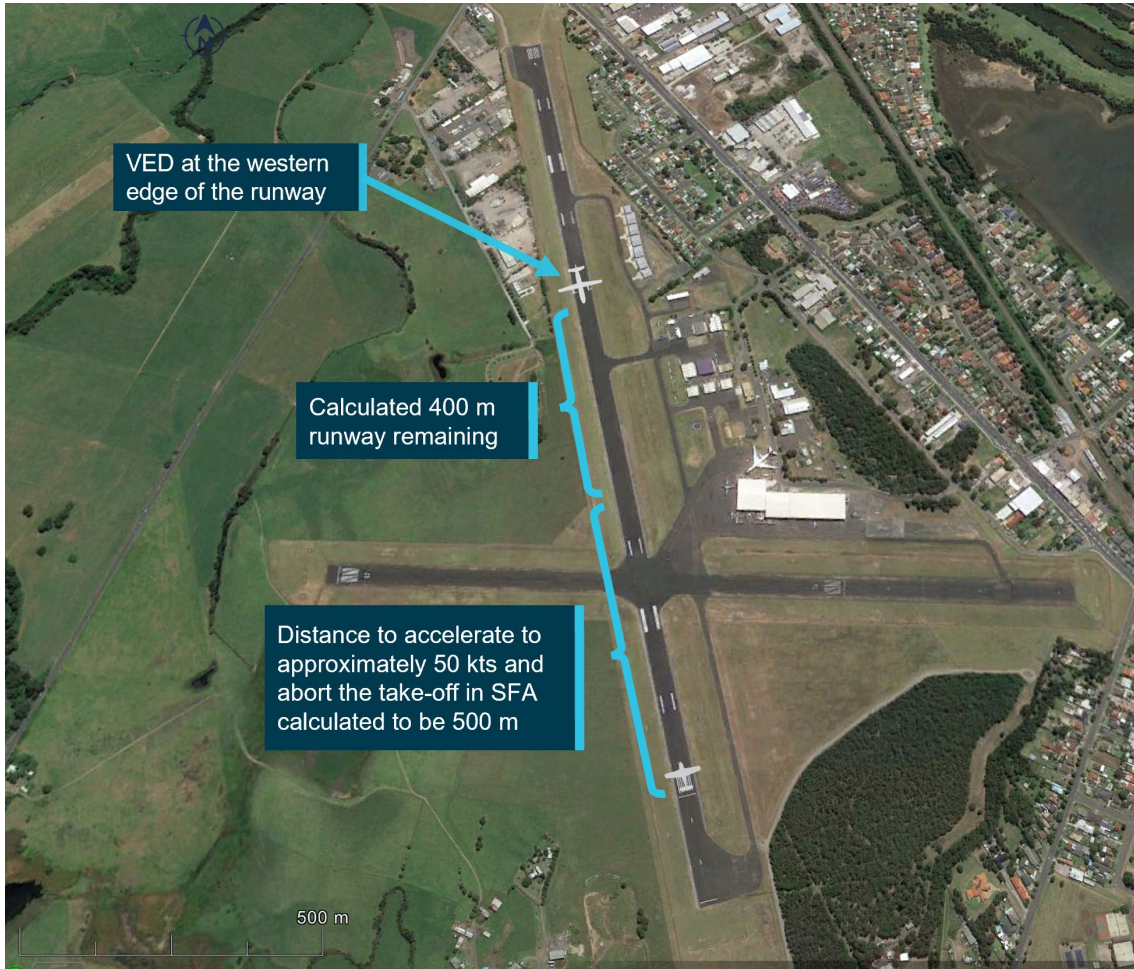
Figure 5: Calculated braking performance in the event of a rejected take-off by VH-SFA

The estimated braking performance for a Piper PA-28 Archer II was used to determine the approximate distance to reject a take-off in the prevailing conditions. Calculations were based upon actual weather observations recorded by the Bureau of Meteorology at Shellharbour, pilot interviews, and the take-off and landing performance charts in the PA-28 Archer II pilot operating handbook (POH). To this calculation, the applicable landing safety factor recommended in CASA guidance material⁴ was applied. The calculations are presented in Figure 5 and show the distance to accelerate to 50 kt and reject the take-off.

The point where the aircraft reached 50 kt and the PA-28 pilot first sighted the Saab was based on the interview with the pilot of the PA-28. Calculations were based on the aircraft commencing take-off from the threshold of runway 34 and not from runway entry at holding point Hotel. The pilot's reported hesitation was not accounted for in this calculation.

Once the pilot of the PA-28 detected the Saab on the runway, their response further added to the potential for a collision. Based on the descriptions provided by the crew of where each aircraft was located on the runway at the time the conflict was detected by the pilot of the PA-28, braking performance calculations showed that there was most likely enough room to stop in the distance available.
