Collision with water involving Bell Helicopter Co 204B, VH-EQW

Tarome, Queensland, on 20 September 2023

ATSB Transport Safety Report

AO-2023-044

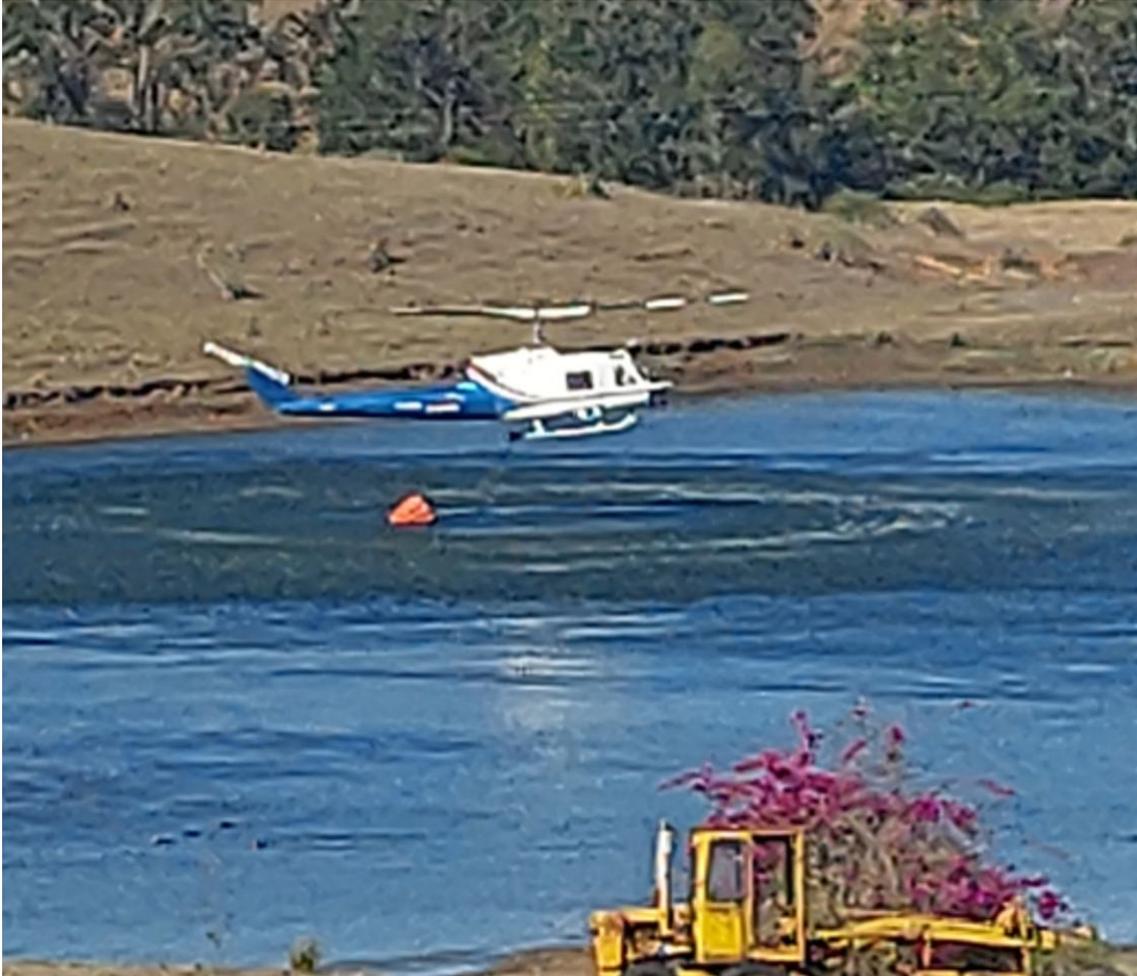
The accident was observed by 2 witnesses (Figure 1). 'Witness 1' observed the helicopter circle, move towards the dam on their property to collect water, and the entirety of the accident sequence. They photographed and videoed the helicopter's movements up until a few seconds before the accident (Figure 2). That witness did not see or hear anything unusual before the helicopter impacted the water. 'Witness 2' was on an adjacent property; they noted a definitive increase in what they thought may have been engine noise just before the accident occurred.

Figure 2: VH-EQW picking up water from the dam just prior the accident
