Collision with terrain involving Cirrus SR22, VH-MSF

near Gundaroo, New South Wales, on 6 October 2023

ATSB Transport Safety Report
Aviation Occurrence Investigation
AO-2023-045
Preliminary - 15 Dec 2023

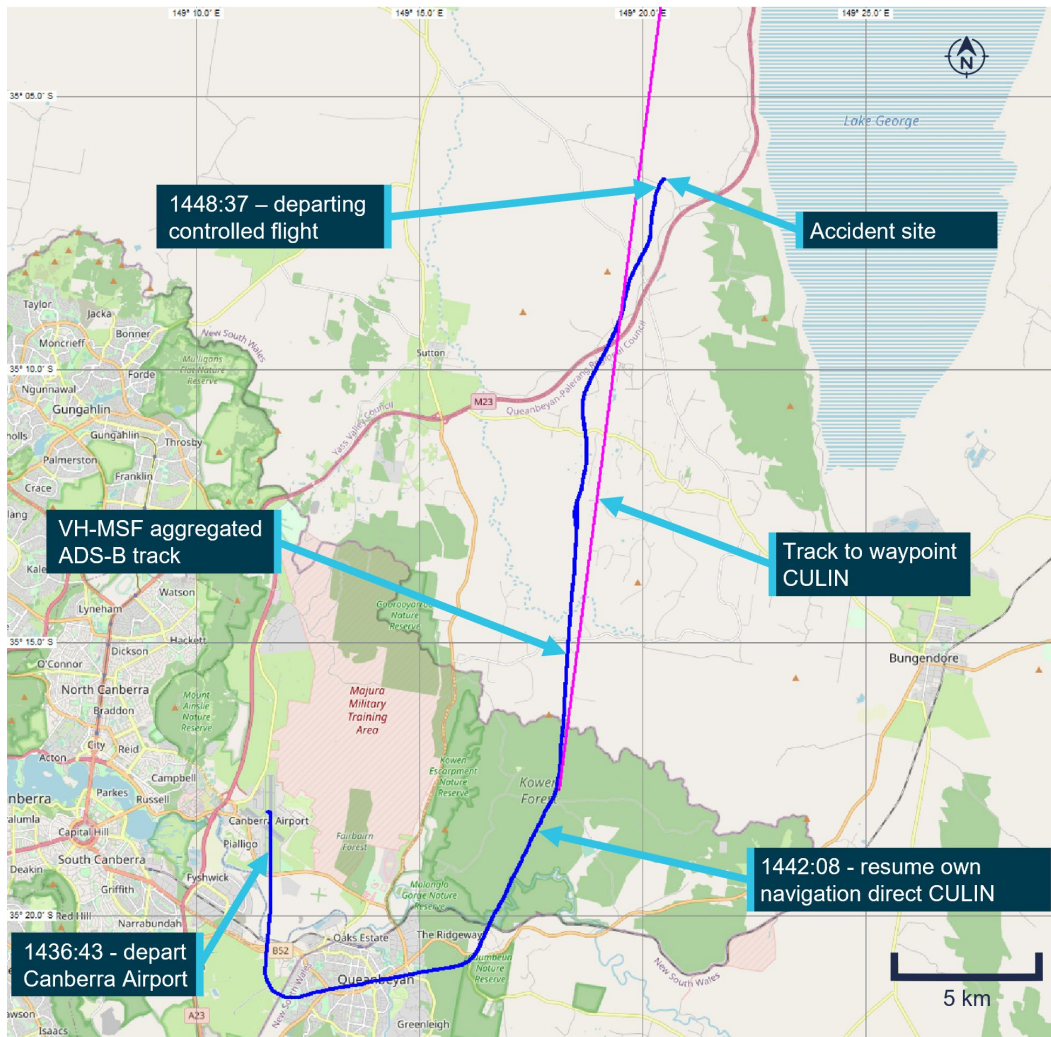
Figure 1: Ground track of VH-MSF from take-off to the accident site

A short time later, the controller instructed the pilot to turn left onto a heading of 010° and the pilot completed readback of the instruction. About 1 minute 30 seconds later, the controller cleared the pilot to resume their own navigation and track direct to waypoint² 'CULIN'. The pilot completed readback of that instruction, which was the last transmission received from the aircraft. Figure 1 illustrates the ground track of the aircraft departing Canberra while assigned radar vectors and the direct track to CULIN.

Twelve minutes after take-off, the aircraft was about 25.5 km north-north-east of Canberra, at an altitude of about 10,000 ft, when it abruptly departed from controlled flight and descended steeply towards the ground. Two eyewitnesses in the local area described seeing the aircraft at a low altitude, descending rapidly with its nose pitched down and rotating like a corkscrew. One of the witnesses stated that they heard the engine running rough and then stop just before the accident. The other eyewitness was seated on a tractor with the engine running and did not hear the aircraft engine.

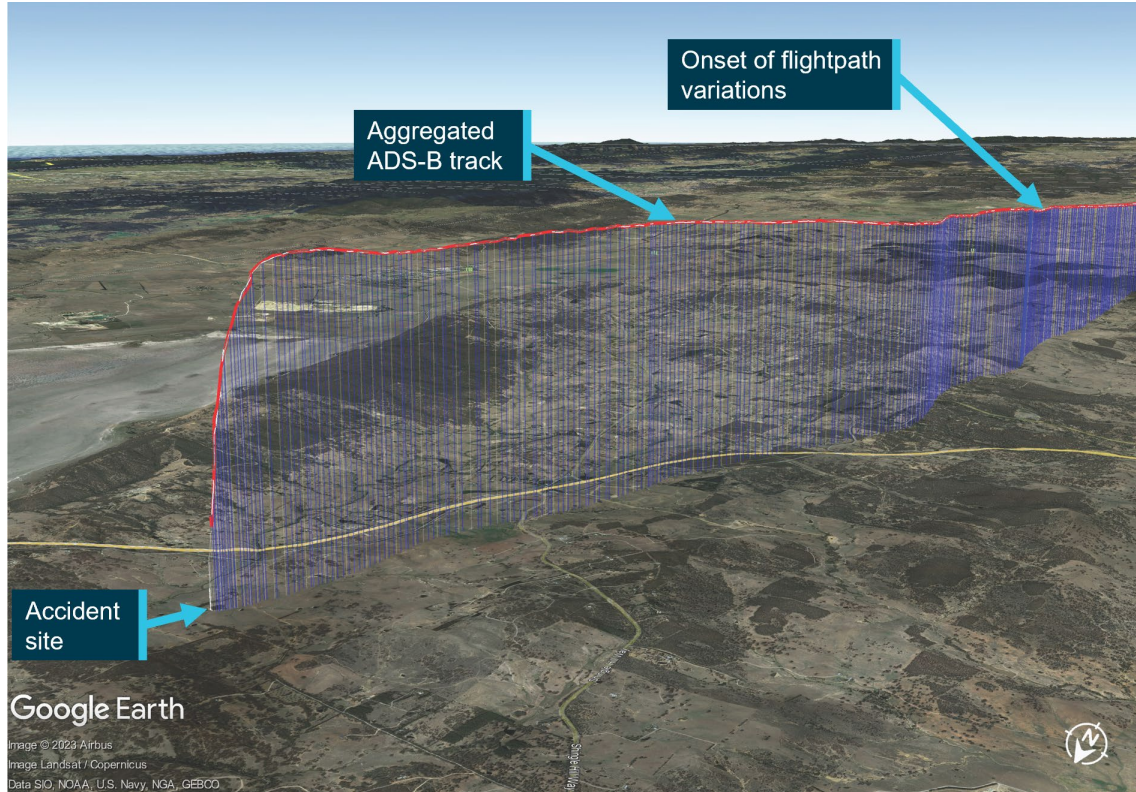
Figure 2: Aggregated ADS-B data for VH-MSF, looking back along the flightpath

Over the next 4 minutes, the aircraft's track varied up to 35° and the groundspeed fluctuated between 90 kt and 120 kt (167–222 km/h). During this period, the altitude was generally increasing although at a varying rate, with shorter periods where the altitude and reported rate of altitude change indicated that the aircraft had started to descend. Several people at locations along the aircraft's flight path during this time reported hearing noises that they described as a rough running or surging light aircraft engine.

Figure 2 depicts the aircraft’s altitude and ground track during the last part of the flight after the pilot was cleared to resume their own navigation and includes the position where the flightpath variations commenced.

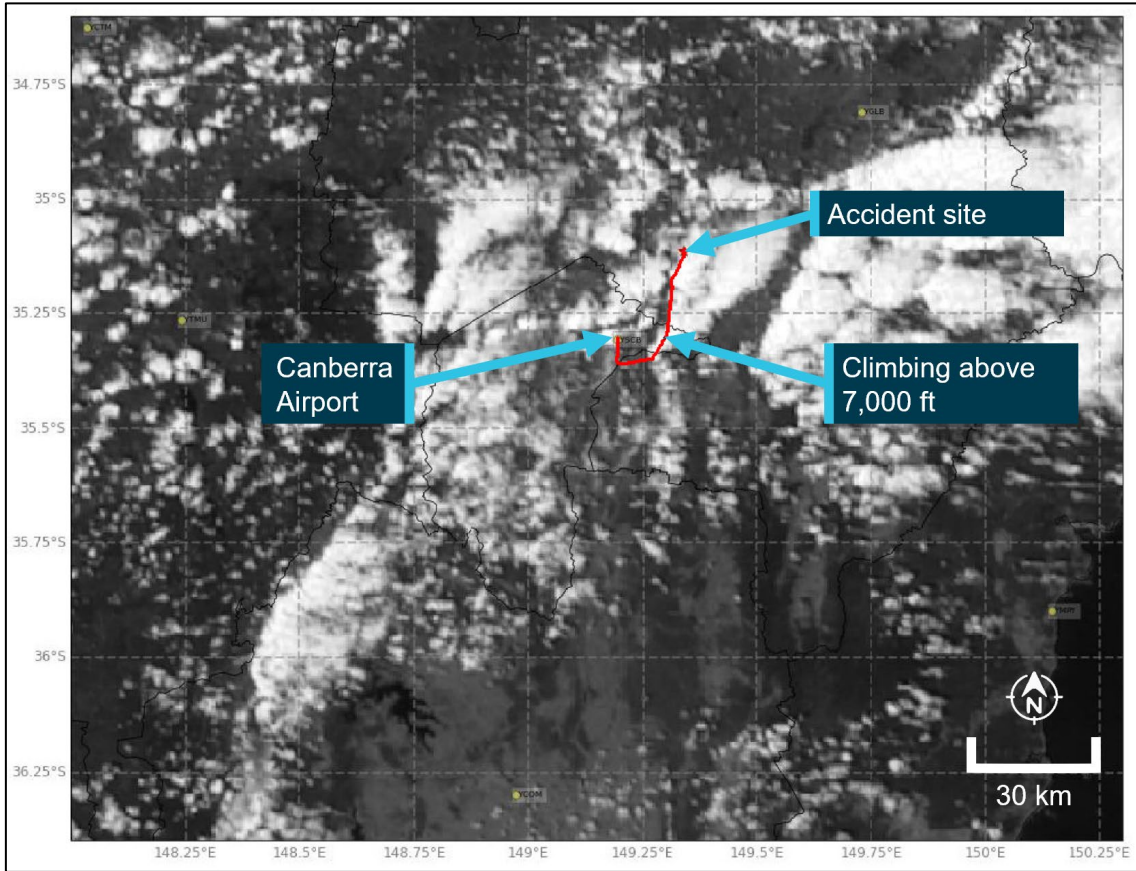
Figure 3: Aircraft flight track overlaid on satellite image

- visibility greater than 10 km, scattered cumulus/stratocumulus cloud⁴ from 5,000 ft to 8,000 ft with broken tops to 10,000 ft in D1
- visibility reduced to 3,000 m in isolated showers of rain, with broken stratus cloud from 1,500 ft to 4,000 ft and broken cumulus/stratocumulus cloud from 4,000 ft to above 10,000 ft
- freezing level⁵ of 5,000 ft in the south and 8,000 ft in the north
- cumulus and stratocumulus cloud implies moderate turbulence
- cloud above the freezing level implies moderate icing.⁶

Figure 3 illustrates the ADS-B ground track of the aircraft, overlaid on a satellite image of cloud in the local area at 1450, about 1 minute after the accident.

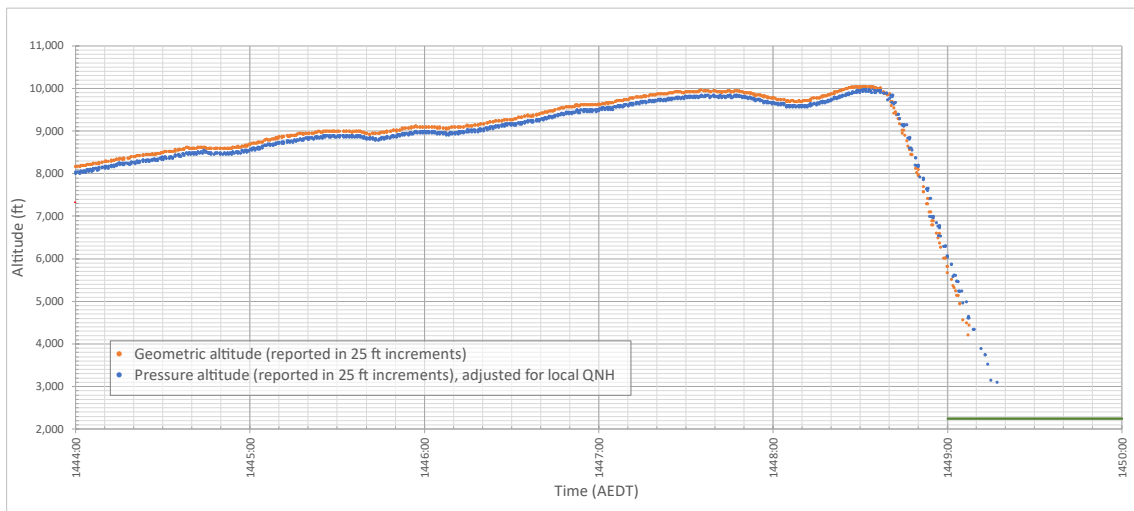
Figure 4: Aggregated ADS-B altitude data

Figure 4 depicts ADS-B altitude data broadcast from the aircraft during the final 5 minutes of the flight. This includes the several relatively minor altitude excursions/descents, together with the larger altitude excursion/descent that occurred immediately before the departure from controlled flight.

Preliminary analysis of the aircraft's reported groundspeed, together with sources of meteorological data⁷ indicated that the aircraft's calibrated airspeed⁸ was about 70 kt (130 km/h) at the time it departed from controlled flight.

The altitude and reported rate of altitude change, indicated an accelerating rate of descent, that increased above 13,000 ft/min before reducing back towards 10,000 ft/min prior to the impact with terrain.

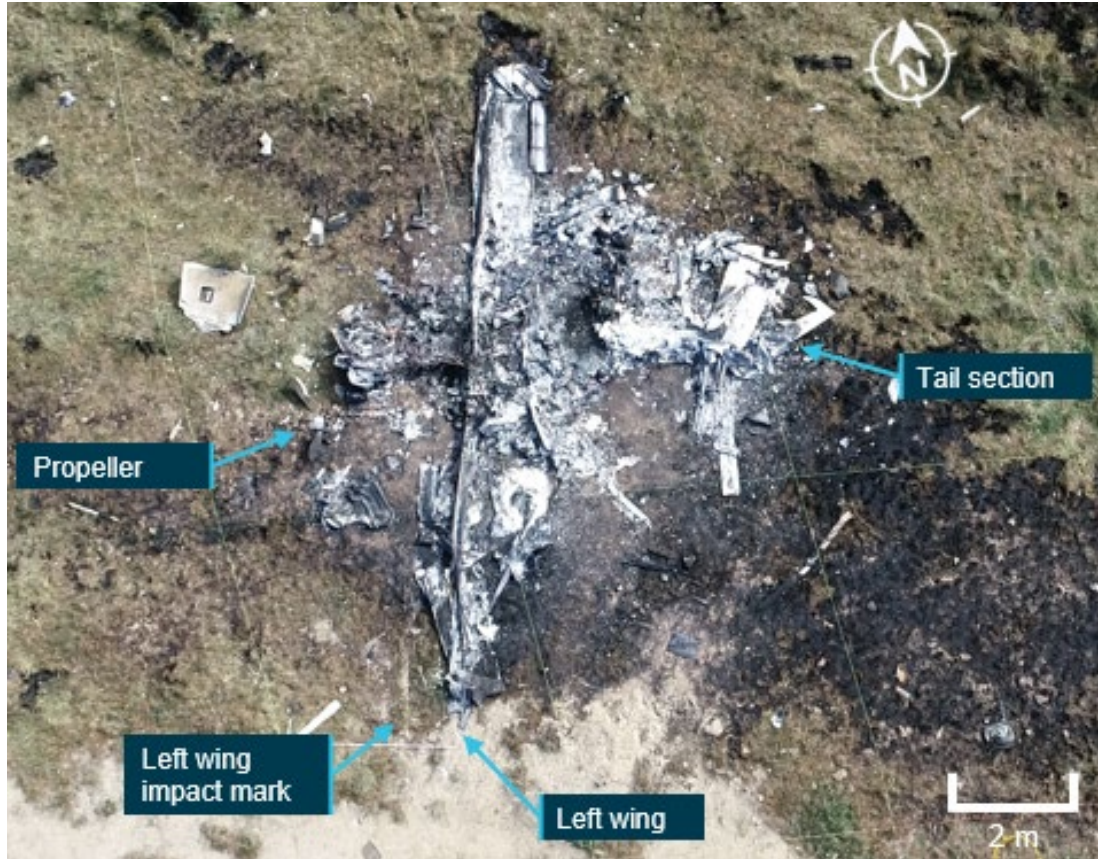
Figure 5: Overview of the accident site

The aircraft came to rest on a private property in an open field adjacent to a dam. Although post-impact fire damage precluded examination of a significant proportion of the aircraft, inspection of the site and wreckage showed that (Figure 5):

- The impact marks and wreckage distribution indicated that the aircraft impacted with terrain upright, with a slight nose low attitude and with little forward momentum, suggestive of a spin.¹¹

- All the aircraft’s extremities and flight controls were present in the immediate area of the accident site.
- There were no identified structural defects in the evidence available.

- The CAPS cover, deployment system and parachute were all located within the wreckage and had not been deployed before impact. However, based on the available evidence, the ATSB was unable to determine if an attempt had been made by the pilot to deploy the parachute system before the impact.

- The damage to the propeller blades indicated that the engine had low or no power at impact. It should be noted though, that spin recovery, icing, un-porting of fuel tank outlets in a spin, preparation for use of the parachute, and an engine mechanical issue could all be reasons for a power reduction.
