Collision with terrain involving a SOCATA-Groupe Aerospatiale TB-20, VH-JTY

65 km west of Mackay Airport, Queensland, on 28 October 2023

ATSB Transport Safety Report
Aviation Occurrence Investigation
AO-2023-052
Preliminary – 14 December 2023

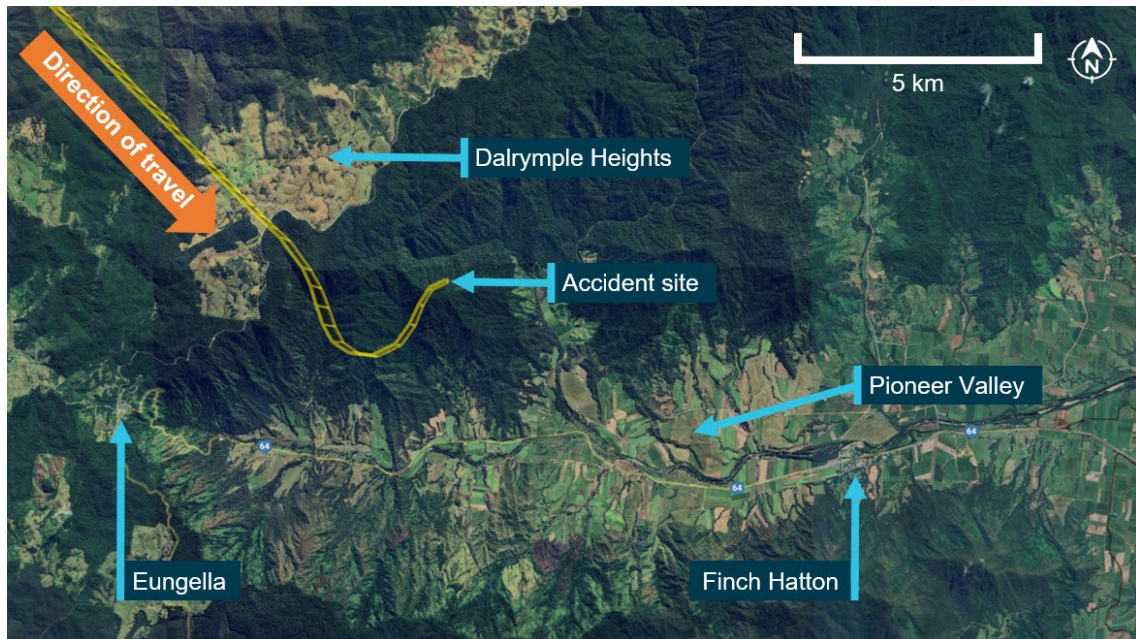
Figure 1: VH-JTY flight track

At about 0834, the OzRunways³ flight track (Figure 1) showed that the pilot made a right turn, followed by a left turn before colliding on the northern side of Bull Mountain, at about 1,900 ft above mean sea level. The aircraft was destroyed, and the pilot and passenger were fatally injured.

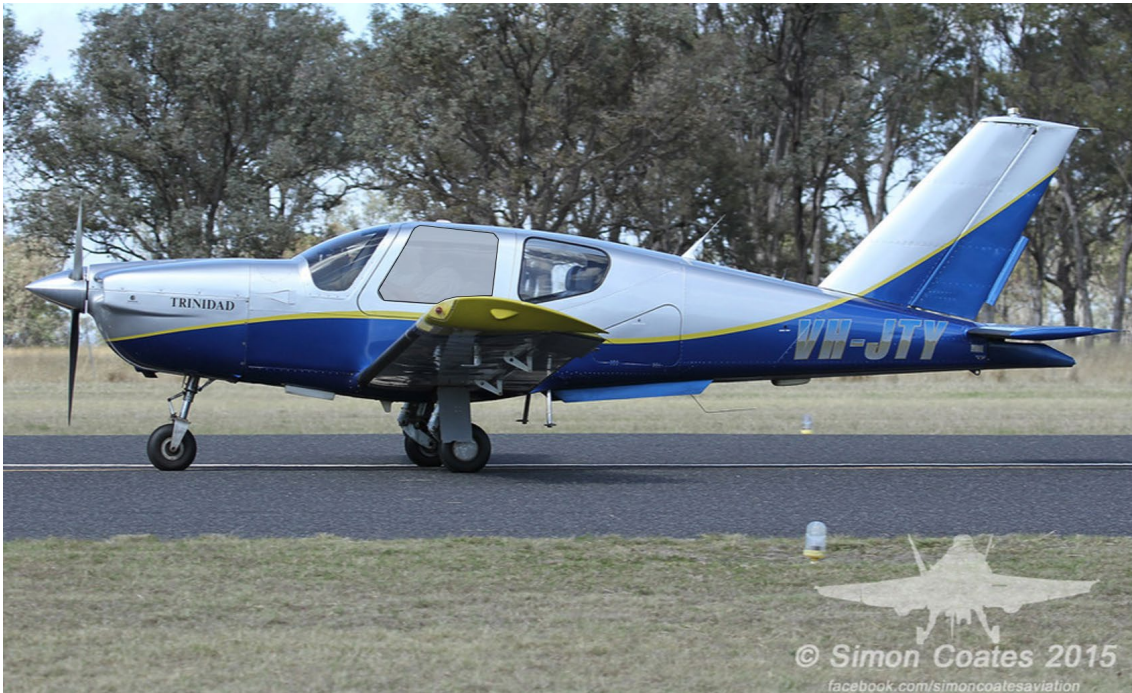
Figure 2: VH-JTY

The TB-20 is an all-metal, 5-place, single engine aircraft with fully retractable landing gear. It was powered by a 6-cylinder Lycoming IO-540 fuel-injected engine, driving a 3-blade constant-speed propeller. VH-JTY was manufactured in France in 1985 and was first registered in Australia in April 1987. The pilot had owned VH-JTY since April 2008 (Figure 2).

The last periodic inspection was conducted on 14 December 2022. In January 2023, VH-JTY sustained rudder and vertical fin damage in a ground handling incident. Structural repairs were carried out and the aircraft returned to service on 25 May 2023. At the time of the accident, it had accrued a total time in service of about 5233.4 hours and had flown about 35 hours since the repairs were carried out.
