A U S T R A L I A N T R A N S P O R T S A F E T Y B U R E A U

TECHNICAL ANALYSIS REPORT

OCCURRENCE 199804715

**ENGINE CYLINDER HEAD
CRACKING – VH-XAJ**

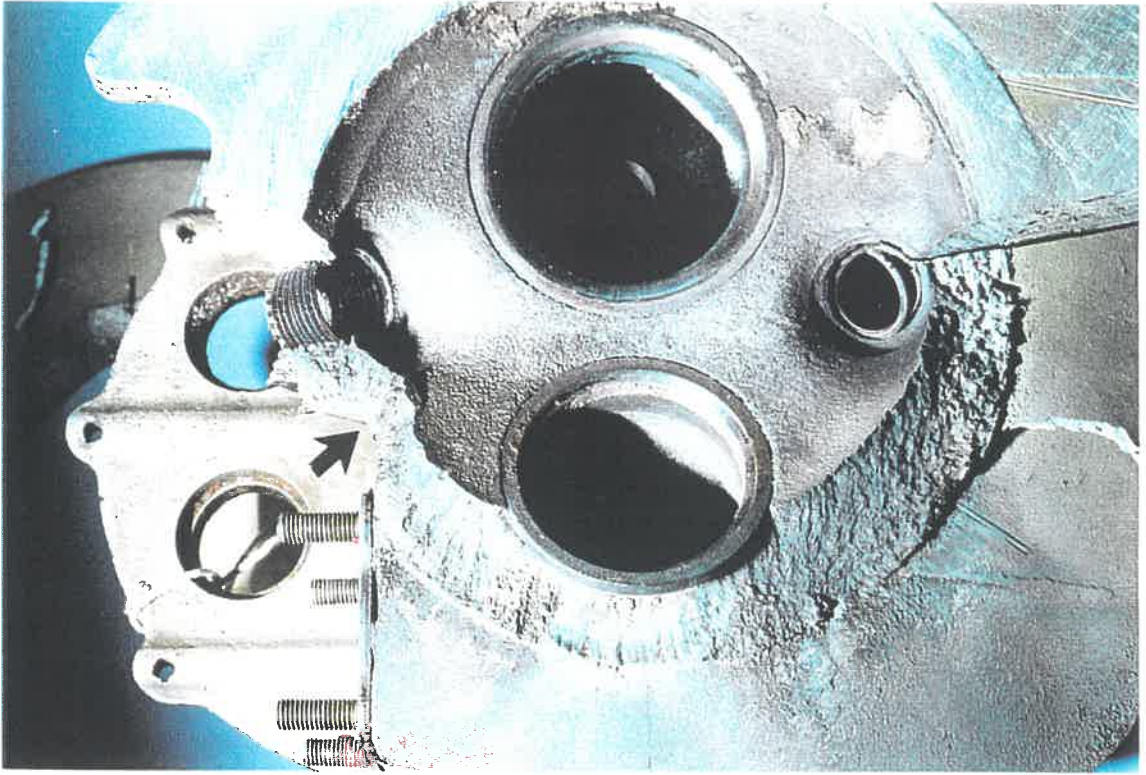
The cylinder head was sectioned to allow the crack surfaces to be examined. It is evident that the cracking had occurred as a result of fatigue. Fatigue cracking initiated at the outer surface of the cylinder head, near the lower spark plug hole. Fatigue cracking extended inwards through the cylinder head wall and around the circumference on the exhaust valve side prior to final rapid crack extension (rapid crack extension occurs when the fatigue crack tip stress intensity exceeds the fracture toughness of the head material). The extent of fatigue crack growth prior to final rapid crack extension could not be determined due to the erosion of fine fracture surface detail by escaping exhaust gas.

THE CRACK SURFACE EXPOSED AFTER SECTIONING THE CYLINDER HEAD
(THE SITE OF FATIGUE CRACK INITIATION IS ARROWED)

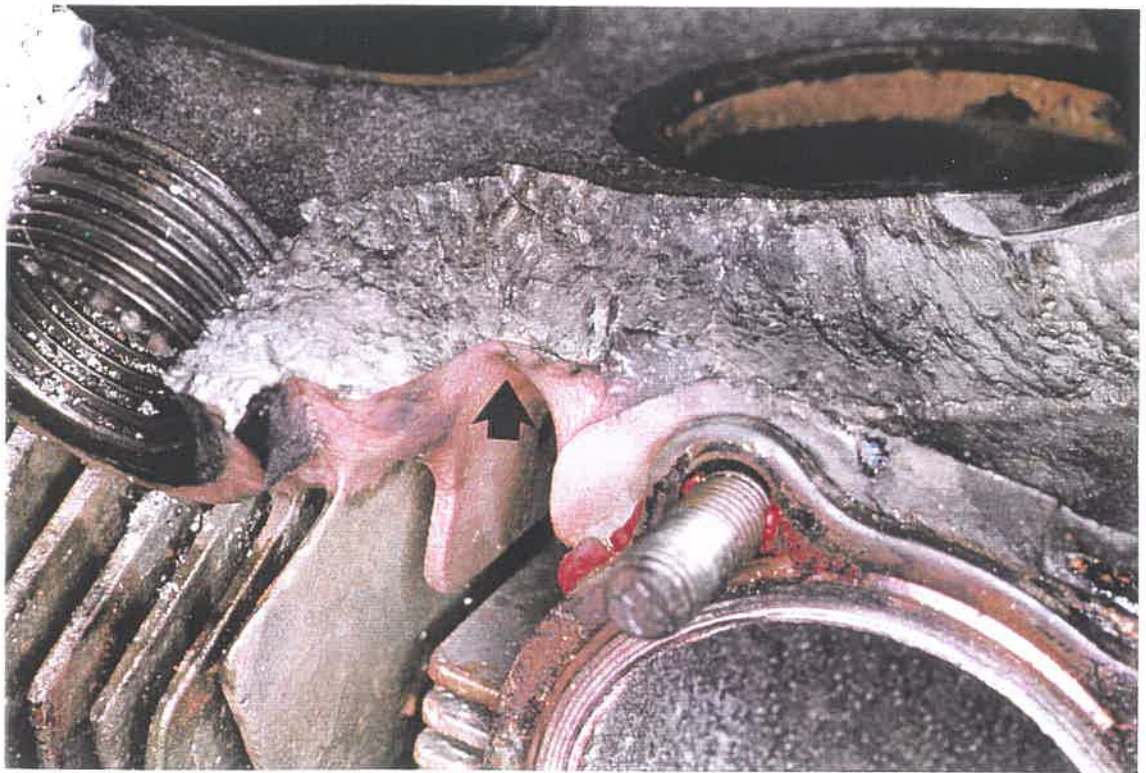
Examination of the outer surface of the #1 cylinder head (VH-XAJ) revealed that the paint applied to the cylinder head had changed colour in the vicinity of the fatigue crack initiation site. This type of paint discolouration indicates that this region of the head had been heated to a higher than normal temperature¹.

The crack in the #1 cylinder of the engine fitted to VH-XAJ was caused by fatigue. Fatigue cracking initiated as a result of overheating of the cylinder head.

DETAILED VIEW OF THE FATIGUE CRACK INITIATION SITE

The factors leading to the overheating of the #1 cylinder head should be investigated.

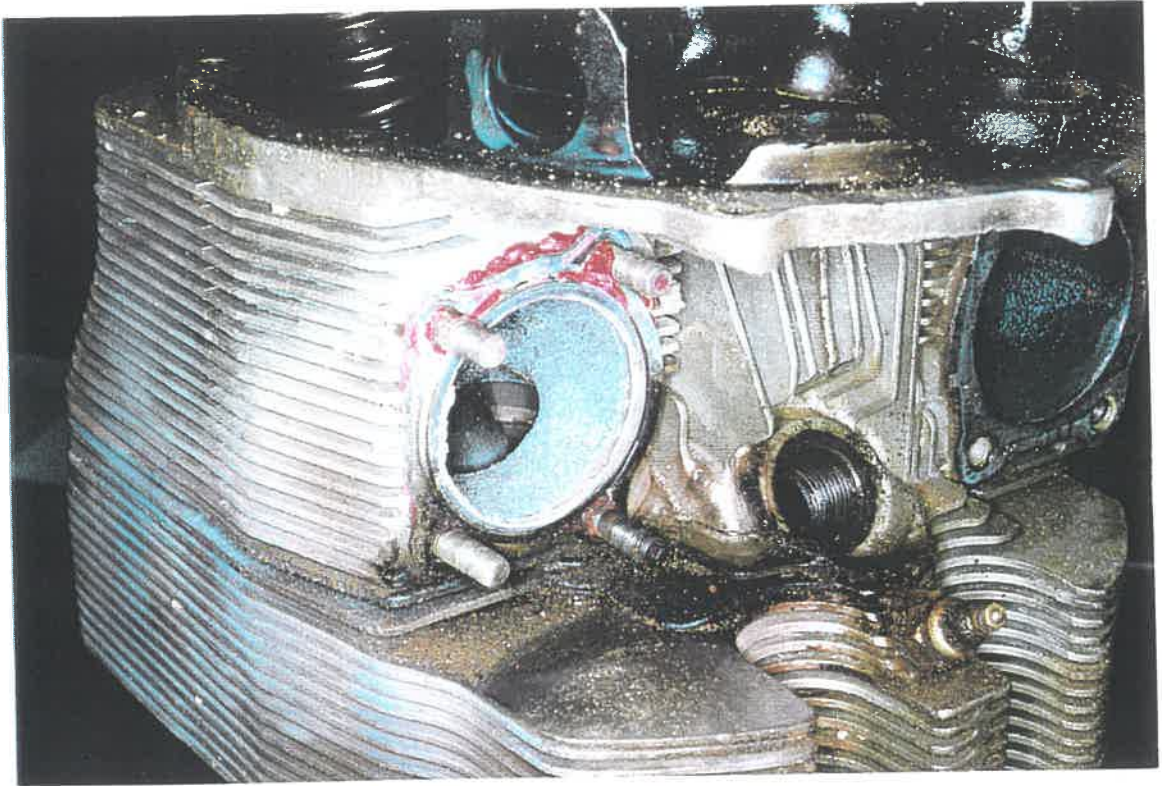
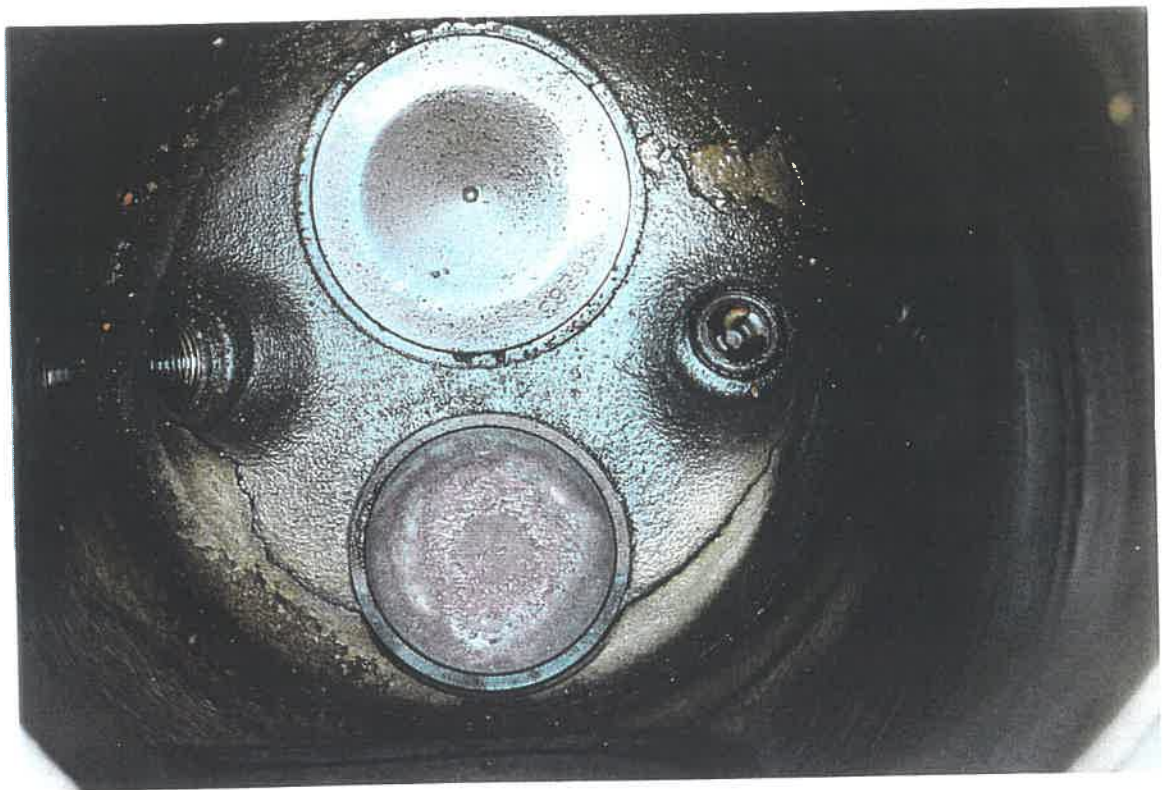
The crack present in the cylinder head extended from the lower spark plug hole over a distance of approximately half the circumference of the cylinder head — on the exhaust valve side, see figures 1 and 2.

THE EXTENT OF CRACKING IN THE CYLINDER HEAD
