# Safeworking irregularity involving passenger trains 1898 and 18A0 near Thorneside, Queensland, on 7 March 2020

**ATSB Transport Safety Report**

Rail Occurrence Investigation (Defined)

RO-2020-003

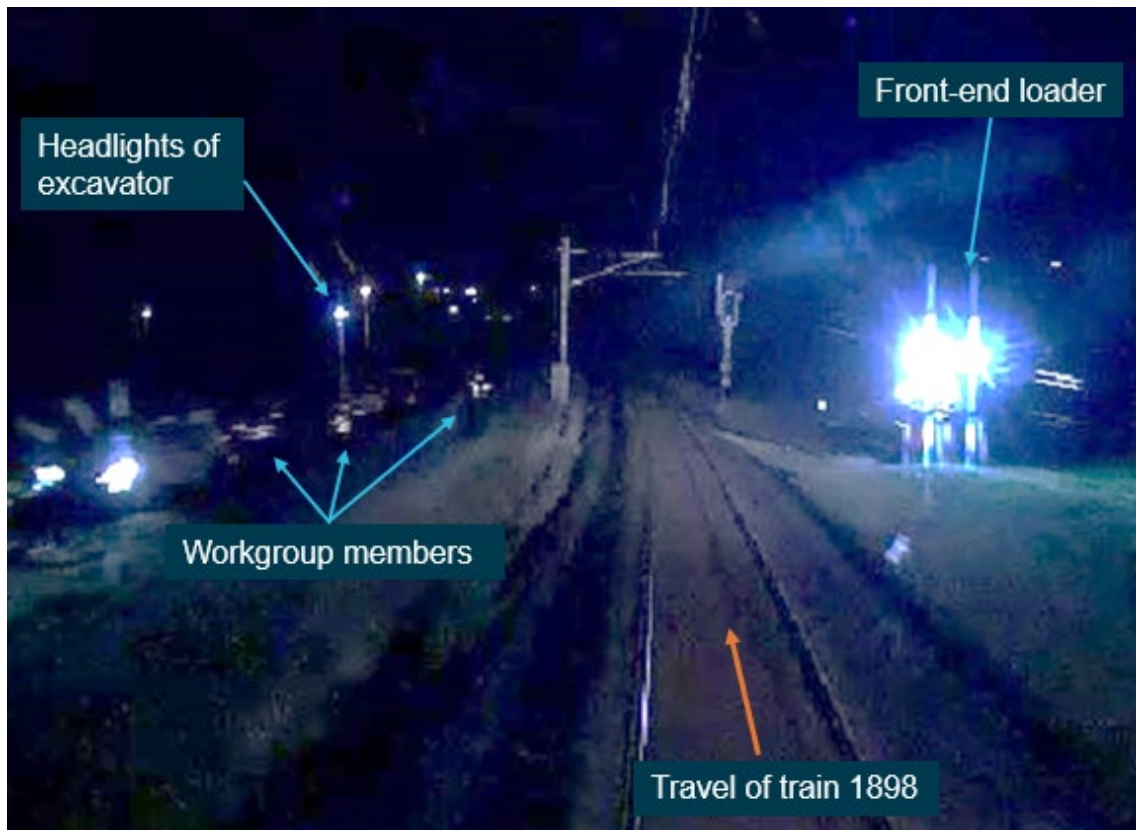
**Figure 2: View from train 1898 showing the work group, front-end loader, and headlights of the excavator in the distance**

As train 1898 passed the work group entrance gate, it accelerated to above 90 km/h along the 100 km/h section of track (Figure 2). The recipient, who only minutes earlier directed the excavator operator to on-track the excavator, had just arrived back at the work group entrance gate as the train passed. On seeing the train, the recipient sounded the car horn in an attempt to warn the excavator operator of the approaching train, and they then proceeded in the car back towards the excavator.

The image is from the front-of-train camera in train 1898. The time is 0108:22, about 19 seconds prior to the near collision. In the distance, the headlights of the excavator can be seen as it travelled towards the worksite.  
Source: Queensland Rail, annotated by the ATSB

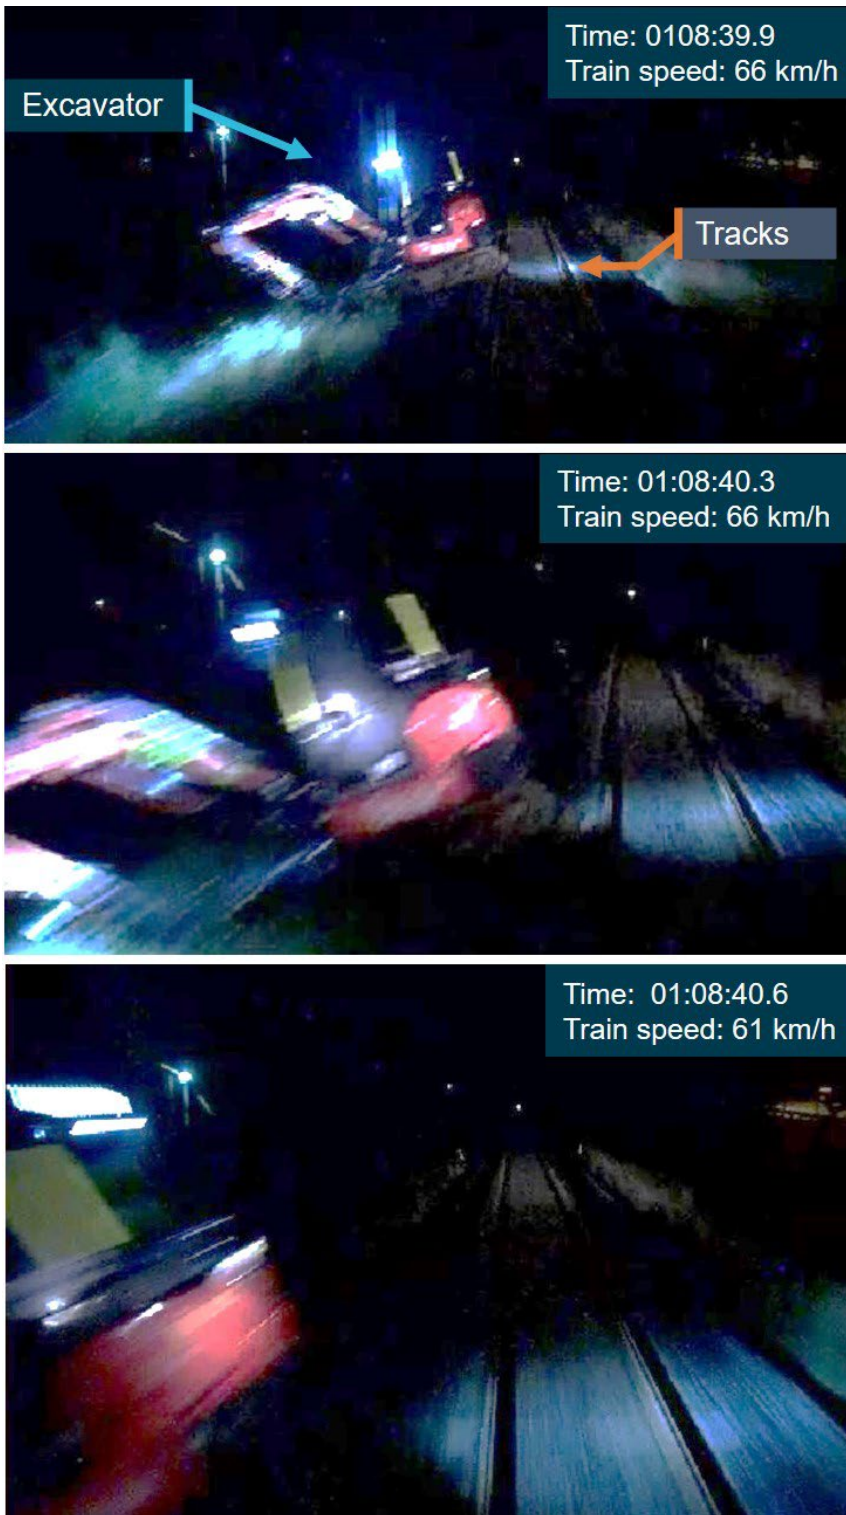
Figure 3: View from train 1898 showing the near collision

The images, from 1898's front-of-train camera, are in sequential order and show the near collision between 1898 and the excavator. The rear of the excavator moved clear of the running line less than 1 second before the train's arrival, with the train travelling at about 61 km/h.
