Collision between tram 6058 and tram 6062

East Melbourne, Victoria, on 20 September 2023

ATSB Transport Safety Report

RO-2023-008

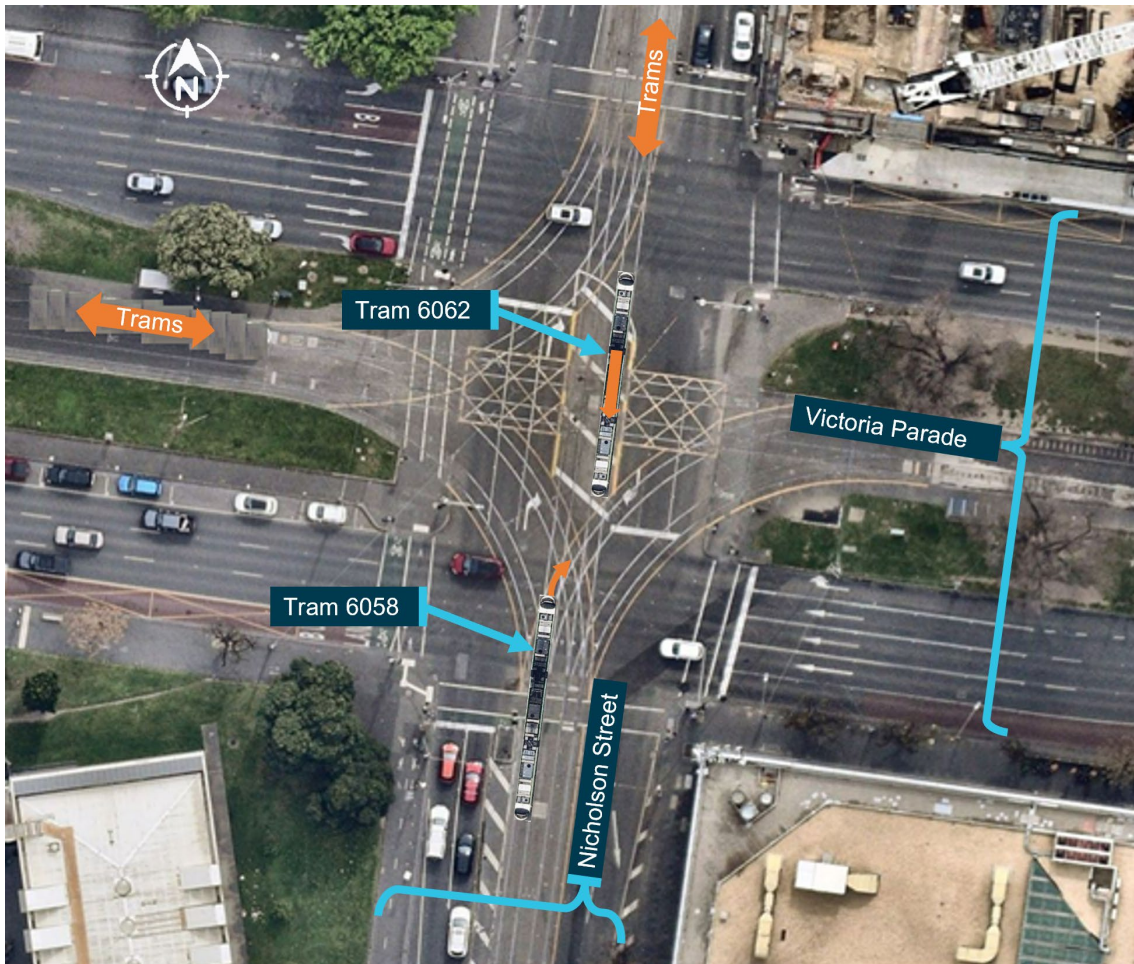
Figure 2: Images of trams superimposed on a view of the intersection of Nicholson Street and Victoria Parade to show the paths of trams 6058 and 6062 leading to collision

As the two trams on parallel tracks converged, tram 6058 turned to the right and into the path of tram 6062, colliding with tram 6062 at about 0952 (Figure 2). The driver of tram 6058 had expected to travel straight across the intersection.

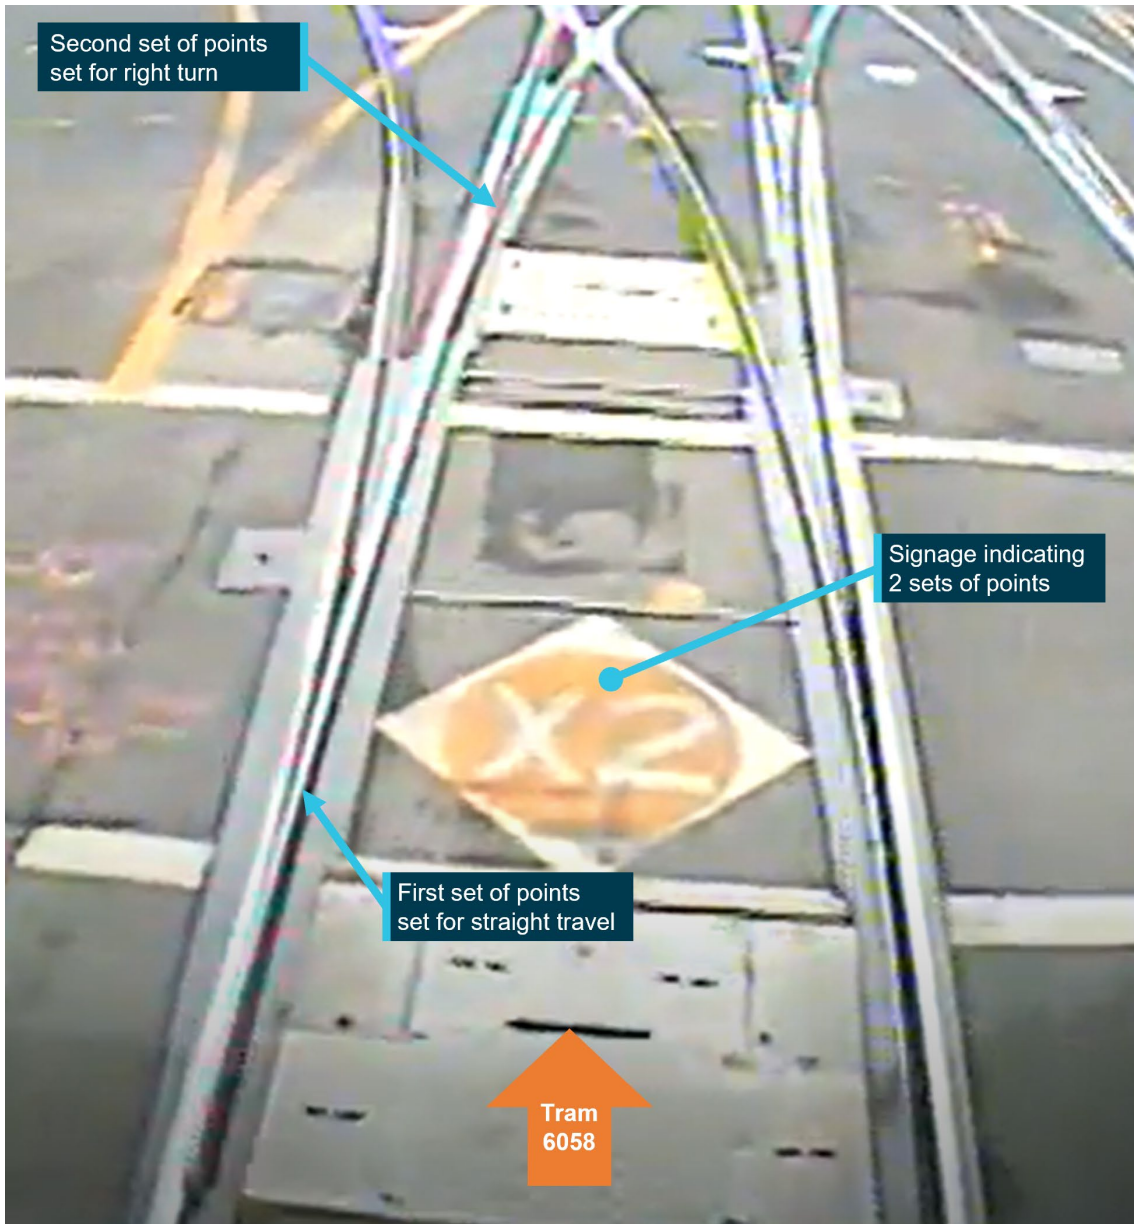
Figure 3: Image from CCTV footage showing the settings of the 2 sets of points

Tram 6058 had travelled through 2 sets of points. The first set of points were set for the straight, and the second set of points were set for the right turn (Figure 3).

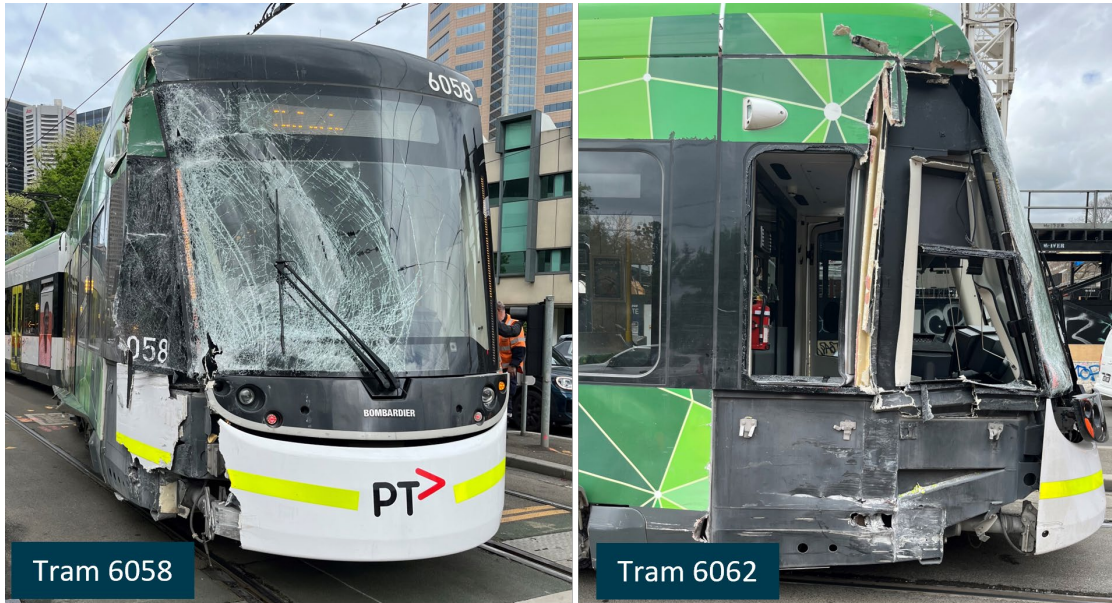
Figure 4: Damage to tram 6058 and tram 6062

Each tram was travelling at about 20 km/h at the time of the collision. The driver of tram 6062 and 5 passengers sustained minor injuries. Both trams derailed and sustained considerable damage to their front and right-hand panels (Figure 4).

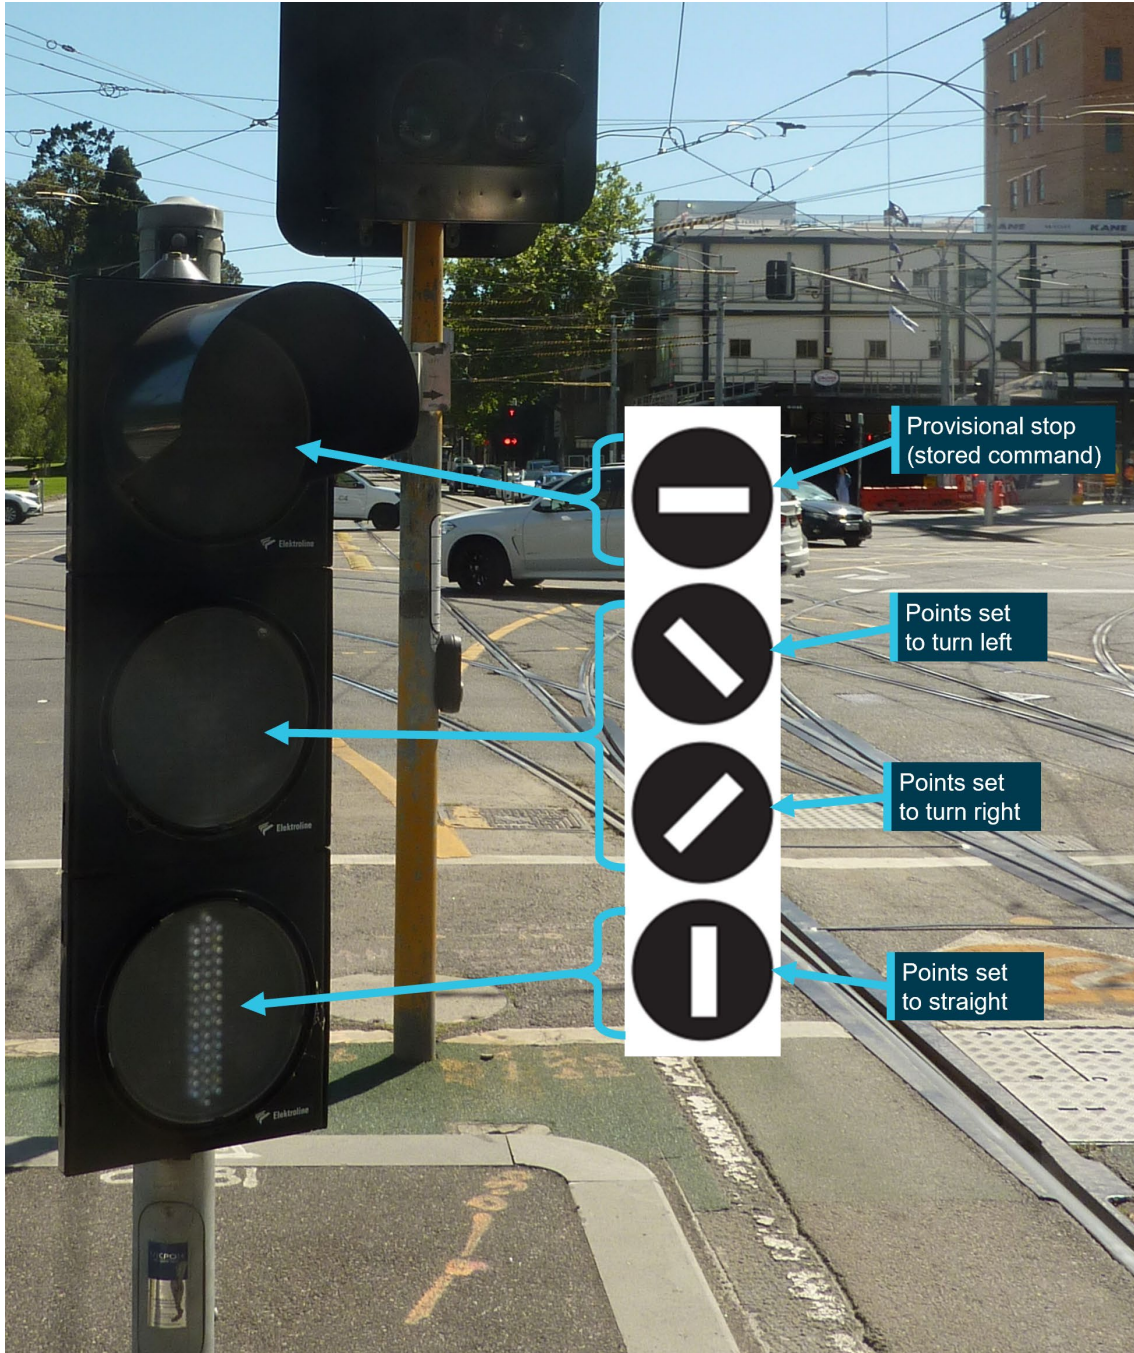
Figure 7: The primary points lantern and the possible lit aspects of each lens

The primary points lantern had 3 lenses with each lens designed to have an unlit (nil) or lit aspect (Figure 7).⁵ The central lens had 2 possible lit aspects and could indicate that the points were set to the left or to the right. The secondary points lantern was of the same configuration, however, on the day of the incident its central lens was non-operational.
