Winching event involving Sikorsky S-92A, VH-IPE

near Broome, Western Australia, 26 August 2017

ATSB Transport Safety Report
Aviation Occurrence Investigation
AO-2017-095
Final – 19 January 2017

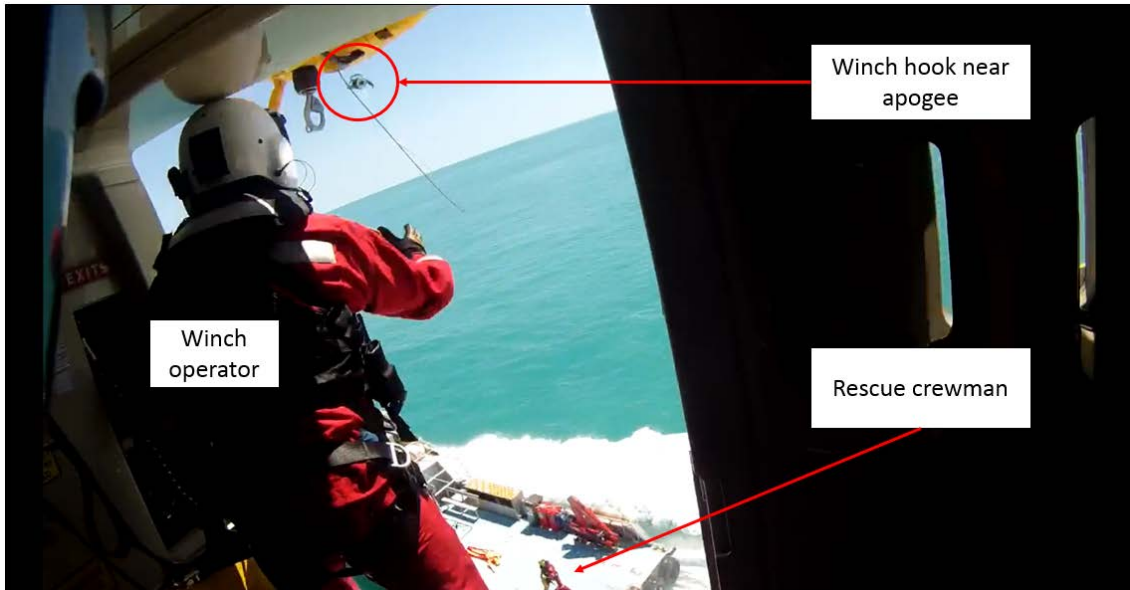
The weak-link immediately fractured and the release of the additional tension sent the winch hook on a near vertical trajectory towards the helicopter's main rotor disc. The winch cable snatched out

of the winch operator's hand and the hook reached its apogee⁹ at about the height of the winch¹⁰ before falling down (Figure 1).

Figure 1: Winch hook near apogee

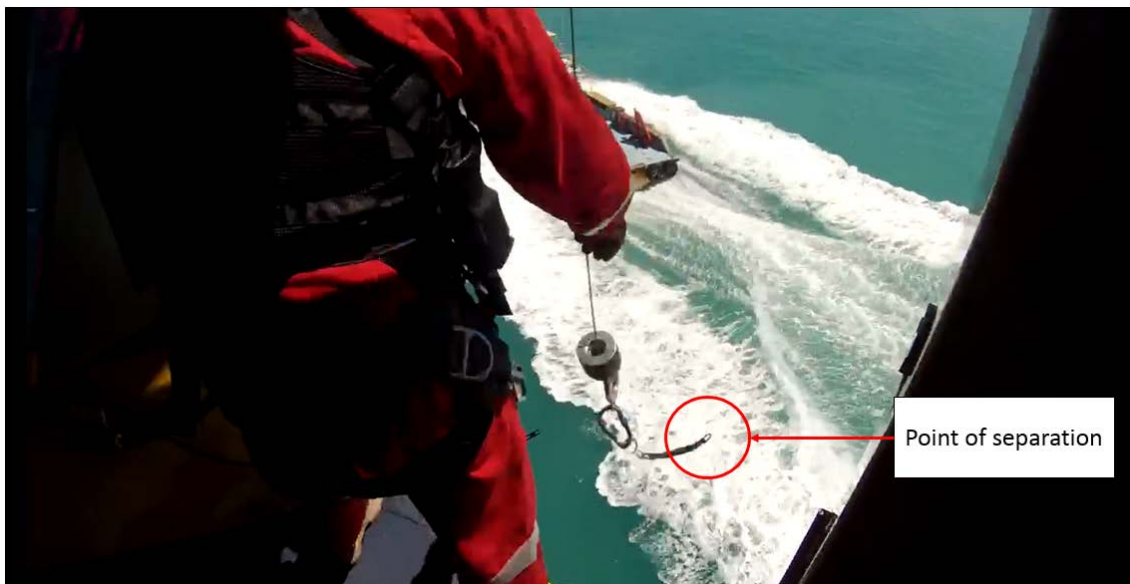
The pilot flying observed the hook appear at about the height of the winch before the winch operator had time to warn the rest of the crew.¹¹ After the winch operator regained control of the cable the helicopter returned to the rest position. The winch operator was then able to inspect the cable and debrief the crew about the incident. On retrieval of the hook, the winch operator noted the weak-link had separated at the line end (Figure 2).

Figure 2: Weak-link point of separation

When a restriction of the line inside the hi-line bag occurred, the weak-link was immediately placed under increased tension due to the relative motion of the helicopter and winch cable with respect to the vessel. The tension was sufficient to fracture the weak-link at the line end. The release of the downward tension when the weak-link fractured sent the winch hook on a trajectory towards the helicopter's main rotor disc. The ATSB could not determine if the weak-link fractured at the advertised breaking force, but a notable amount of tension was required to be released to send the winch hook on its trajectory.

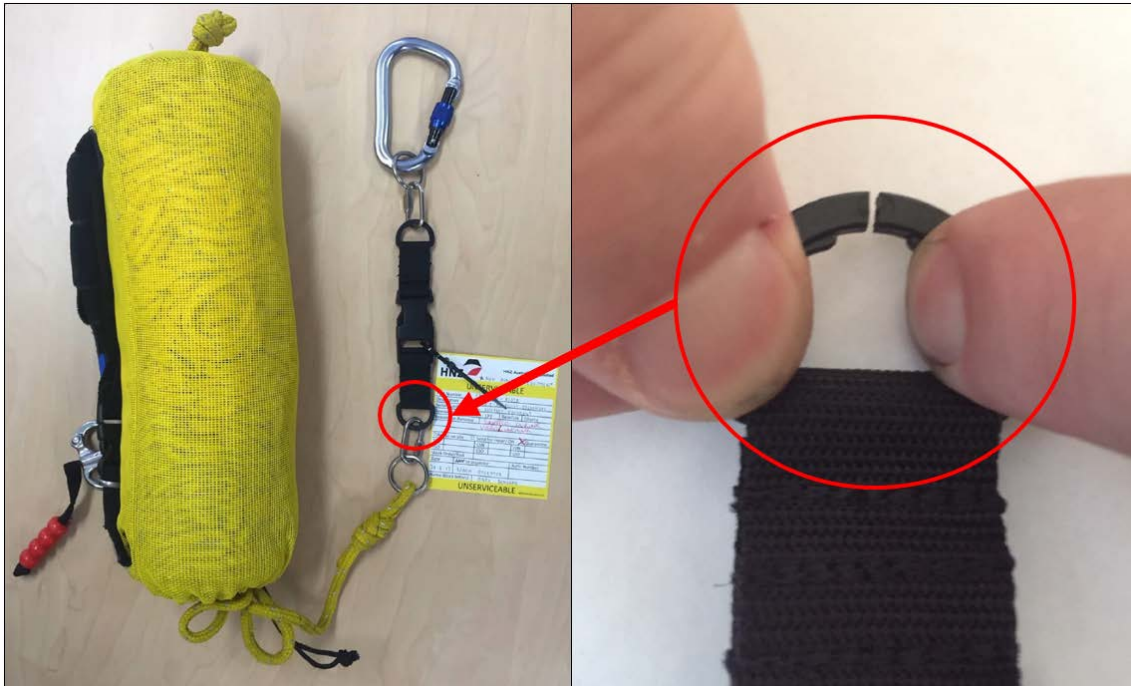
The hi-line equipment comprised of a hi-line bag, a 300 ft x 15/64 inch (91 m x 6 mm) line (rope) inserted in the bag and a break-away weak-link, which connected the line to the winch hook. The weak-link consisted of a plastic buckle and webbing with plastic D-rings at each end. One end was connected to the line, and the other end was connected to a carabiner, which was connected to the winch hook (Figure 3 left). The incident weak-link had an advertised breaking strength of about 90 pound force (400 N). Figure 3 right depicts the fracture of the weak-link that occurred at the line end.

Figure 3: Hi-line with weak-link and carabiner (left) and fractured weak-link (right)

The operator inserted a 300 ft line into a hi-line bag that was advertised as either a stand-alone item, or fitted with a 75 ft line. In addition, the hi-line bag was a sausage shaped bag with a narrow throat relative to the amount of line inserted. Therefore, when assembled, the hi-line equipment presented an increased risk for restrictions during a hi-line evolution and the equipment was no longer fit-for-purpose.

- During the winching evolution with the vessel, the hi-line became restricted inside the hi-line bag, which, combined with the motion of the winch hook relative to the vessel, resulted in sufficient tension on the weak-link to fracture it and send the winch hook on a trajectory towards the helicopter's main rotor disc.
- The operator's management of change for the introduction of the search and rescue contract capability did not capture risk assessments for their role equipment, which resulted in the use of a small hi-line bag with a narrow throat relative to the length of line required for the task.

They have removed the Priority 1 Air Rescue breakaway weak-link and hi-line bag from service, introduced new replacement equipment and initiated their management of change process for their search and rescue role equipment. The performance of the operator's replacement weak-link will be monitored following the recommencement of hi-line winch evolutions.
