VFR into IMC, loss of control and collision with terrain involving Airbus Helicopters EC130 T2, VH-XWD

near Mount Disappointment, Victoria, on 31 March 2022

ATSB Transport Safety Report

AO-2022-016

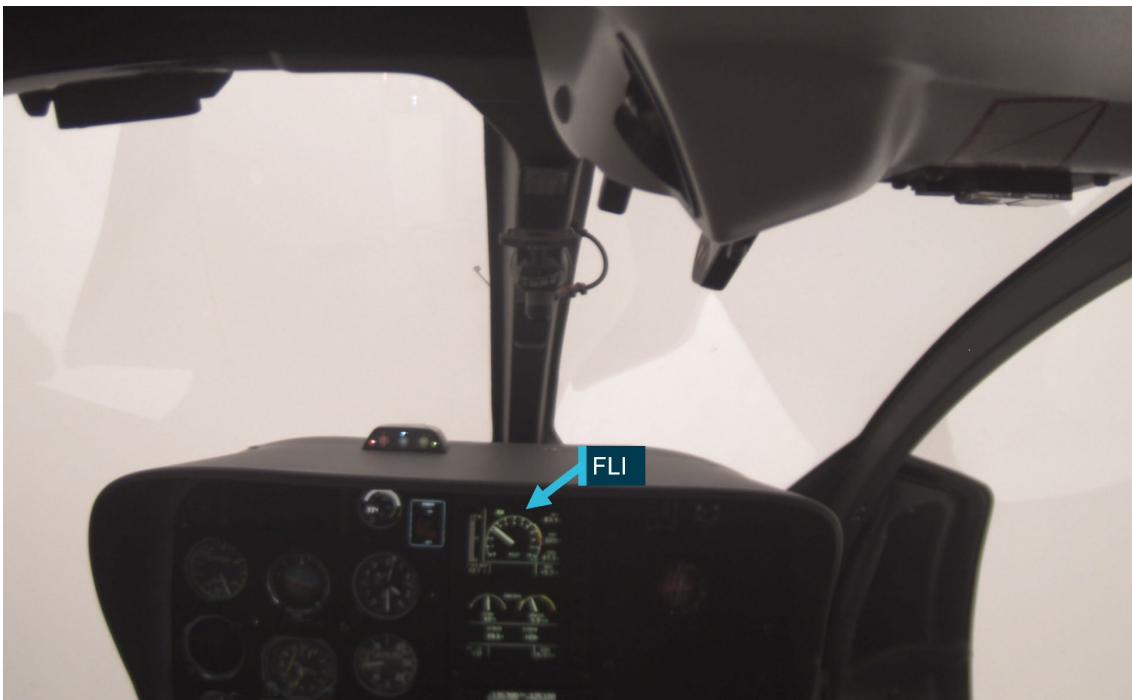
Figure 4: Footage of weather conditions from XWD at 0757:09

At 0756:54, while maintaining 3,600 ft with FLI 5, the Appareo camera recording showed that the cloud through the windscreen of XWD appeared to change from broken to overcast. Over the next 5 seconds, the FLI reduced to 2 and XWD started to descend at about 500 ft/min.⁹ The pilot also started actively scanning to the left and above.

At 0757:00, WVV had turned onto a southerly track (186°), climbed to 3,967 ft with a ground speed of 73 kt, and was close to passing abeam XWD, which was at 3,504 ft tracking north (359°), with a ground speed of 116 kt. The pilot and passengers onboard WVV sighted XWD when they passed above and abeam the left-side of XWD. This was the last visual contact with XWD. Figure 4 depicts the meteorological conditions from XWD shortly after the helicopters passed abeam each other at 0757:09.

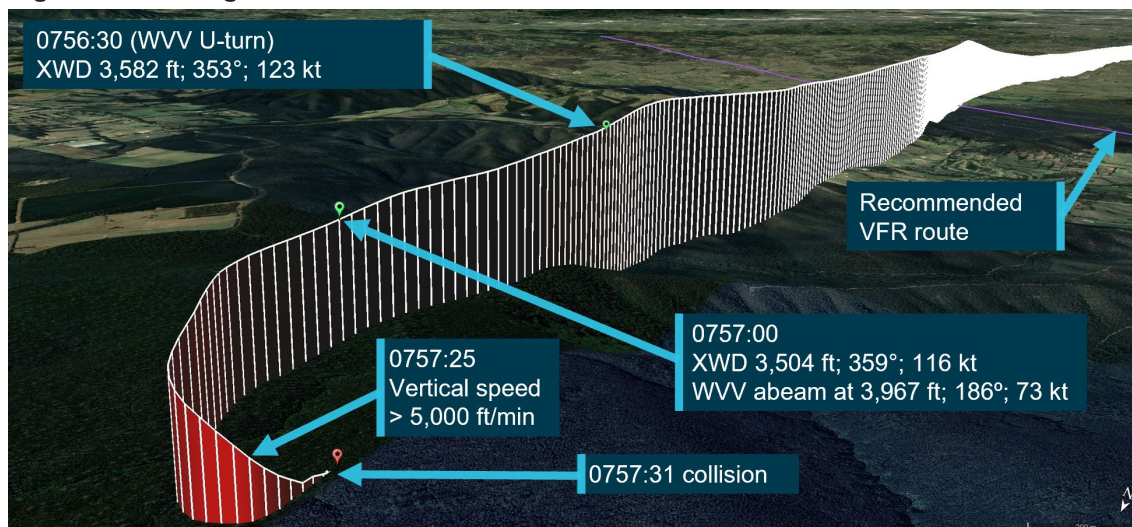
Figure 5: XWD flight track and accident site

At 0757:29, at an altitude of about 2,700 ft, with a low FLI setting and the vertical speed indicator still at full-scale deflection, trees became visible in the cloud. In the last second of footage, the helicopter pitched significantly nose up while the altimeter continued to decrease from 2,700 ft to 2,600 ft. The vertical speed indicator remained at full-scale deflection, the airspeed decayed by 20 KIAS, there was no significant change in the FLI indication, and the LIMIT¹⁰ caution light activated twice. The Appareo cabin area microphone also detected the rotor overspeed warning activate and the sound of the rotor blades striking the trees. The collision with tree occurred at 0757:31. The flight track for XWD is presented in Figure 5.

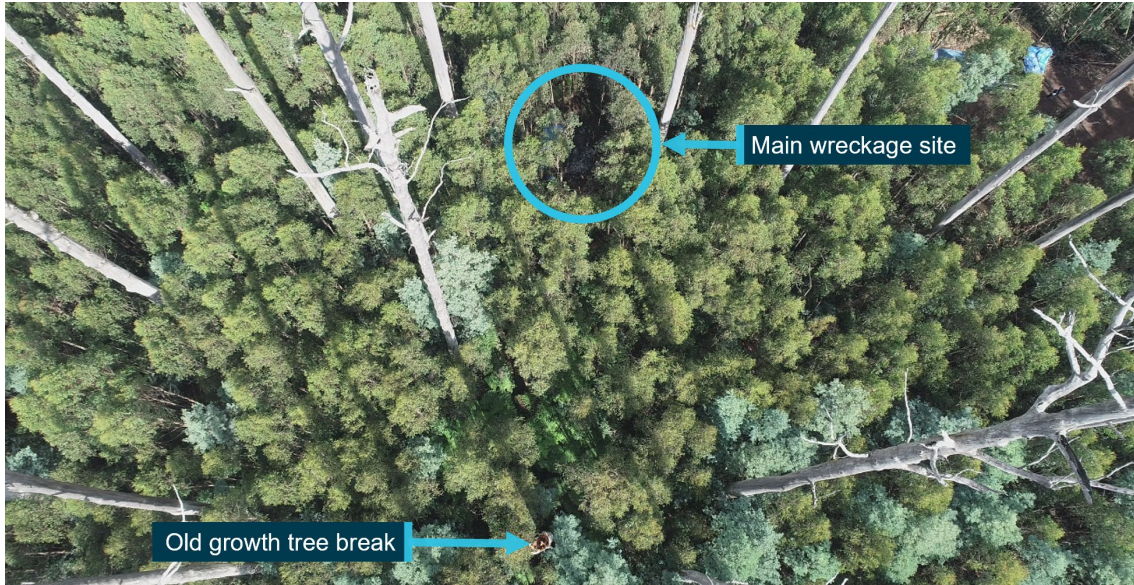
Figure 7: Overhead view of old growth tree break and main wreckage site

The vegetation surrounding the accident site comprised of 2 distinct levels of growth. A new growth canopy with a height of about 24 m, and old growth trees with a height of about 70 m, as measured by a remotely piloted aircraft system. The elevation of the base of the old growth tree was 718 m, which indicated that the elevation of the top of the tree was about 788 m. The tree break was 41 m above ground level at an elevation of 759 m. Therefore, the tree impact very likely occurred at an altitude of 2,490–2,585 ft (759–788 m).

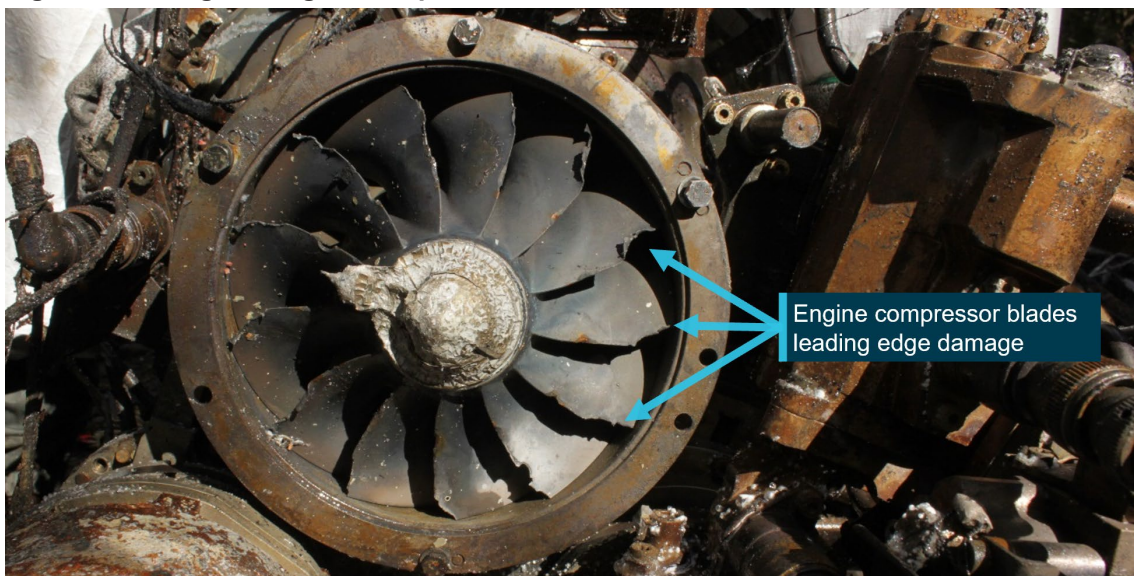
Figure 9: Damage to engine compressor blades

The engine had disconnected from both the main rotor and Fenestron driveshafts. The Fenestron driveshaft exhibited significant scoring damage, which indicated it was rotating at high speed during the accident sequence. Damage to the leading edges of the engine compressor blades was also characteristic of high-speed rotation (Figure 9) and the power turbine exhibited blade shedding. The rupture of the engine to main gearbox transmission drive shaft and flexible coupling,²³ with its screws sheared on the main gearbox side, was consistent with a sudden over-torque. Overall, the damage observed indicated that the engine was producing power at the time of impact.
