Collision with terrain involving Stoddard Hamilton Aircraft Glasair Super II FT, N600

Near Wedderburn aircraft landing area, New South Wales, on 26 December 2022

ATSB Transport Safety Report

AO-2022-068

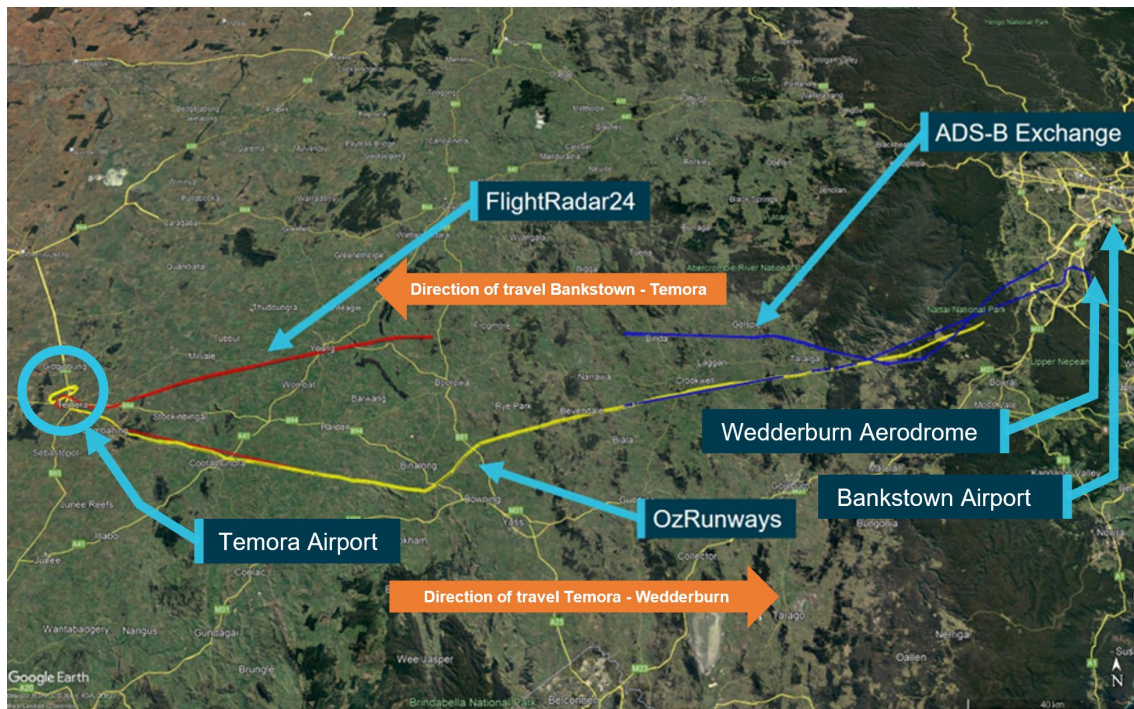
Figure 1: Flight tracking data from N600 on 26 December 2022

Flight tracking data (Figure 1) showed the aircraft being flown to Temora, landing at about 1133. The aircraft was then refuelled and conducted 2 circuits² before departing about an hour later for Wedderburn, which was expected to be its planned destination.

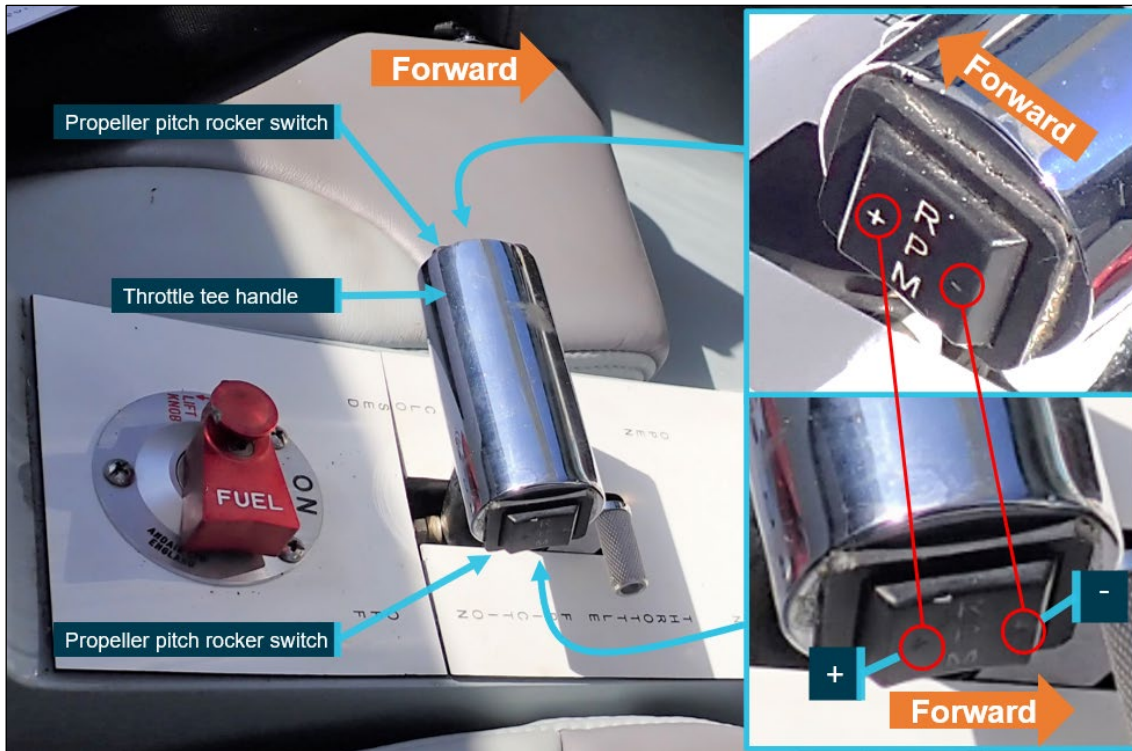
Figure 3: Engine throttle tee-handle lever showing propeller rocker switches mounted to each side

It was also found that N600 was fitted with propeller pitch change rocker switches on the left and right side of the throttle which were reversed in orientation for each flight crew member. This increased the risk that a pilot flying from the right seat could operate the propeller pitch change opposite to the intended selection.

Propeller pitch change control (Figure 3) was achieved with two rocker switches (one for each crew seat) mounted on either side of the throttle tee-handle lever, activating the electric pitch change motor. It took about 10 seconds to cycle between the course and fine pitch stops. The rocker switches were identical in their design and operation, in that when viewed directly on, the left side of the switch had the increase pitch selection (+), and the right side had the decrease pitch selection (-). This meant that if the switches were wired in accordance with the '+' and '-' labelling, the switches would be actuated in opposite directions relative to each pilot's seated position to achieve the desired propeller pitch change. The switch orientation and wiring was confirmed by the original aircraft builder as being wired correctly to the switch orientation when the aircraft was constructed.

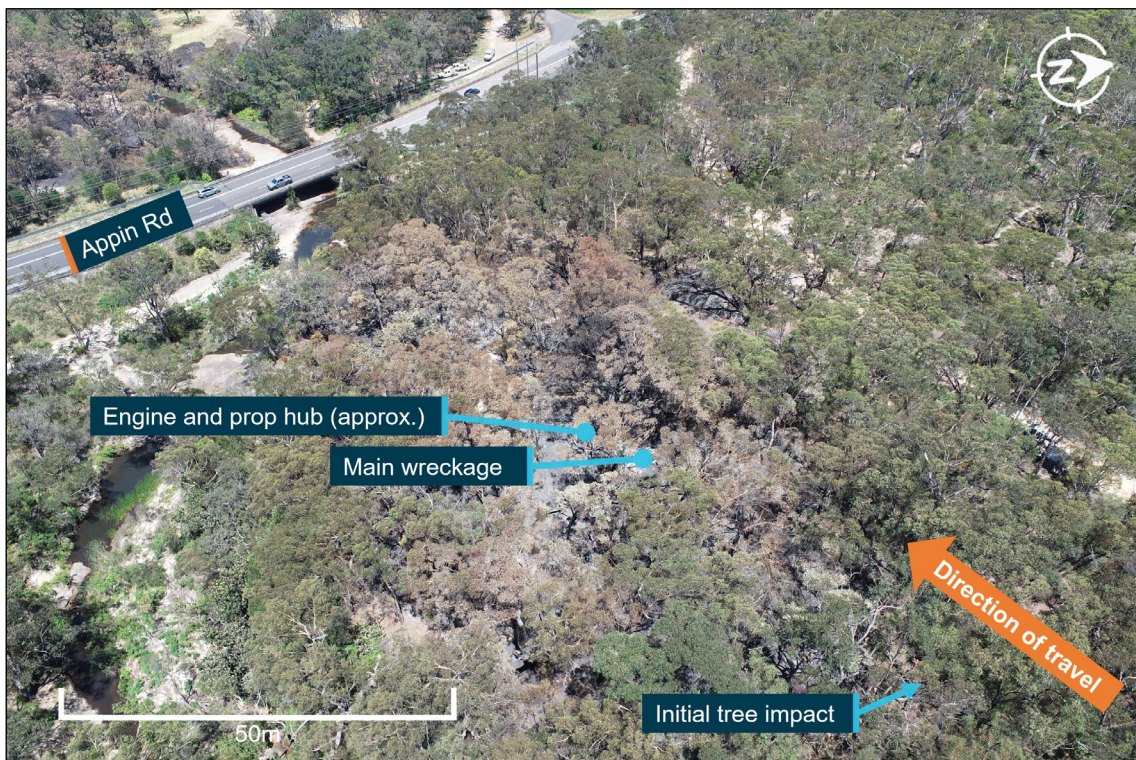
Figure 4: Accident site

The accident site was located about 1.2 km to the south-east of Appin township (Figure 4).

N600 entered trees on an approximate heading of 237° and the first tree impact was about 50 ft above ground level (Figure 4) at 833 ft above mean sea level. The left-wing tip (fuel tank) was located to the left of that tree, and a piece of the upper left wing was to the right of the direction of travel, most likely as a result of initial tree impact. The aircraft then continued for about 45 m, hitting further trees, before impacting a large rock. The airframe was upright and facing opposite the direction of travel. The main wreckage was spread along a path of about 90 m and was heavily disrupted and fire affected.

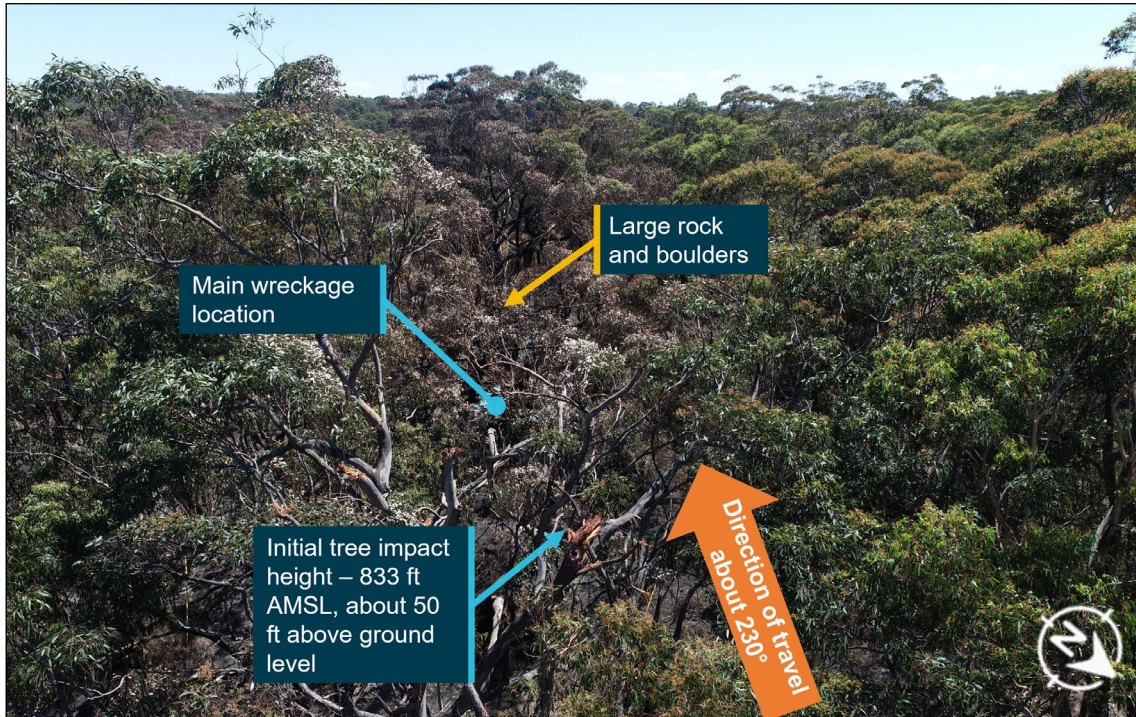
Figure 5: Direction of travel N600

During the accident sequence, the engine and propeller assembly had detached from the airframe and came to rest about 10 m further in the direction of travel, and was heavily affected by fire. Initial propeller contact with trees led to both blades separating from the hub. Most of the wreckage was contained within the fire zone with a small fragment of unburnt propeller blade located about 100 m from the initial tree impact point to the right of aircraft direction of travel.

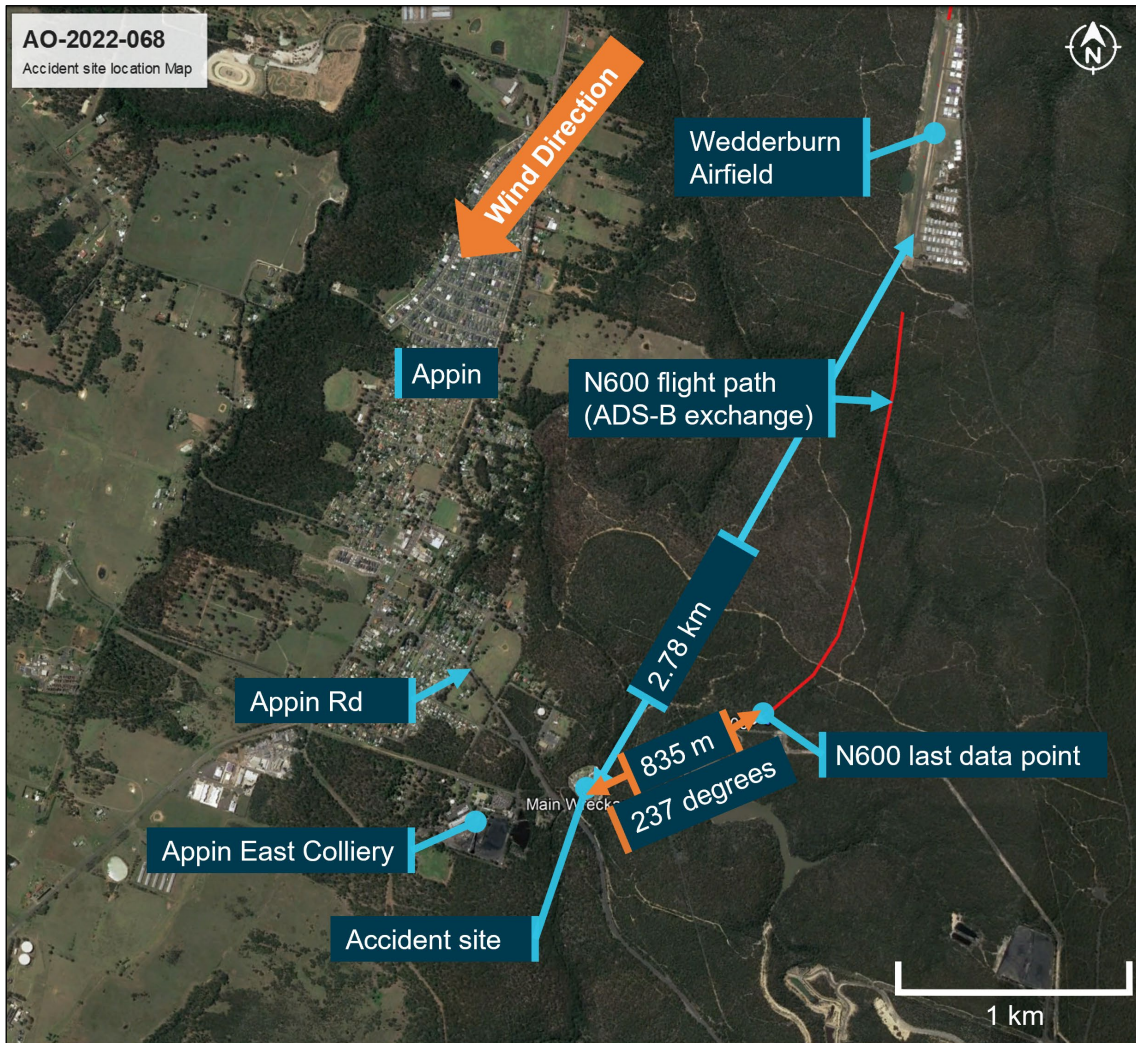
Figure 6: Final track N600

CCTV at Wedderburn showed the aircraft in a shallow climb, enough to just clear rising terrain and trees at the end of runway 17. After clearing the trees in the vicinity of the airfield, the aircraft then disappeared from CCTV view. Recorded data indicated that about 2 minutes later, N600 collided with terrain about 2.7 km from the end of the runway, about 150 m from Appin Road (Figure 6).

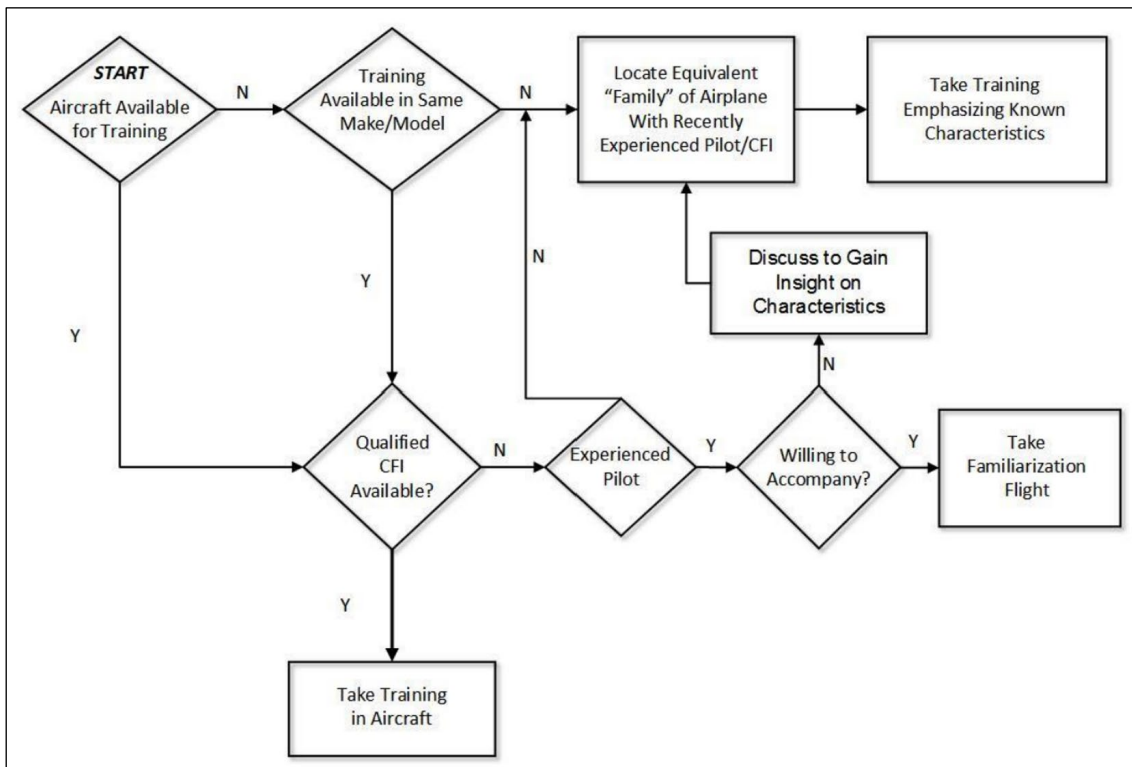
Figure 7: FAA recommended airplane transition training approach

The AC recognises the importance of providing guidance to pilots transitioning between aircraft types, or to experimental aircraft with differing design features to high performance and complex aircraft. It recommends that pilots should develop a training strategy (Figure 7) for mitigating the risks of operation of an unfamiliar aircraft type.

The guidance recommends firstly that pilots should consider undertaking flight training with a qualified flying instructor in the proposed transition aircraft, the same make and model or an aircraft that exhibits the same design features or characteristics of the transition type. If instruction is unavailable, seek another experienced pilot to conduct a familiarisation flight. However, if the instructor is unwilling, at least discuss the differences and expected characteristics of the transition aircraft.

The guidance further recommended that pilots take a risk management approach to formally identify the hazards and mitigate any known or elevated risks identified.
