# Mid-air collision involving Eurocopter EC130B4, VH-XH9, and Eurocopter EC130B4, VH-XKQ

Main Beach, Gold Coast, Queensland, on 2 January 2023

**ATSB Transport Safety Report**  
Aviation Occurrence Investigation  
AO-2023-001  
Interim – 2 January 2024

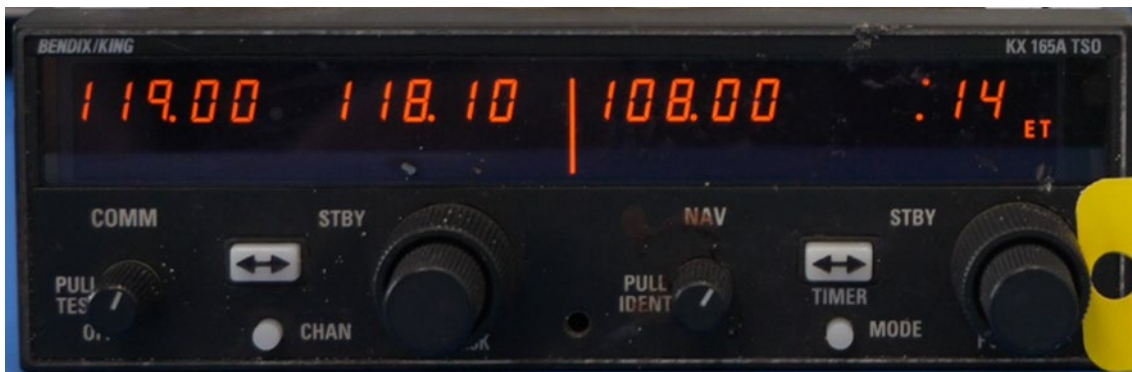
**Figure 5: Bendix King KX-165A from VH-XH9 - Indication on power up**

- Com1 – Damaged beyond repair due to main rotor blade strike. The ATSB could not determine the settings on this unit.
- Com2 – The selected frequency was 119.00 MHz, with a standby frequency 118.10 MHz. The volume knob on the unit was found to be set at approximately 50% (see Figure 5).
- Com3 – This unit was carried and not configured for use in XH9.
- Audio Panel – Both transmit and receive functions had only Com2 selected. The audio panel volume control was positioned at approximately 40%. The intercom mode was set to 'All'.

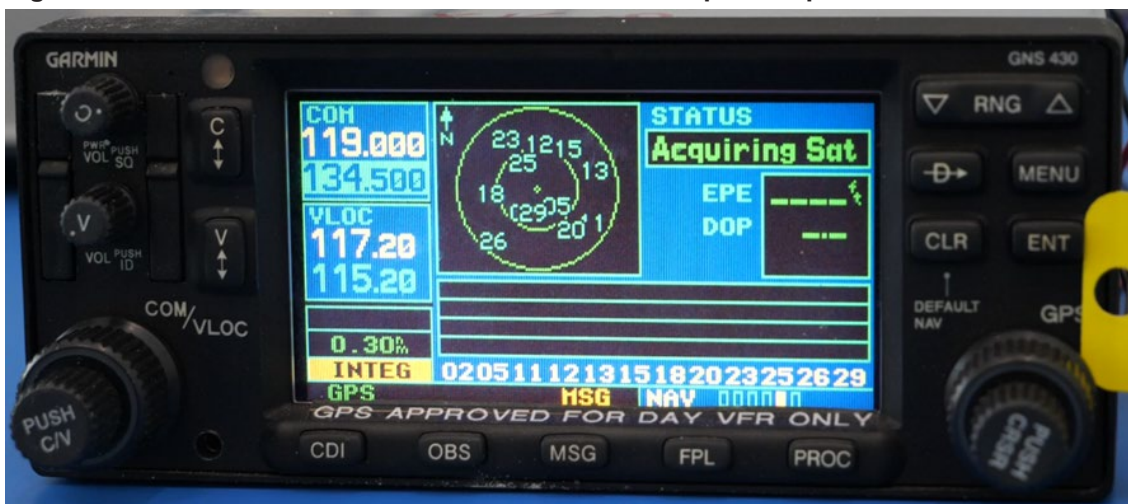
**Figure 8: Garmin GNS430 from VH-XKQ - Indication on power up after self-test**

- Com1 – The selected frequency was 119.00 MHz, with a standby frequency 134.50 MHz. The volume knob on the unit was found to be set at approximately 75% (see Figure 8).
- Com2 – The selected frequency was 118.70 MHz, with a standby frequency 128.75 MHz. The volume knob on the unit was found to be set at approximately 10%.
- Audio Panel – Both transmit and receive functions had only Com1 selected. The audio panel volume control was positioned at approximately 75%. The intercom mode was set to 'Isolate'.

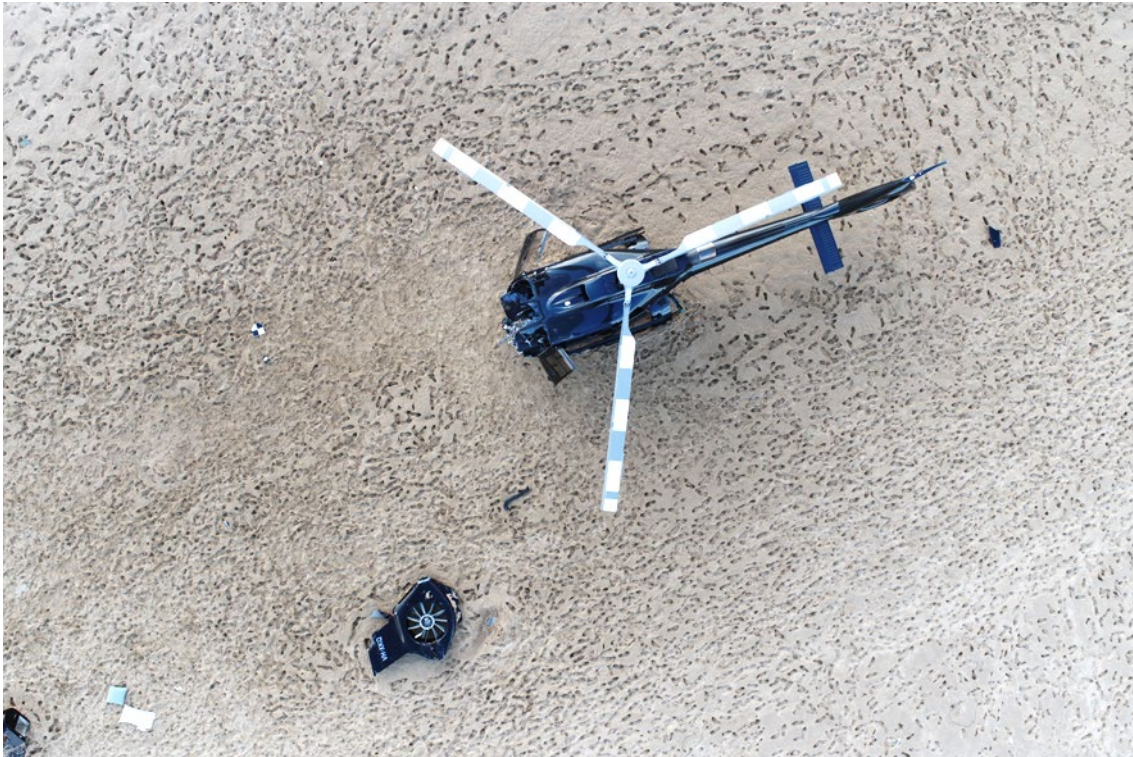
**Figure 10: XH9 and tail rotor of XKQ**

In the time available at the accident site, the ATSB had uninhibited access to XH9, and took photographs and recovered evidence from that helicopter. Access to XKQ in its position and location was limited and controlled examination and recovery of components was not possible.

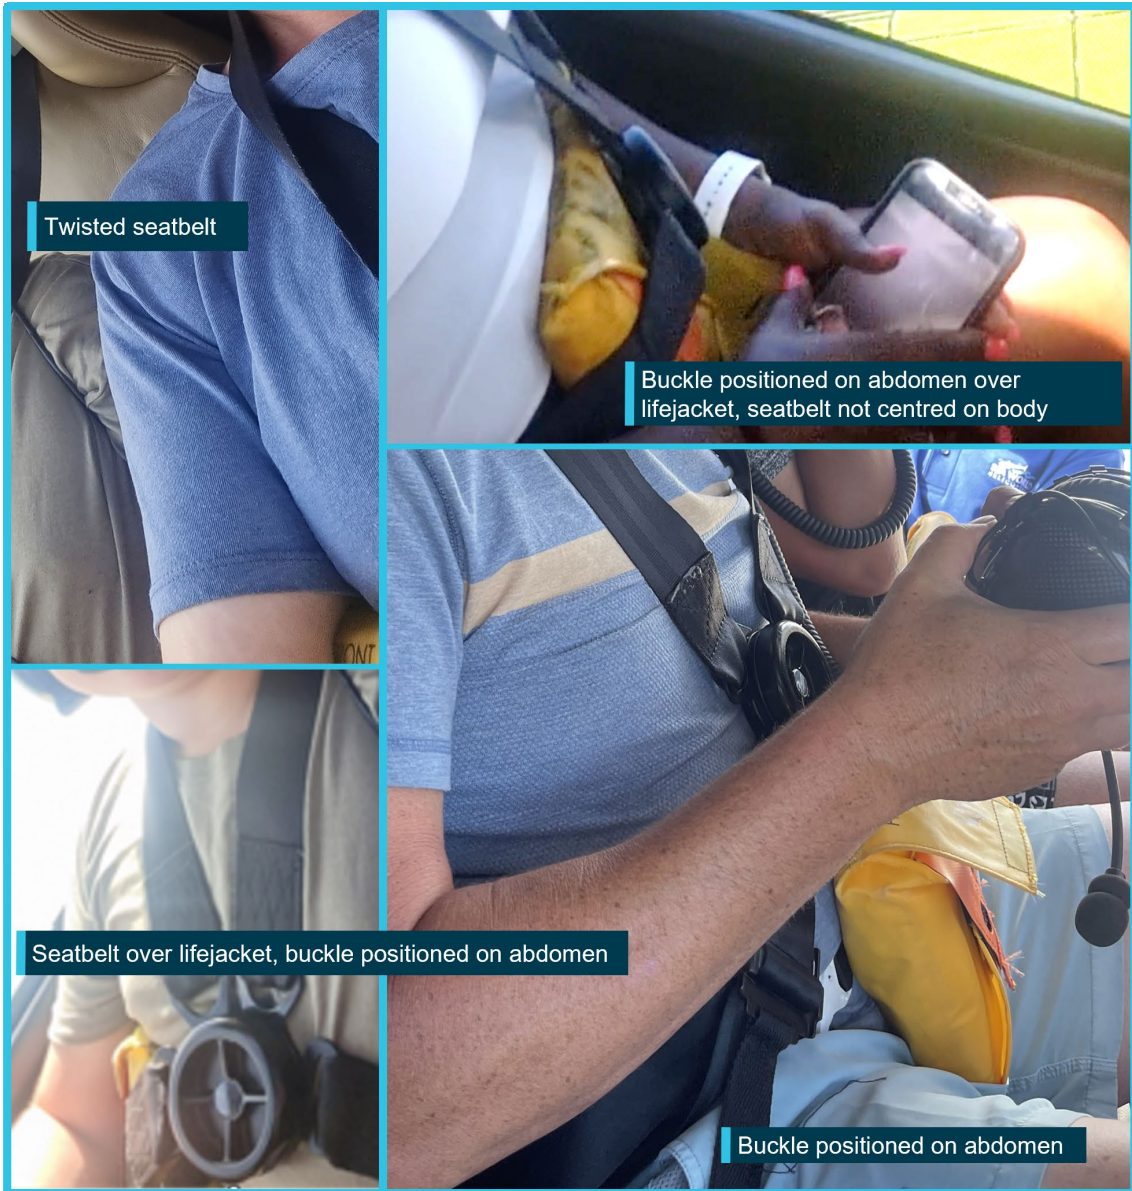
**Figure 20: Examples of passenger incorrect seatbelt fitment**

Photographs, videos and interviews indicated that some passengers did not have their seatbelts fitted correctly (Figure 20). Incorrect fitment included:

Further investigation determined that seatbelts were not being fitted correctly by the operator on a regular basis. In interview, it was reported by 1 ground crew member that in preparation for passenger loading, 2 portions of the 4-point restraints would already be clipped in, so that when passengers boarded, there was only 1 shoulder harness and 1 waist component that would be required to be inserted. Unless the seatbelt is readjusted correctly whereby the lower portion of the harness is fitted low and tight across the hips, this can lead to incorrect fitment of the seatbelt.

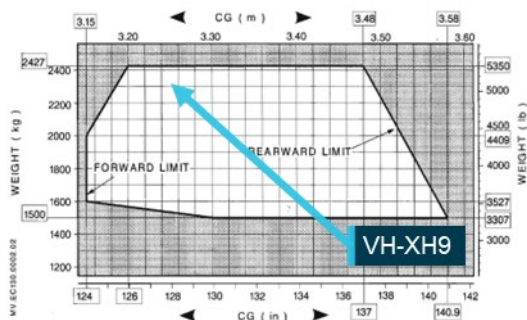
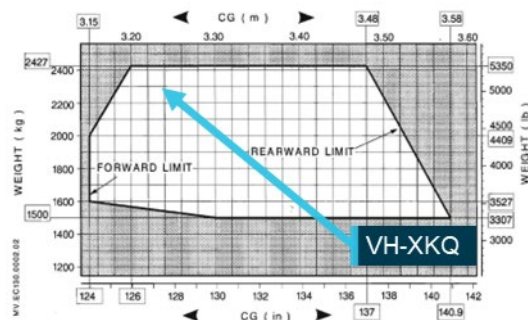
Figure 23: XH9 and XKQ calculated longitudinal centre of gravity for accident flight

For the loading of XKQ, the combined weight of the front seat passengers exceeded the usual limit as indicated by the operator’s loading chart. The ground crew member responsible for checking this, spoke with the pilot who then manually calculated and confirmed that the passengers could be seated in the front (Figure 23).
