Loss of control and in-flight break-up involving Robinson R66, VH-KFT

near Hawks Nest, New South Wales, on 26 October 2023

ATSB Transport Safety Report
Aviation Occurrence Investigation
AO-2023-051
Preliminary – 23 January 2024

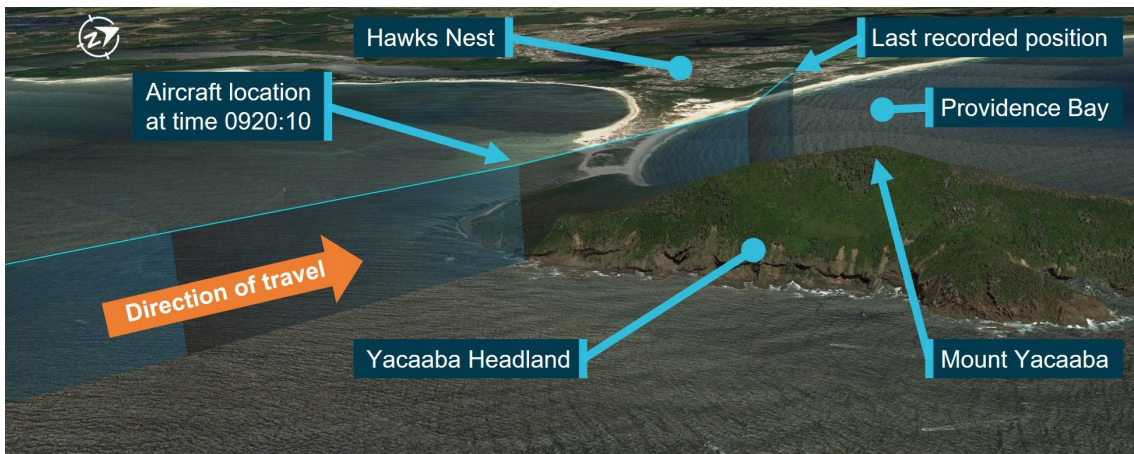
Figure 2: VH-KFT flight path

- Between 0920:19 – 0920:21 the helicopter rolled 25 degrees to the left, pitched nose up to about 10 degrees, and yawed to the left. The helicopter then climbed through about 1,000 ft AMSL and rolled to level.
- Between 0920:22 – 0920:26 the helicopter passed north of Yacaaba Headland and over Providence Bay. The helicopter rolled left slightly, then right and left to bank angles of about 10 to 15 degrees. During this time, the nose remained pitched up at about 6 degrees and the helicopter climbed to about 1,100 ft AMSL.
- Between 0920:26 – 0920:29 the helicopter nose had pitched down and it had rolled to the right to become completely inverted (180 degrees), then continued to roll right to about 270 degrees.

The helicopter sustained an in-flight break-up and impacted the waters of Providence Bay, near Hawks Nest. The pilot was fatally injured.

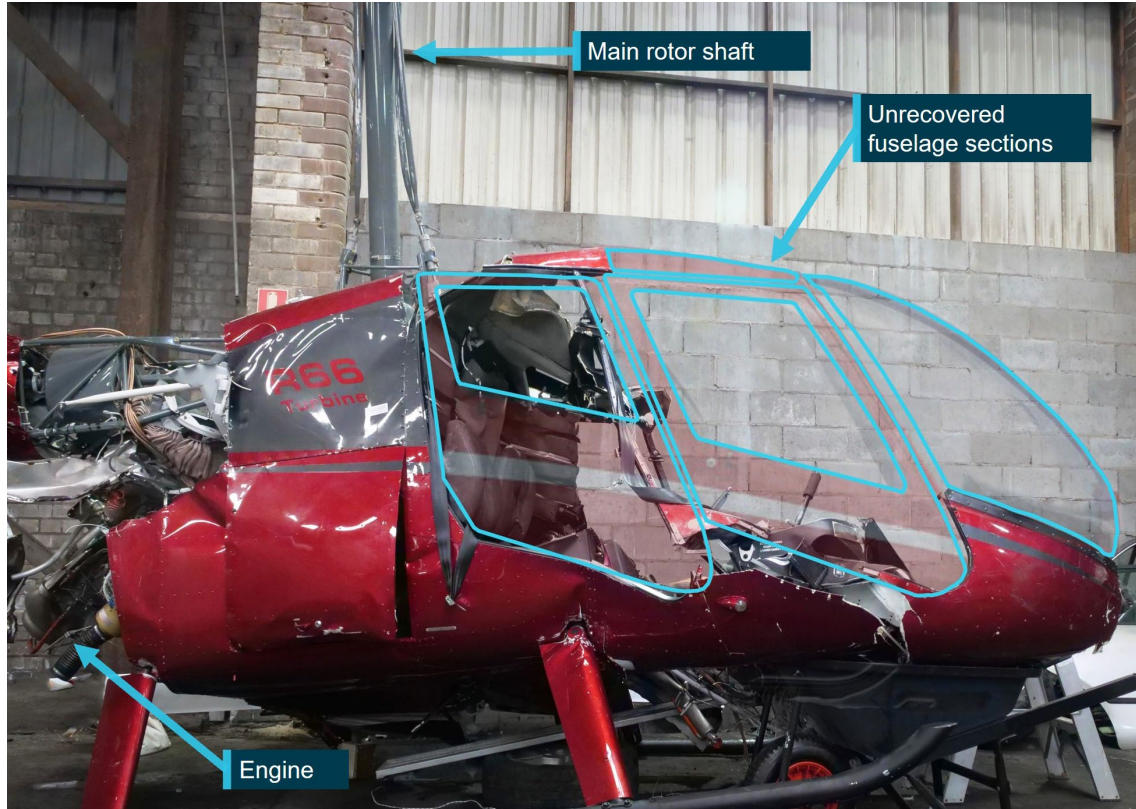
Figure 3: Wreckage examination

On 28 October 2023, NSW police divers located the helicopter’s cabin and tail boom on the sea floor in Providence Bay at a depth of about 5 m (Figure 2). The wreckage was recovered to a secure facility in Newcastle for examination by the ATSB. The entire windshield and forward cabin roof section, as well as the main rotor head and both main rotor blades, were not located from the sea search operation (Figure 3).

ATSB’s examination of the recovered helicopter structure indicated that a main rotor blade had likely impacted the right side of the cabin. The examination identified that the tail boom had separated from the fuselage aft of the engine fairing from a main rotor blade contact, prior to impacting the water. Damage to the fuselage was consistent with the fuselage impacting the water on the left side. The on-site inspection of the recovered wreckage did not identify any pre-existing faults or defects.

The image has been annotated to highlight areas of missing cabin structure.
