# Runaway and derailment of loaded grain train 3966

Dombarton (12 km from Wollongong), New South Wales, on 15 December 2020

**ATSB Transport Safety Report**  
Rail Occurrence Investigation (Defined)  
RO-2020-022  
Final – 24 January 2024

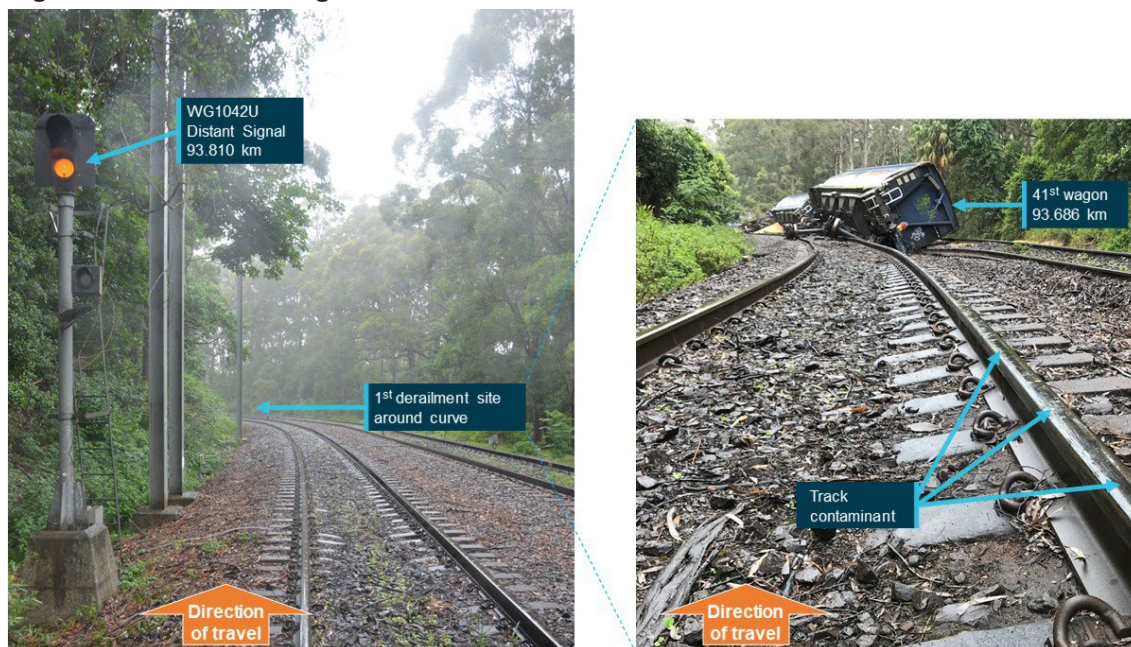
**Figure 7: Rail line leading to first derailment site**

Observations of the track leading up to the first derailment site and the second derailment site were documented and photographs taken (Figures 7, 8 and 9). Initial assessment of the track condition was noted as not having any obvious defects that could be expected to increase the risk of derailment. Track measurements were taken by ARTC post incident. Superelevation<sup>24</sup> measurements were compared against design superelevation and short twist and long twist<sup>25</sup> were calculated.

The track leading up to the first derailment site, 93.810 km to 93.714 km was measured. ARTC had identified a point of first derailment at 93.710 km. The results of the track measurements at this location showed no exceedances of short or long twist.

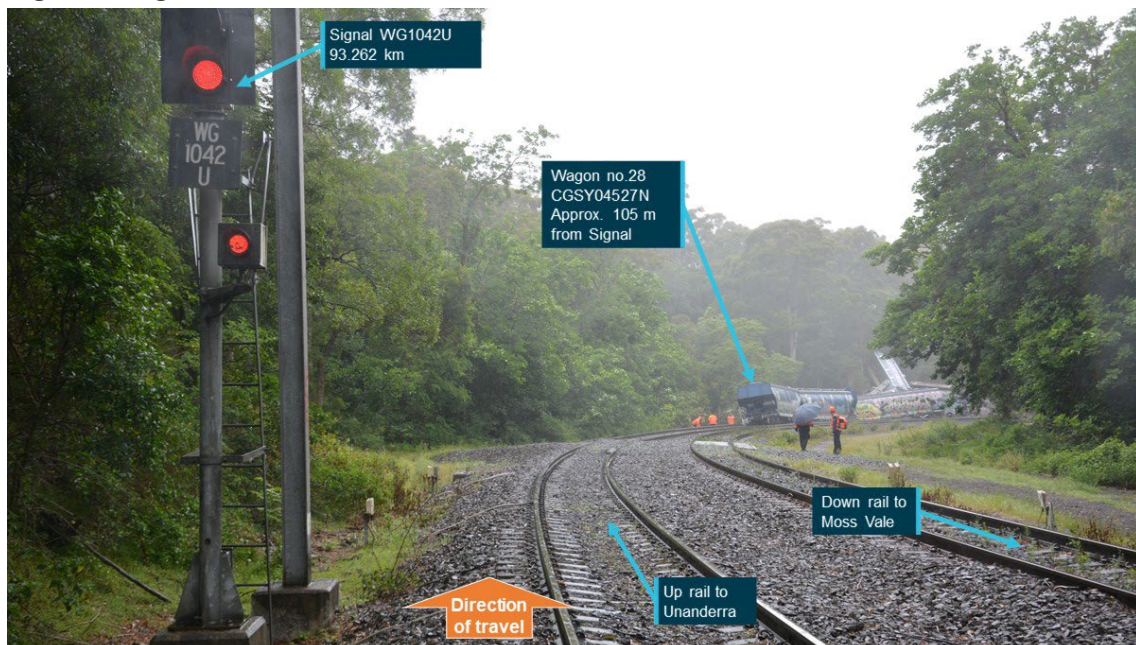
**Figure 9: Signal WG1042U to second derailment site**

Qube also contracted an engineering group to inspect the track post incident, who identified evidence of a derailment point, for the second derailment, at 93.220 km. However, the associated wagon and wheelset that made the markings could not be conclusively determined.

ARTC also took measurements of the rail track before and after the second derailment site. There were no exceedances of short or long twist found.

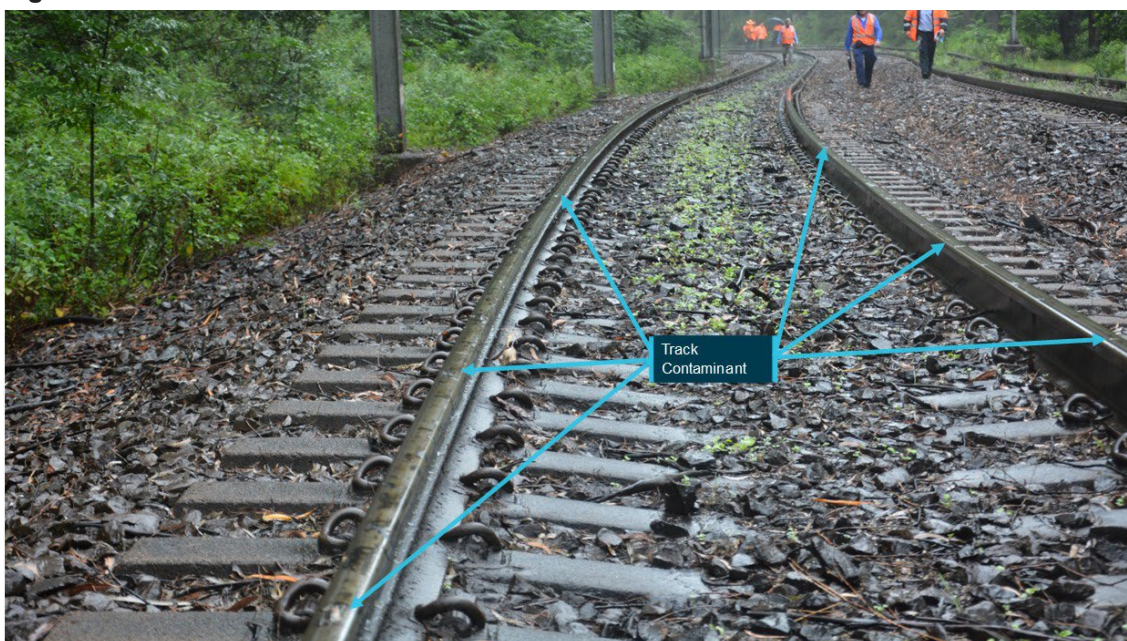
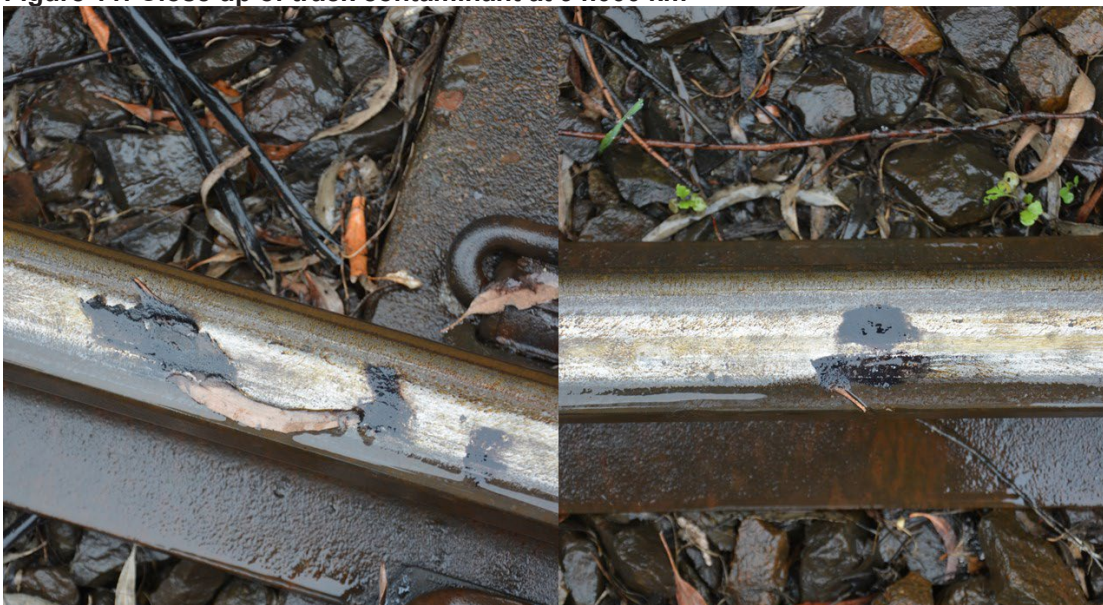
A contaminant was observed on the head of the rail lines across the area of track that was inspected. The contamination was more prominent in areas with more tree foliage. There was evidence of wheels rolling over and skidding through the contaminant at 94.000 km (Figure 10 and Figure 11).

**Figure 10: Track contaminant at 94.000 km**

**Figure 11: Close up of track contaminant at 94.000 km**

*Pictures of the contaminant in Figures 10 and 11 were taken approximately 300 m prior to the first derailment, evidence of wheels rolling over and skidding through the contaminant*  
Source: OTSI

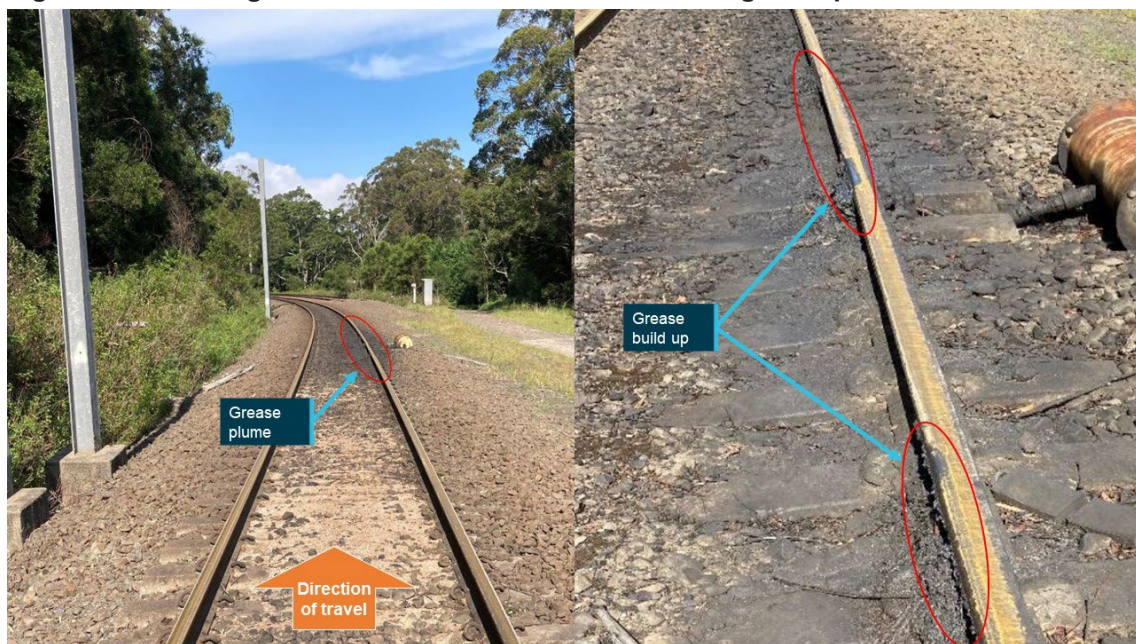
**Figure 12: Rail flange lubrication device at 97.030 km and grease plume**

Following draft report feedback, ARTC produced a listing of all rail flange lubricators which included a rail flange lubricator at 97.030 km. ARTC also stated that this rail flange lubricator serviced trains travelling on the down (uphill) (Figure 12). No additional maintenance records were provided with the revised list.

General inspection of rail flange lubrication over this section of the rail line was last conducted between 96.893 km and 150.600 km on 14 June 2020, approximately six months prior to the incident.

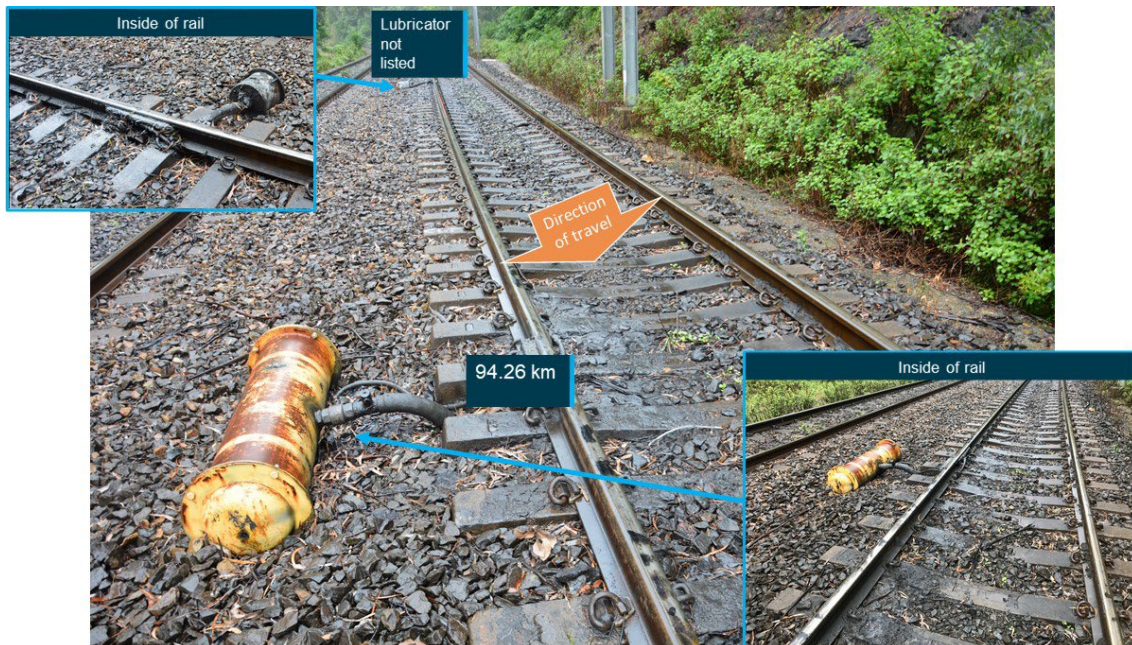
**Figure 13: Rail lubrication devices leading to left hand curve and site of first derailment**

Additionally, two rail flange lubricators listed in ARTC's maintenance history records at 94.958 km and 94.535 km were less than the required 500 m separation stipulated in RC 2411.

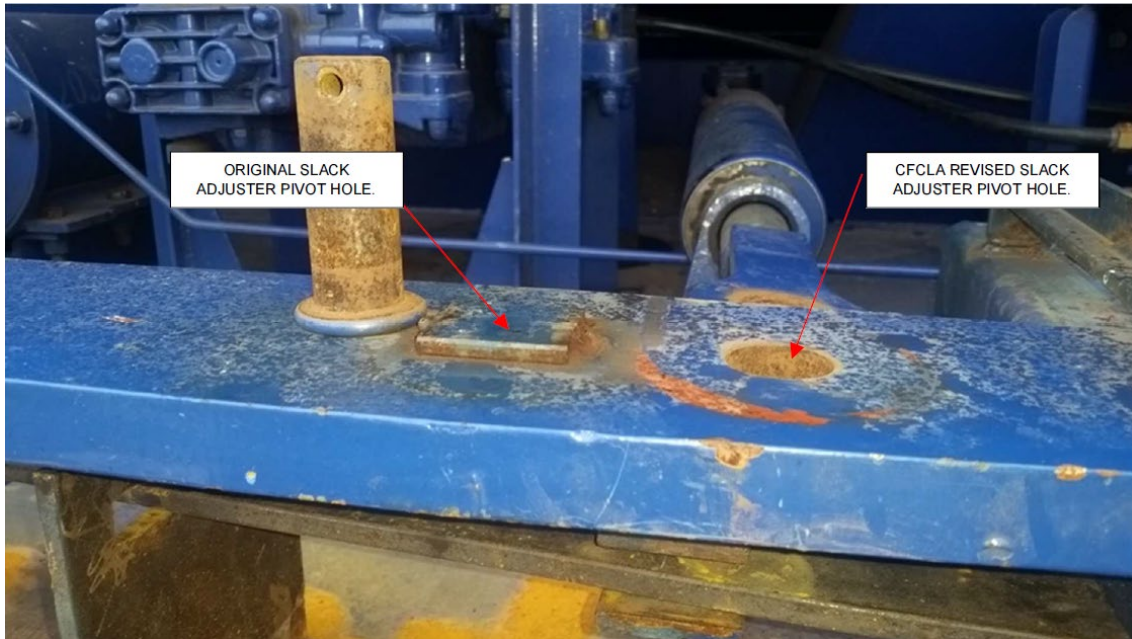
**Figure 14: Revised slack adjuster pivot holes**

CIMC's review of the wagon's design identified an error in the brake rigging system, in the setup of the control rod on the slack adjuster. The control rod on the slack adjuster had been fixed to the wagon structure. This did not permit the slack adjuster to perform its primary function of reducing the slack in the brake system. This resulted in the brake cylinder piston travel increasing as brake blocks wear, with an eventual reduction in brake block forces on the wheels.

CIMC revised the design to incorporate a control lever.

When the revised control lever design was fitted by CFCLA to a trial wagon, they found there was no change to the operation of the brakes. The slack adjuster was still unable to reduce the slack in the brake rigging.

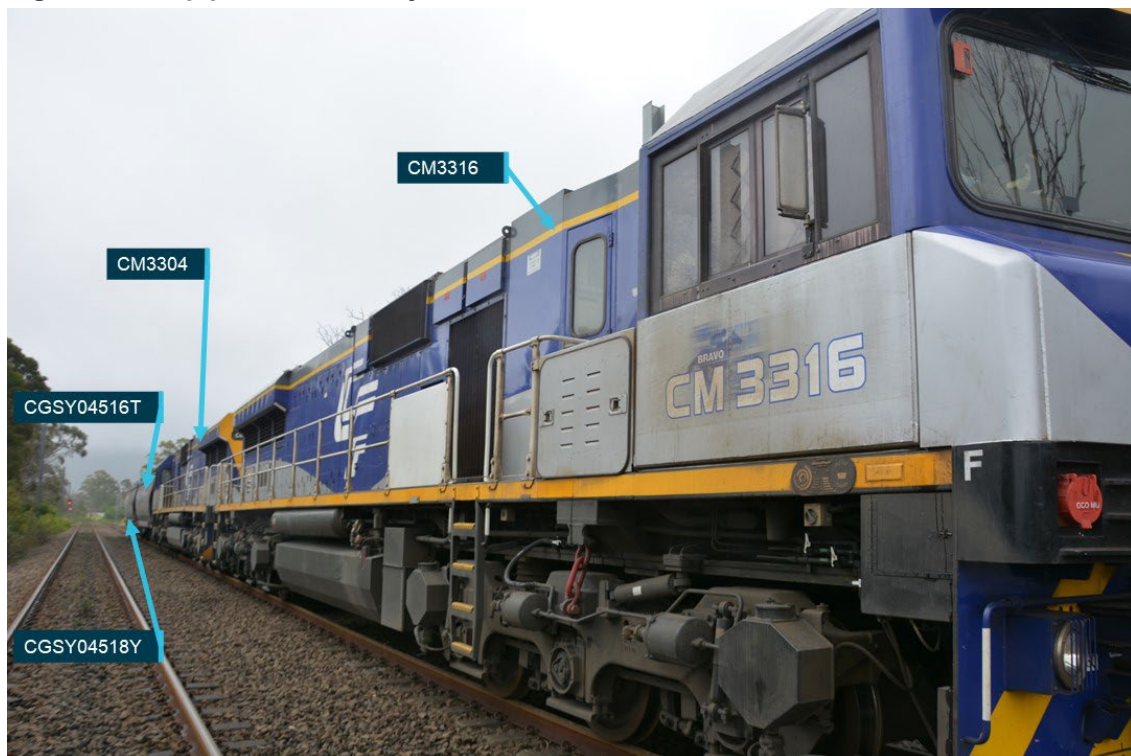
**Figure 16: Stop point of runaway train 3966**

On arrival at the locomotives and two wagons it was observed that the coupler knuckle was closed and locked on the back of the second wagon CGSY 04518Y and that both main reservoir (MR) and brake pipe (BP) isolation cocks were closed. It was later confirmed that the driver's assistant had isolated the cocks post derailment to stop air leaking from the main reservoir and brake pipe.

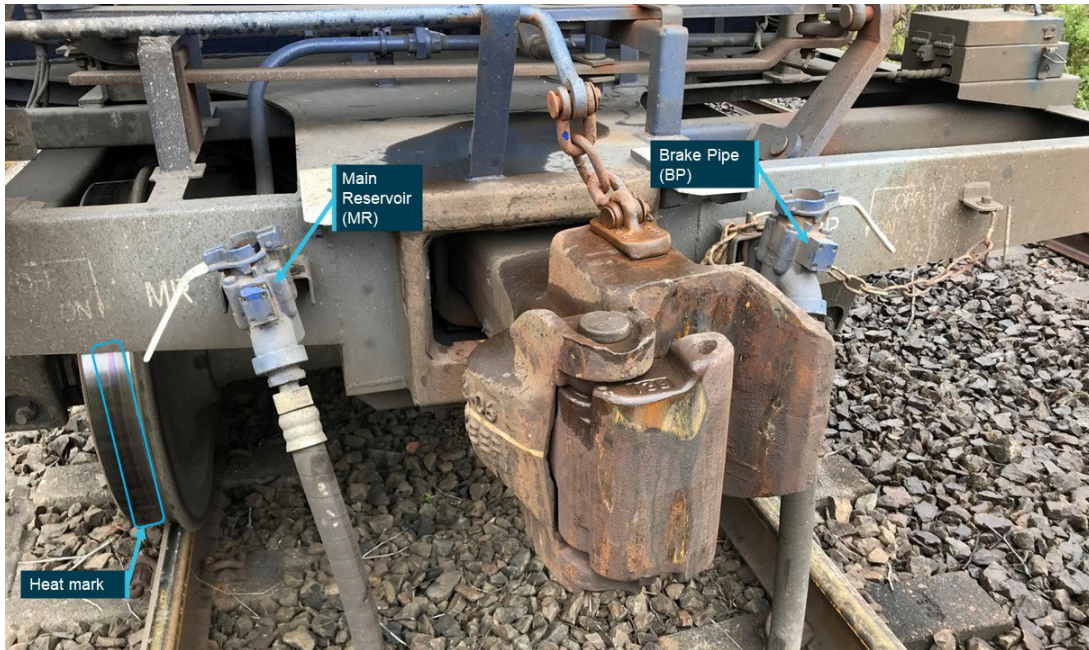
**Figure 17: Back of 2<sup>nd</sup> wagon CGSY 04518Y**

The wheels on the remaining connected wagons showed some signs of heat (see Figure 17). There were no visual signs of flat spots on the wheels. This was later confirmed when the rolling stock was tested on 17 December 2020, prior to moving to Port Kembla to unload the wagons. Sand was also evident on the rail head located under the wagons and locomotives.

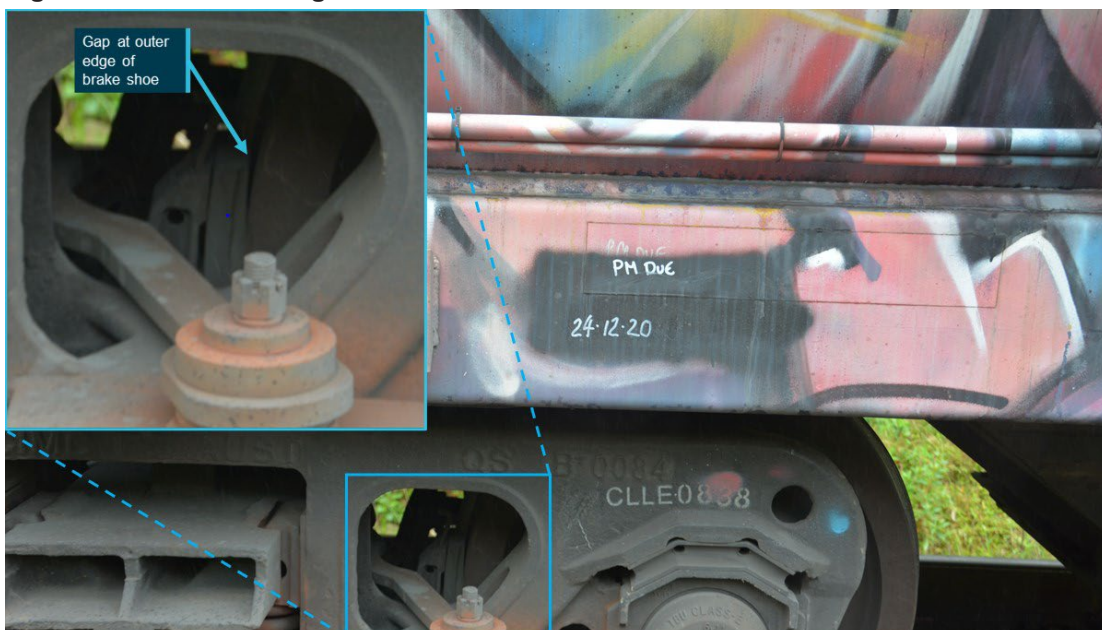
**Figure 18: Side of 1<sup>st</sup> wagon CGSY 04516T brake shoe**

The brake shoes were in contact with the wheels across both locomotives and wagons. The contact patch of the brake shoes was not aligned with the wheel diameter on some wagons (Figure 18).
