Australian Transport Safety Bureau

Derailment of coal train 9QJ5

near Mount Rainbow, Queensland, on 30 October 2021

ATSB Transport Safety Report
Rail Occurrence Investigation (Short)
RO-2021-013
Final – 30 January 2024

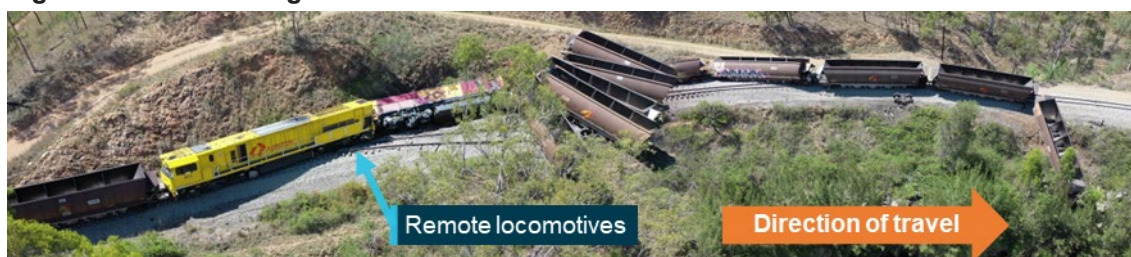
Figure 2: Main wreckage site

After securing the train, one of the drivers walked back, discovered that the wagons had derailed (Figure 2), and reported the derailment to Aurizon network control.

The following 20 wagons derailed (not including the 35th position wagon) and 2 remote distributed power locomotives derailed (located at position 51 and 52 in the consist). The train travelled about 400 m in a derailed condition. Aurizon specialists inspected the rolling stock in-field and found no pre-existing defects.

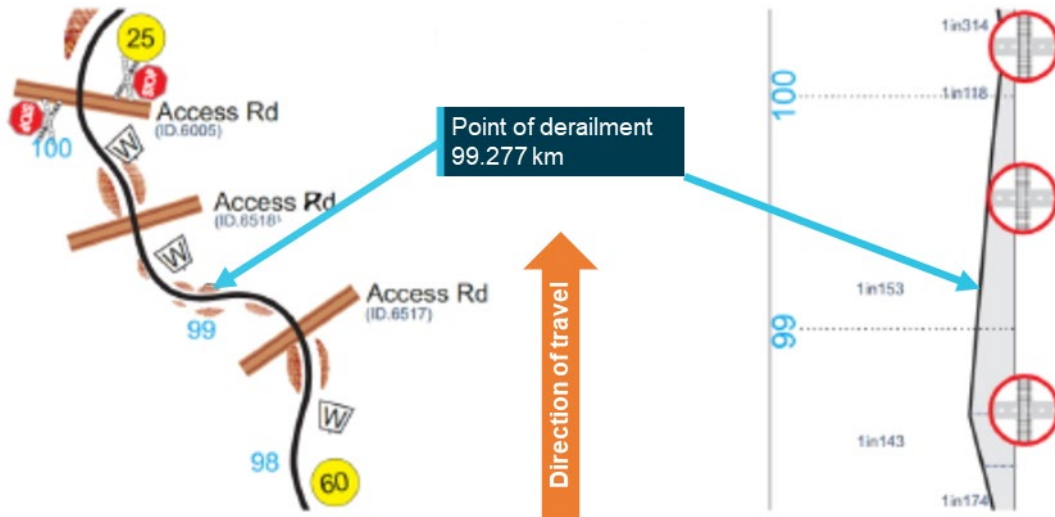
Figure 3: Track details at the point of derailment

curves (Figure 3 left). The point of derailment was located between 301 m radius reverse curves on a 1 in 153 downhill grade (Figure 3 right).

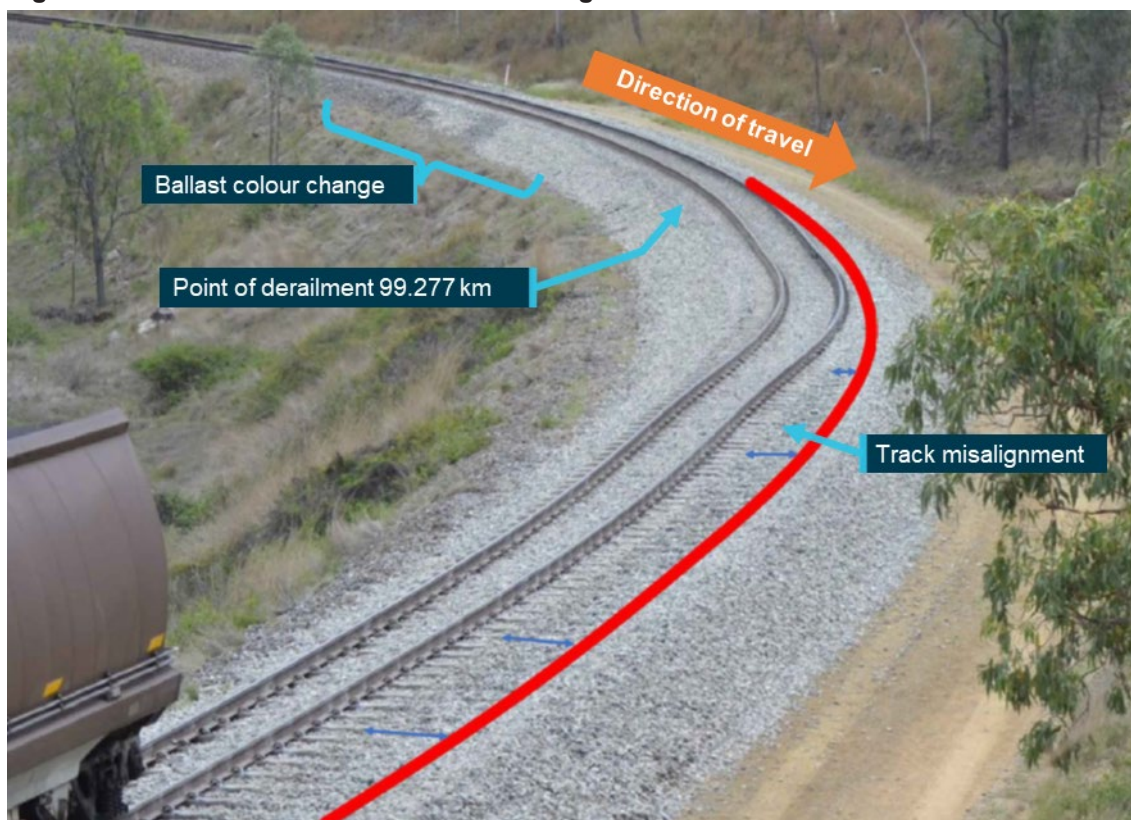
Figure 4: Point of derailment and track misalignment

When approaching the 99 km, the rail traffic crew noticed a transition in ballast colour from dark to light (Figure 4). A short time later, at 1556:50, the recorded brake pipe pressure began to decrease in the remote distributed power locomotives. At 1556:57, travelling at 54 km/h, the emergency brake was activated (due to a loss of brake pipe air) in the leading locomotive, stopping the train about 160 m later at about 100.220 km. The in-cab telemetry between the leading locomotive and remote locomotives was broken.

Aurizon found evidence of a track misalignment commencing at about 99.270 km, just prior to the point of derailment, where the concrete sleepers had begun to move both vertically and laterally (left and right). The track misalignment progressively worsened beyond the point of derailment (Figure 4). The ballast in the work location was also analysed. Although the ballast failed under 53 mm and 37.5 mm sieve tests,⁴ Aurizon determined that the specification failure identified was not considered to have been contributory to the accident.⁵

Aurizon concluded that the recent track maintenance activity had a substantial impact on the compressive stress condition of the track leading up to the point of derailment in the heat of the day. This resulted in the track infrastructure becoming unstable and a flange climb derailment due to track misalignment.

Note: The rear portion of wagons was removed from the site before the above photograph was taken. New ballast is lighter in colour.
 Source: Aurizon, annotated by the ATSB

Without dismantling the track, the ballast cleaning machine undercut the ballast bed with a moving chain beneath the rails and sleepers, removing contaminated and degraded ballast. The ballast was replaced with new ballast under the track, shown as the lighter colour in Figure 4.

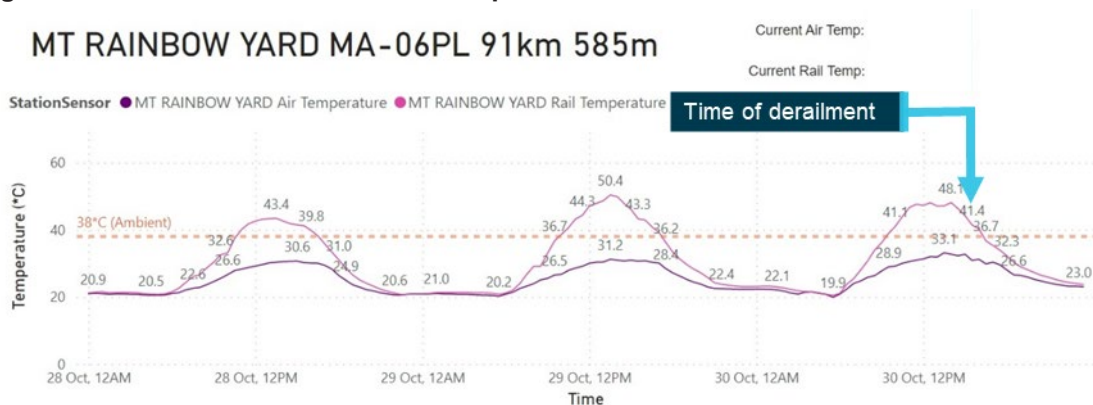
Figure 9: Mount Rainbow air and rail temperatures

Figure 9 and Figure 10 show Aurizon recorded air and rail temperatures at Mount Rainbow and Dumgree between 28 October 2021 and 30 October 2021. The maximum air temperatures on each day were below the design stress-free temperature of 38°C for the rails. However, at the time of the derailment, the rail temperature was decreasing and was about 40.1 °C at Mount Rainbow and 49 °C at Dumgree.

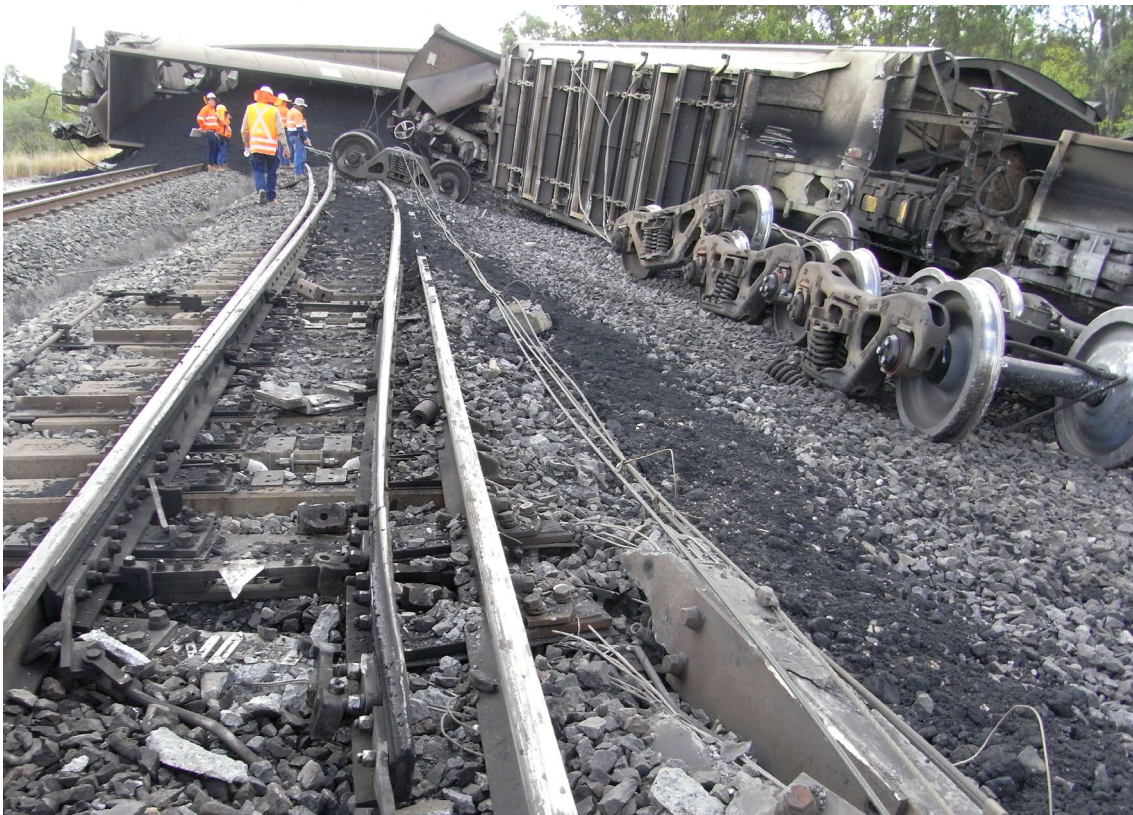
Figure 11: Duaringa derailment site

On 24 January 2018, at about 1347 local time, loaded Aurizon coal train EF01 encountered a track buckle at Duaringa, on Aurizon Network’s Blackwater System between Emerald and Rockhampton, Queensland. The buckle resulted in 17 wagons in the train consist derailing (Figure 11), damaging 502 m of track on the down line and 54 m of track on the adjacent up line, with rails, sleepers and overhead line equipment requiring replacement.

The ATSB found that the track buckle had formed on a falling 1 in 50 grade at the point of the track where ballast cleaning and track stabilisation work had been completed less than 12 hours earlier. The ballast cleaning operational plan did not consider compressive stress in the continuous welded rail as a risk at this location.

The compressive stress, steep grade, proximity to a turnout and high ambient temperature meant the track structure had a limited capacity to constrain lateral forces. While the ballast cleaning, track resurfacing and dynamic track stabilisation work met Aurizon Network’s civil engineering track standards, negative operational outcomes were not anticipated when a risk assessment was done for the site.

Following this occurrence, Aurizon changed its procedures to ensure a temporary speed restriction was applied to all work sites on which ballast undercutting had been performed. The restriction was to remain in place until rail adjustment or stress testing had been completed and it had been determined that the rail stresses were within accepted limits. In addition, sites with a high risk of compressive rail stress would be identified and added to the site hazard map before conducting ballast cleaning.
