Engine malfunction and forced landing involving Robinson R22 Beta II, VH-NKV

85 NM north-east of Karumba aerodrome, Queensland, on 6 August 2022

ATSB Transport Safety Report

AO-2022-038

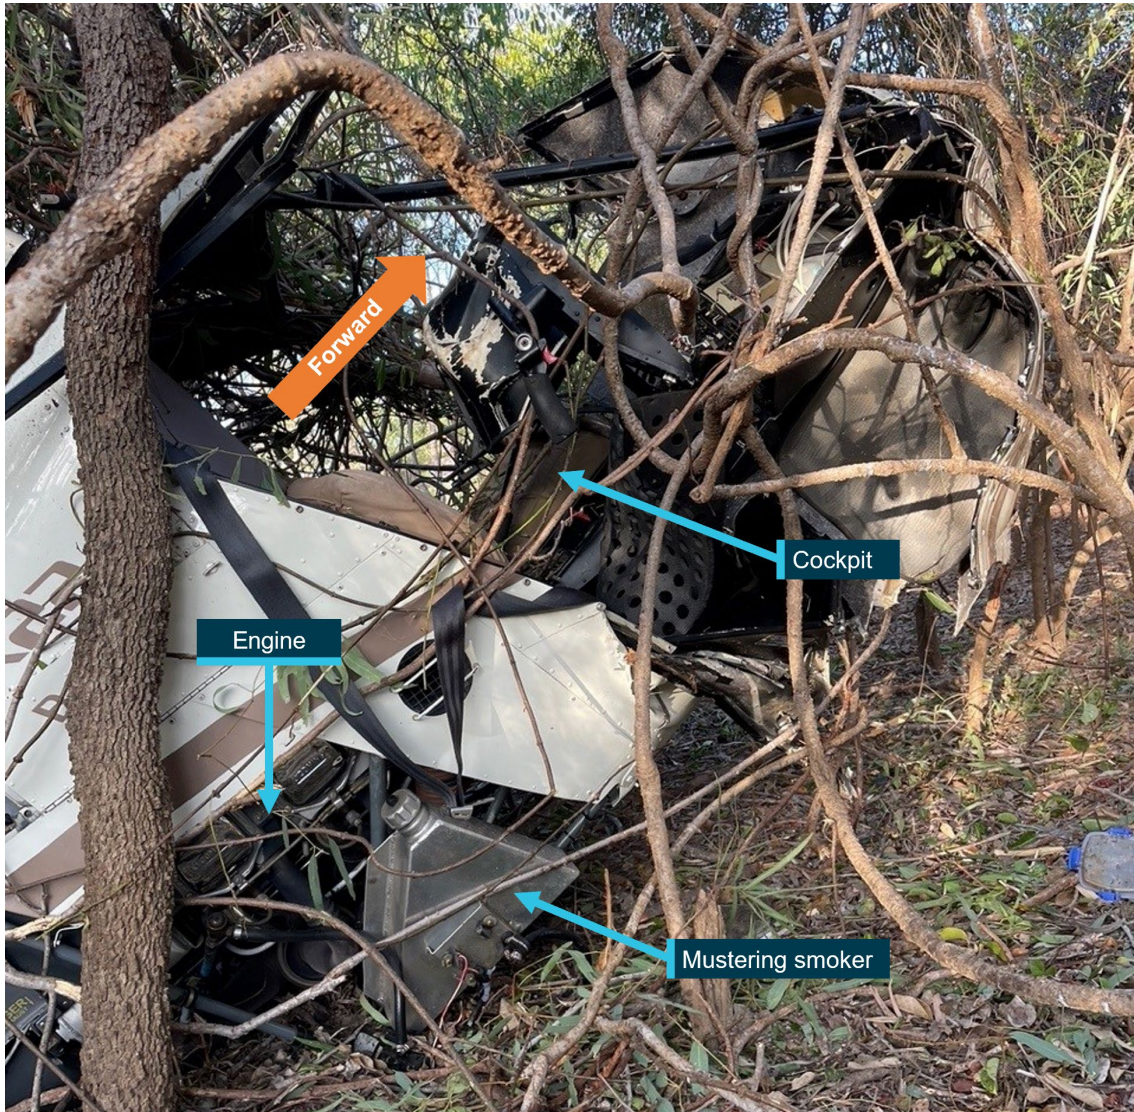
Figure 1: VH-NKV at the accident site

In response, the pilot initially raised the collective, then after recognising the engine and rotor RPM continuing to decrease, rapidly lowered the collective to maintain rotor RPM. The pilot commenced an autorotation, flaring the aircraft just above the trees in a heavily wooded area. The aircraft collided with trees and was destroyed (Figure 1). The pilot was uninjured, and was able to exit the aircraft unaided. There was no fire, and after it was safe to do so, the pilot returned to the aircraft to shut the fuel and master switch off.

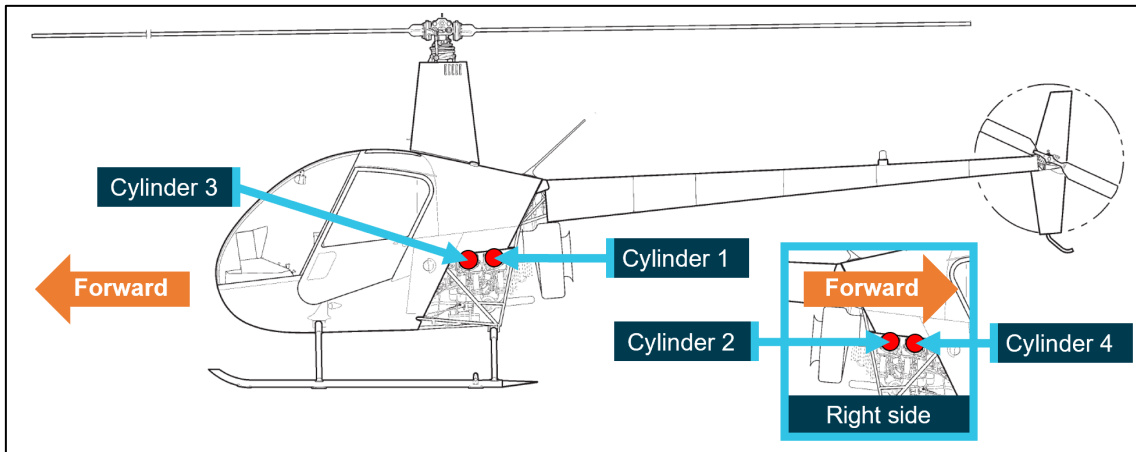
Figure 2: R22 Beta II engine cylinder layout

The engine cylinder layout is shown in Figure 2. An overhauled engine was installed on 26 October 2020 and in the following 18 months, 15 cylinders were changed across the 4 cylinder positions because they were found to have low compression when tested² (Table 1). Cylinders fitted to positions 3 and 4, located closest to the engine firewall, had been changed on more occasions than cylinders fitted to positions 1 and 2. The last cylinder replacements (numbers 1, 2 and 4) were made during the periodic inspection carried out on 13 May 2022. The compressions on all cylinders were within limits when tested during subsequent periodic inspections carried out on 23 June and 20 July 2022 (Table 2).

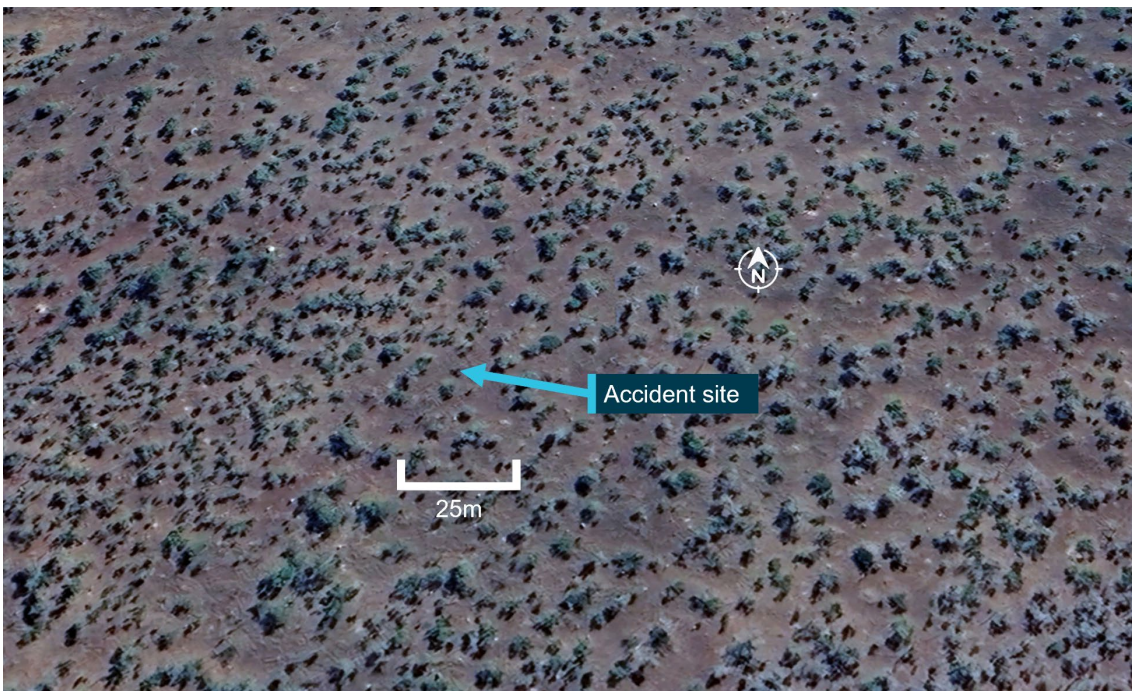
Figure 3: Accident site overview

The accident site was located in a heavily wooded area with limited clearings to successfully complete an autorotation (Figure 3). The ATSB did not attend the accident site. The operator, Gulf Coast Aviation, recovered the wreckage, after which it was transported to an independent maintenance provider. The engine and a selection of components were removed for detailed examination by the ATSB. This examination revealed that multiple components showed evidence of the engine running at impact, however the level of power that would have been available could not be determined.
