# Safety Advisory Notice

Number: AO-2022-038-SAN-01

## R22 and R44 cylinder durability issues

More data is needed to understand ongoing engine cylinder issues in R22 and R44 helicopters

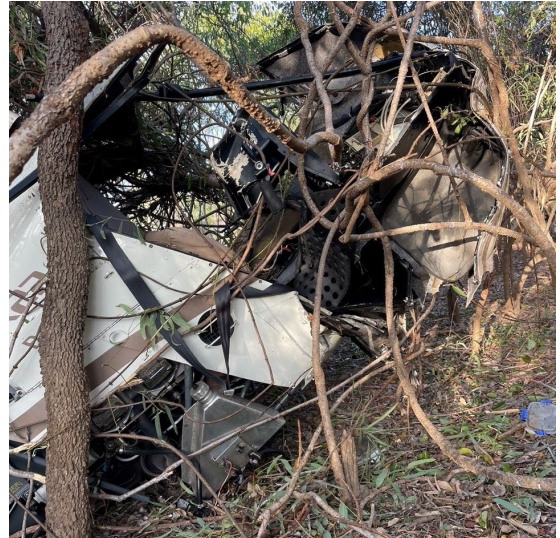
On the morning of 6 August 2022, the pilot of a Robinson R22 Beta II was flying at about 500–600 ft en route to conduct aerial mustering in northern Queensland. After some time in cruise, the helicopter suddenly began to 'shake and vibrate'. In response, the pilot conducted an autorotation, flaring the aircraft just above the trees in a heavily wooded area. The aircraft collided with trees and was destroyed. The pilot was uninjured, and there was no fire.

The ATSB found that the engine issues prompting the pilot to attempt a forced landing were likely the result of carbon deposits that had accumulated on the valve stem of the no. 2 cylinder exhaust valve and within its guide, reducing clearance to less than the specified minimum. The reduced clearance likely resulted in the valve binding in the guide, and not fully closing.

**AO-2022-038-SAN-01:** The ATSB strongly encourages maintainers, operators, and pilots of Robinson R22 and R44 helicopters fitted with Lycoming O-320, O-360 and O-540 series engines to complete a Lycoming cylinder durability investigation group defect report form 1529 any time engine cylinder issues are identified.
