Brake failure and fire involving DHC-8-202, VH-TQS

Sydney Airport, New South Wales, on 8 November 2022

ATSB Transport Safety Report

AO-2022-056

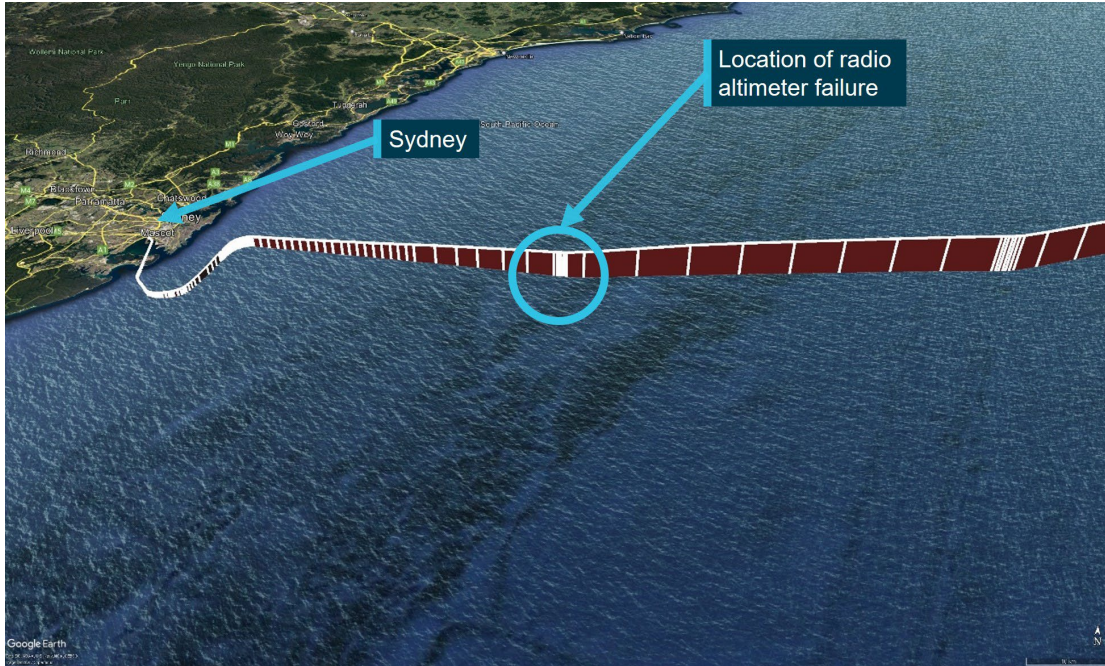
At about 1658 local time, while descending through flight level (FL)² 175 on approach to Sydney (Figure 1), the flight crew were alerted to a failure of the traffic alert and collision avoidance system (TCAS)³ as well as the ground proximity warning system (GPWS).⁴ Shortly after, they noticed the radio altimeter (RadAlt) had also failed.

Figure 1: ADS-B⁵ derived flight data showing the approximate location of the radio altimeter failure on approach to Sydney

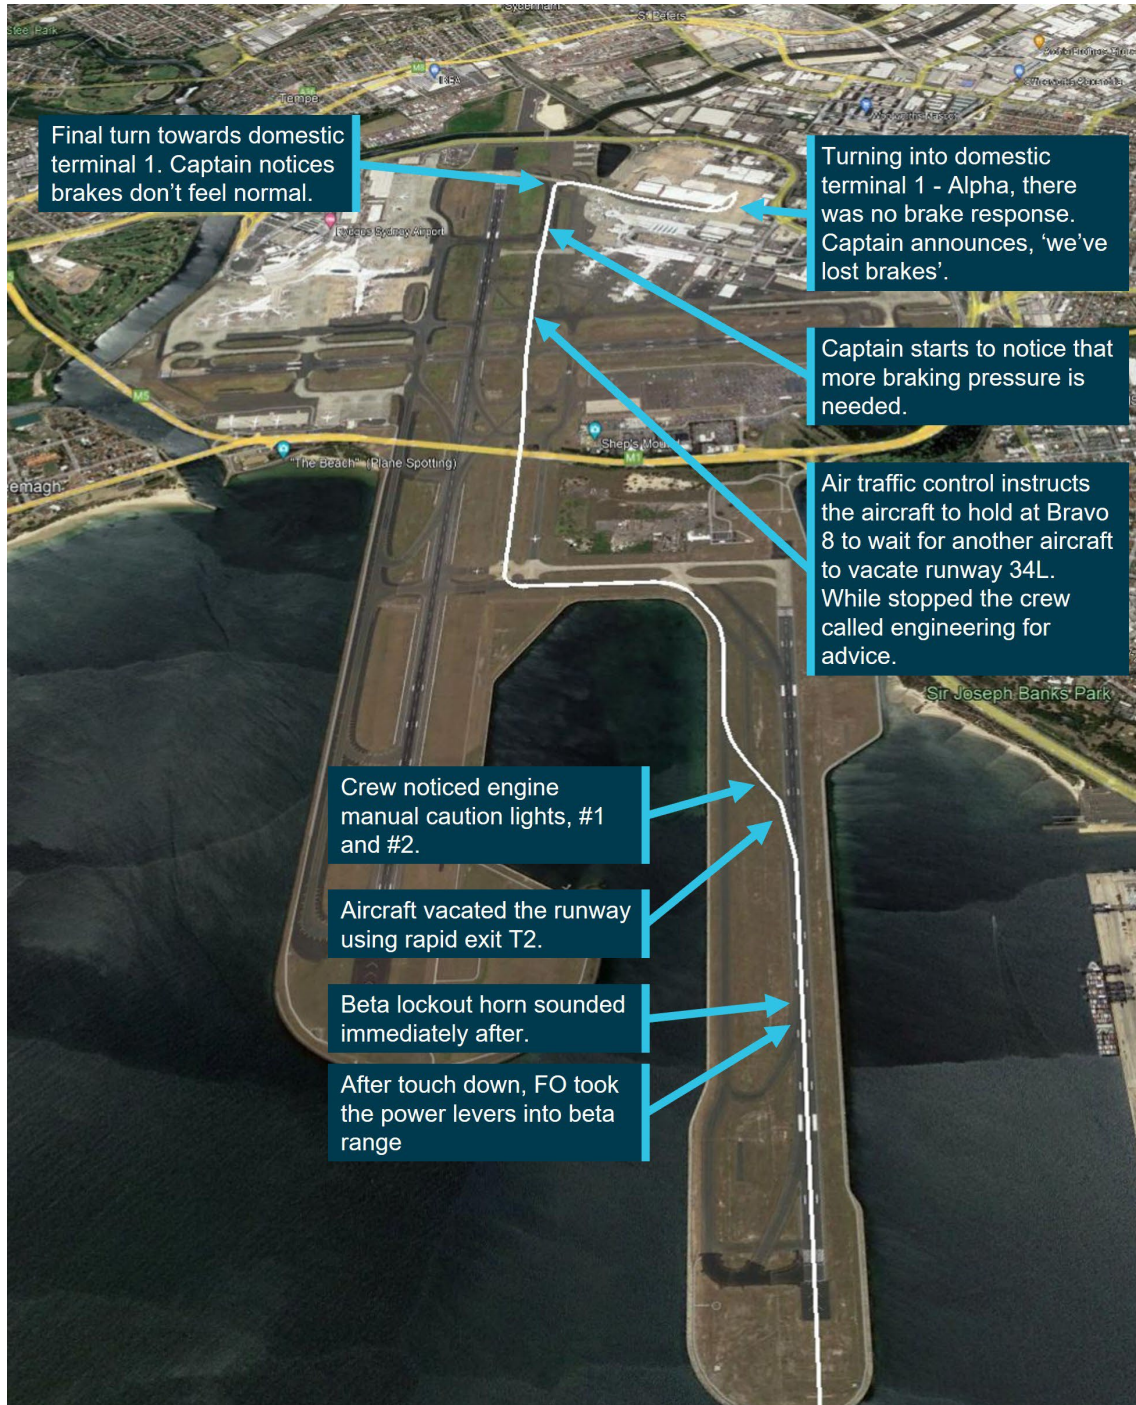
After about 3.3 km of taxiing, the aircraft reached the bravo 8 holding point (Figure 2). The captain brought the aircraft to a stop as air traffic control had instructed them to hold. While stopped, the flight crew contacted engineering support seeking advice on the dual engine manual condition. However, engineering was unable to provide advice within the available timeframe.

Once permitted, the taxi continued towards the domestic terminal. From this point, the taxi had a slight downhill slope and the captain started to notice the response from the brakes reducing. The braking performance continued to deteriorate, and during the final turn into the domestic 1A area (Figure 2), after about 5.5 km of taxiing, there was no braking response and the captain verbalised, 'We've lost brakes'. The captain manoeuvred their aircraft to avoid colliding with another aircraft that was turning into a bay, and then brought the aircraft to a stop. At that time, the cabin crew reported via the interphone that there was fire, including visible flames, from both sides of the aircraft. The captain initiated an evacuation at which point the FO referenced the checklist in the QRH. They then exited the aircraft with the fire extinguisher. As the passengers disembarked, the FO went to both landing gear and attempted to extinguish the fires. A short time later, emergency services arrived and extinguished both fires using foam fire retardant.

Following the occurrence, the aircraft was inspected by maintenance personnel. That inspection identified that all 4 main wheels and brakes were heat affected. Several of the brake and wheel components were replaced as a result of the brake fires. Maintenance testing could not replicate the RadAlt fault and the reason for its failure remains unknown.

Figure 2: ADS-B derived flight data showing the track of the aircraft on the ground at Sydney and the location of the brake failure

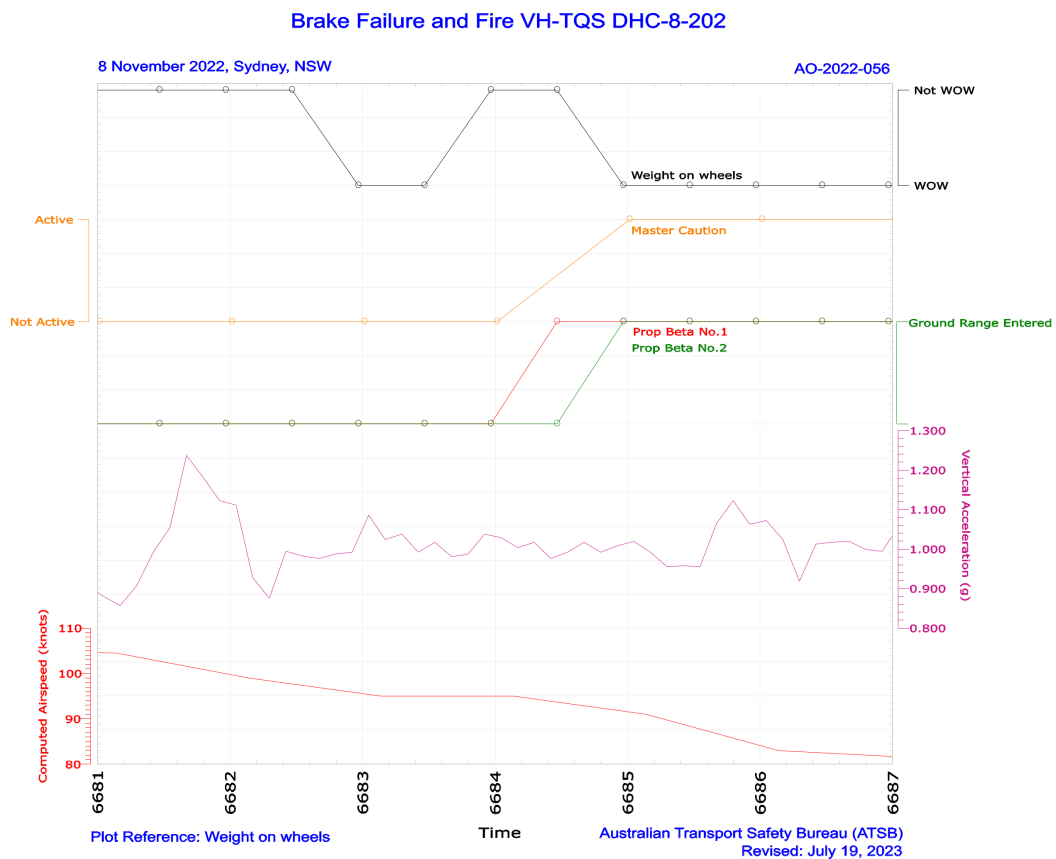
The data showed that the WoW system indicated an on-ground condition on initial touchdown (black track in Figure 3). One second later, the system recorded an in-air condition for one second, before returning to the on-ground condition for the remainder of the landing sequence. In that one second period in which the WoW returned to the in-air state, the data showed (red and green traces in Figure 3) that both propellers were placed into the beta mode. Coincident with this, the data showed the master caution (orange trace) activating.

Figure 3: Recorded flight data showing the timing of weight on wheels indication in relation to when the propellers were placed into beta mode

The flight data showed that, in the same second the power levers were retarded to beta range, the WoW sensors recorded a momentary 'in-air' condition. With the system registering an 'in-air' condition while the power levers were in beta range, the beta lockout system activated. The activation of the beta lockout resulted in engine manual caution warnings for both engines as the ECUs reverted to manual mode. Consequently, as the ECUs were not providing the under-speed governing during ground operations, this meant that reverse thrust was not available to slow the aircraft during the landing and subsequent taxi.
