Separation occurrence involving Boeing 737, VH-VZM, and Boeing 737, VH-VZW

Sydney Airport, New South Wales, on 29 April 2023

ATSB Transport Safety Report

AO-2023-022

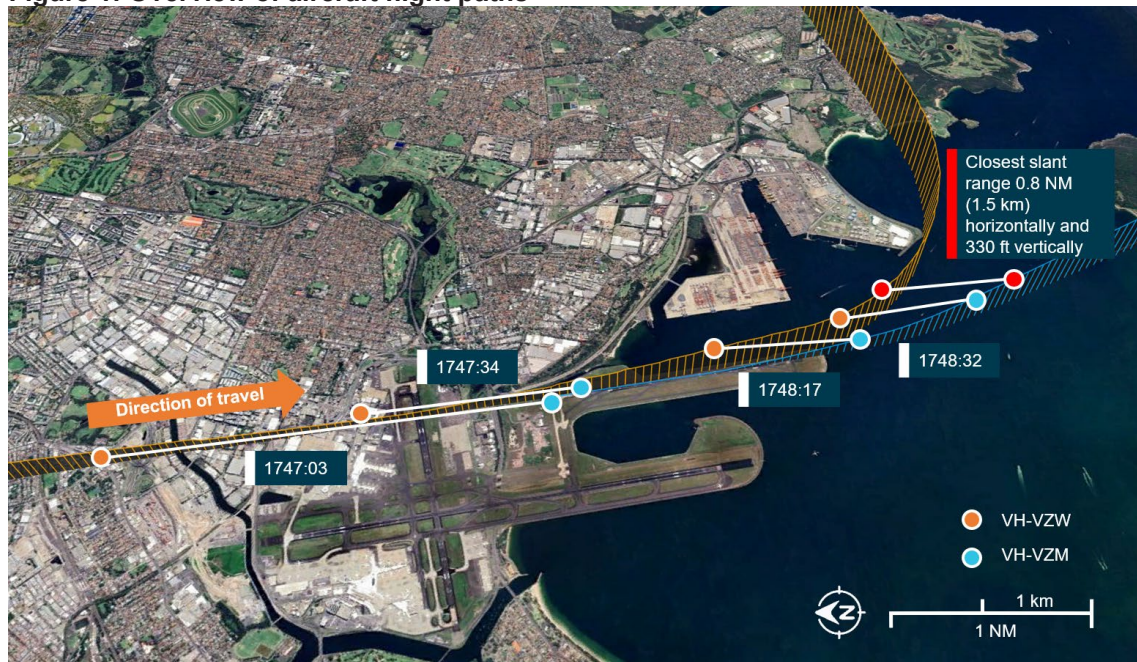
Figure 1: Overview of aircraft flight paths

At 1748:38, the closest slant range between the 2 aircraft occurred, with separation reducing to 0.8 NM (1.5 km) horizontally and 330 ft vertically (Figure 1). Neither crew had visual contact with the other aircraft and no TCAS resolution advisory⁹ or traffic advisory¹⁰ was triggered. The controllers had both aircraft in sight throughout the occurrence, and the ATSB later assessed that the visual and surveillance information available to the controllers in the tower, accounting for the possibility of visual errors, was sufficient for visual separation¹¹ to be maintained.

White lines link the locations of the two aircraft at the same point in time.
Source: Google Earth, annotated by the ATSB

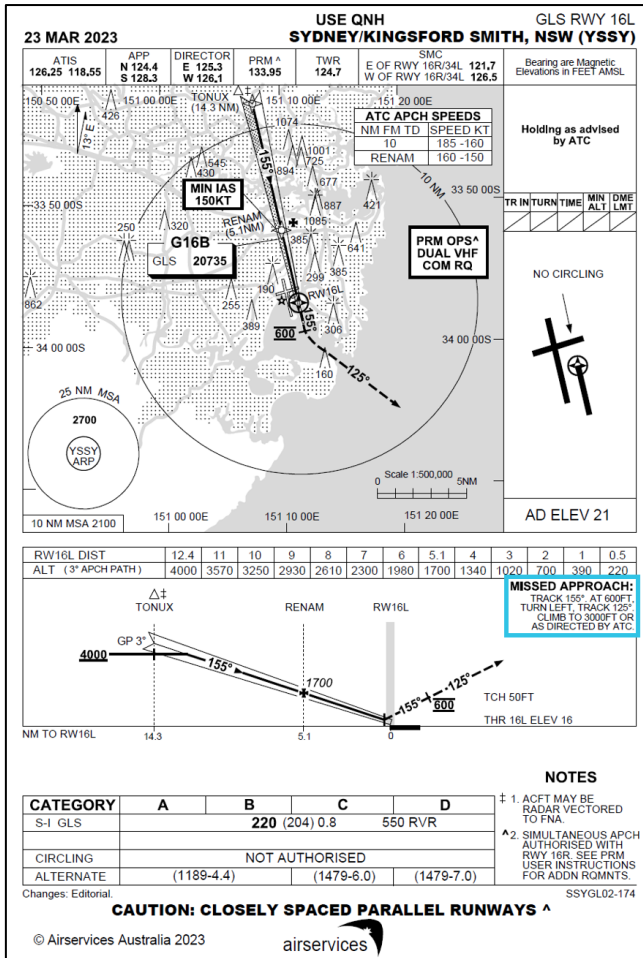
Figure 2: Sydney GLS runway 16L approach chart with missed approach requirements (blue box)

A missed approach procedure provides instrument flight rules¹⁵ aircraft with terrain and obstacle clearance along the missed approach path during a go-around. The flight crew of VH-VZW were flying a GBAS landing system (GLS) approach for runway 16L. In the event of a go-around, the missed approach procedure required a flight crew to initially climb to 600 ft and then execute a left turn onto a heading of 125° (Figure 1). The crew were then required to climb to 3,000 ft or as directed by air traffic control.
