# Collision with terrain involving Magni M16C Tandem Trainer gyroplane, G1850, while avoiding Extra EA 300L, VH-IOG

Lake Macquarie Airport, New South Wales on 12 May 2023

**ATSB Transport Safety Report**

AO-2023-024

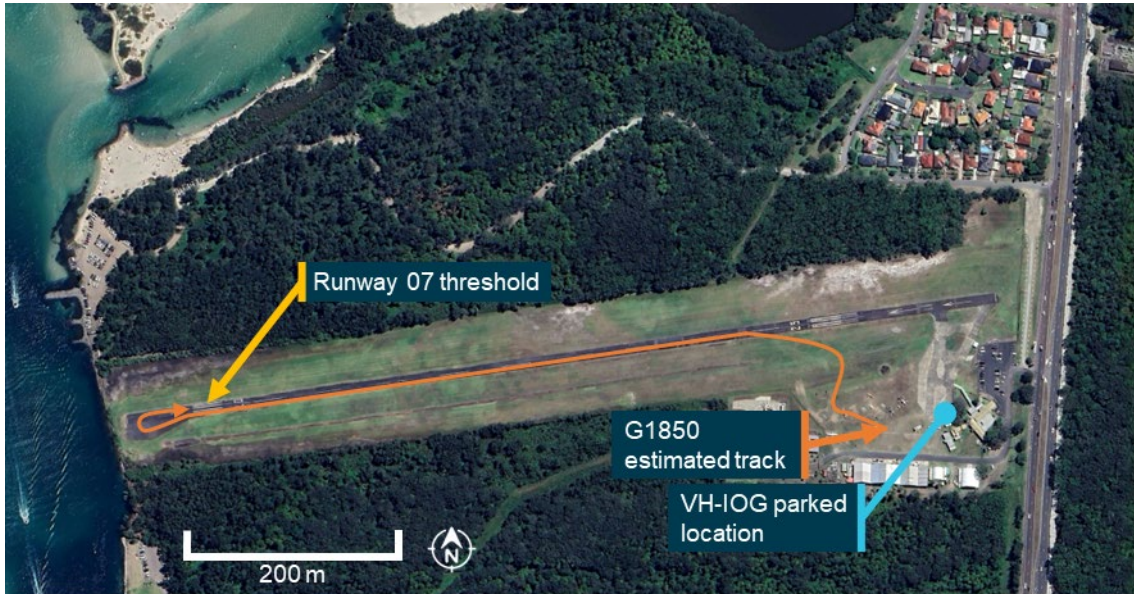
**Figure 1: Lake Macquarie Airport showing G1850 estimated ground track and VH-IOG location**

*G1850 track estimated using CCTV footage and pilot statements. VH-IOG location based on CCTV footage.  
Source: Google Earth, annotated by ATSB*

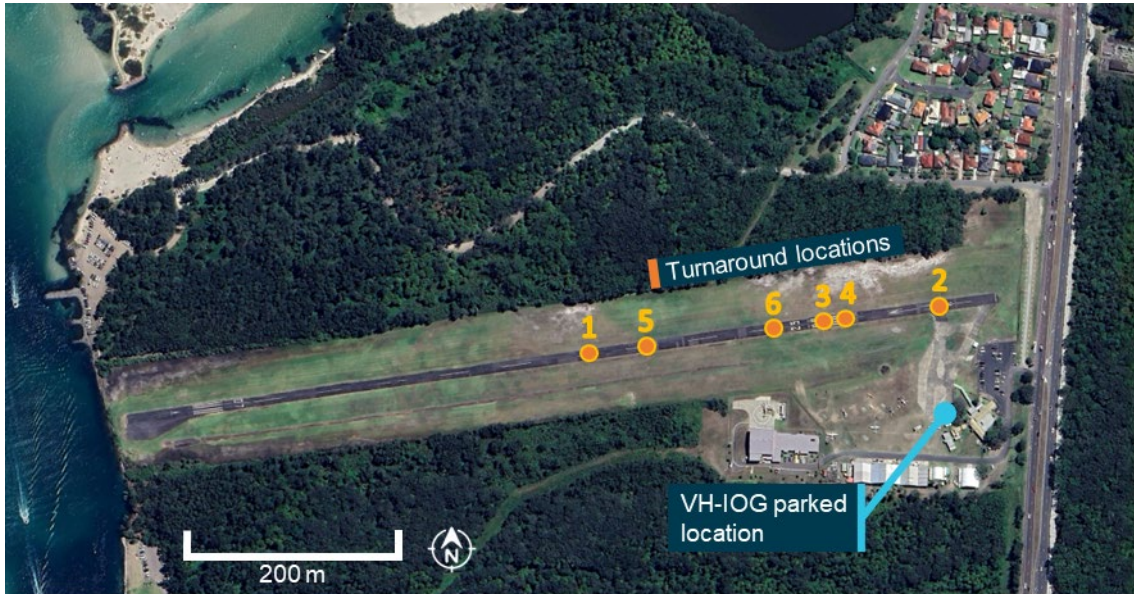
**Figure 2: G1850 turnaround locations**

Over the next 8 minutes, the Extra’s pilot secured the passenger in their seat, provided a pre-flight briefing, and then climbed into the rear seat, putting their seatbelt and helmet on. During this time, the instructor and student pilot performed a further 4 wheel balance exercises, with the gyroplane turning around at different locations along the runway (Figure 2), but none as far as during the second wheel balance exercise (near the airport apron). The student pilot and instructor recalled radio calls being made prior to the commencement of, and during the turnaround at the end of, each wheel balance exercise.

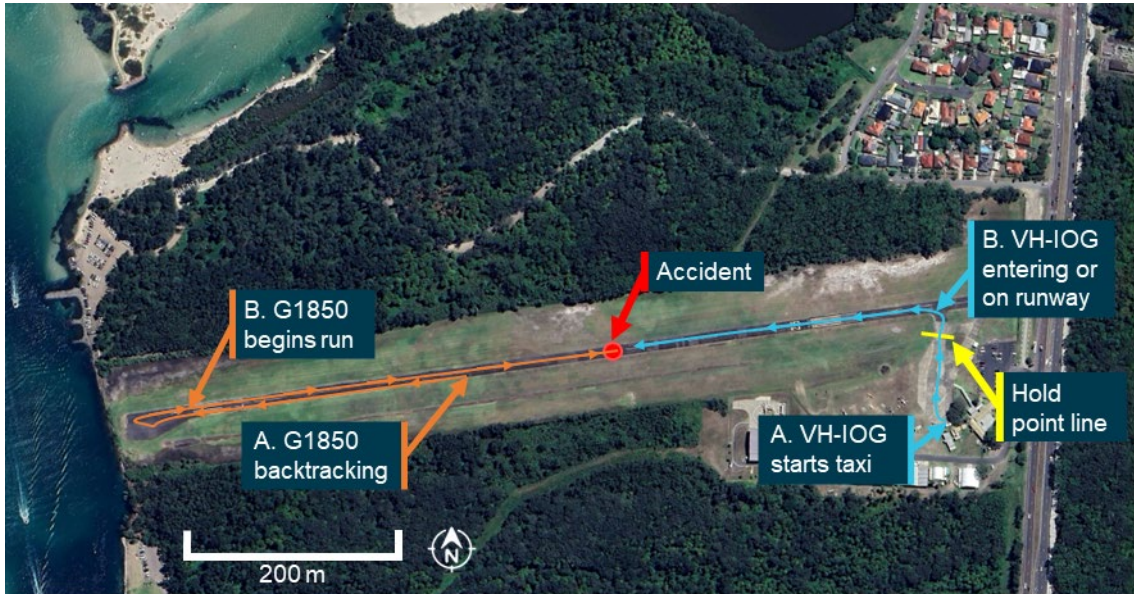
Figure 3: G1850 and VH-IOG ground tracks before accident

As the Extra backtracked runway 07, the student was accelerating the gyroplane along the runway. About 30 seconds later, as the gyroplane approached the midpoint of the runway, the instructor and student observed the Extra about 20 m ahead and backtracking towards them. The instructor took control and banked the gyroplane right to avoid a collision. The rotor blades impacted the runway surface before the gyroplane veered off the runway and collided with terrain, coming to rest on its side. The gyroplane sustained substantial damage to the rotor blades, propeller blades, and landing gear. The instructor was seriously injured, with the student sustaining minor injuries. The Extra pilot saw the gyroplane veer off the runway to the left, stopped their aircraft and exited to provide assistance. The Extra was not damaged and its occupants were uninjured.

Labels 'A' and 'B' are timestamps for the approximate locations of each aircraft.  
Source: Google Earth, annotated by ATSB

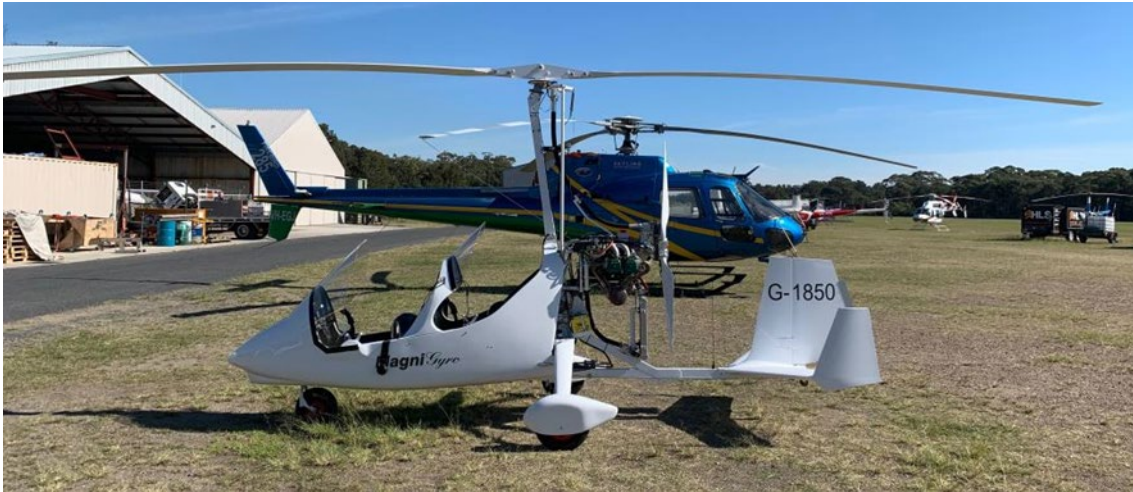
**Figure 4: G1850**

The Magni M16C Tandem Trainer is a 2-seat gyroplane with fixed tricycle landing gear (Figure 4). A 4-cylinder piston engine drives a 3-bladed pusher propeller, with an unpowered rotor to develop lift. The gyroplane has a pre-rotation system linking the engine to the rotor which, when engaged, can drive the rotor to start it spinning without needing forward motion.

The Magni M16C is 4.7 m long, 2.7 m high (fuselage about 1.5 m high), and 1.8 m wide, with a rotor diameter of about 8.5 m. An external landing light was fitted to the front of the fuselage with strobe lights fitted to each side of the fuselage and one on the rear of the mast.

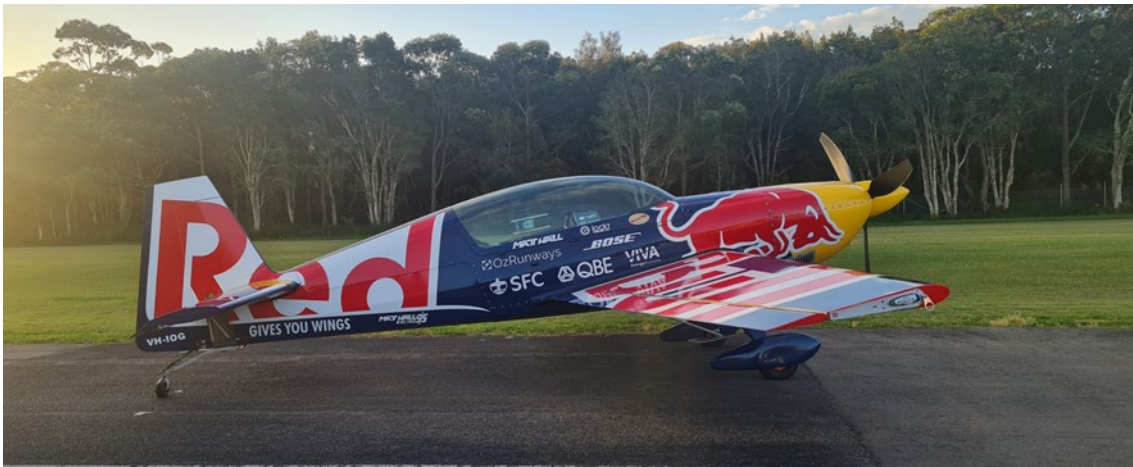
**Figure 5: VH-IOG**

The Extra EA 300L is a low-wing, 2-seat aerobatic monoplane with fixed tailwheel landing gear and the rear seat was instrumented for the pilot in command. A 6-cylinder piston engine drives a 3-bladed tractor propeller. VH-IOG was manufactured in Germany in 1999 and first registered in Australia in June 2005 (Figure 5).

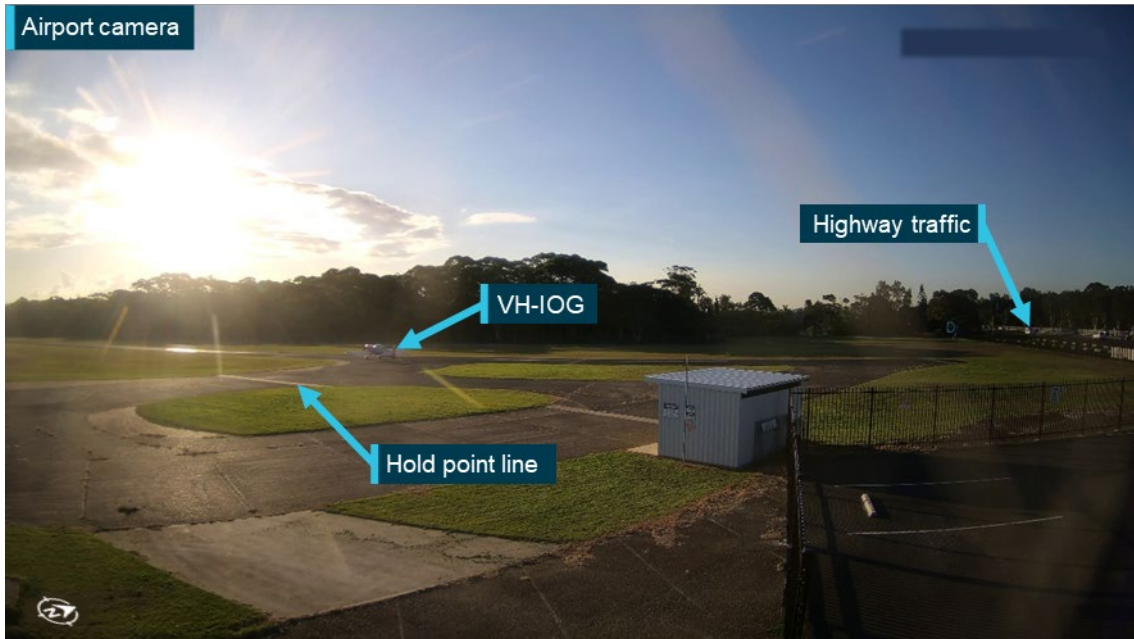
**Figure 6: VH-IOG turning left to backtrack runway 07**

At the time the Extra's pilot was taxiing towards the runway from the apron (heading north), the sun was positioned at about the 10 o'clock (300°) position,<sup>5</sup> at an elevation of about 12°. This would have placed the sun in the pilot's field of view while looking towards the runway 07 threshold (Figure 6). It is likely that the gyroplane would have been illuminated by the sun at this time. The Extra pilot stated that as there was a light wind, a take-off from runway 07 was preferable since the sun was getting low in the west making it difficult to look in that direction. The pilot stated that they were wearing a tinted helmet visor, which would have reduced sun glare.

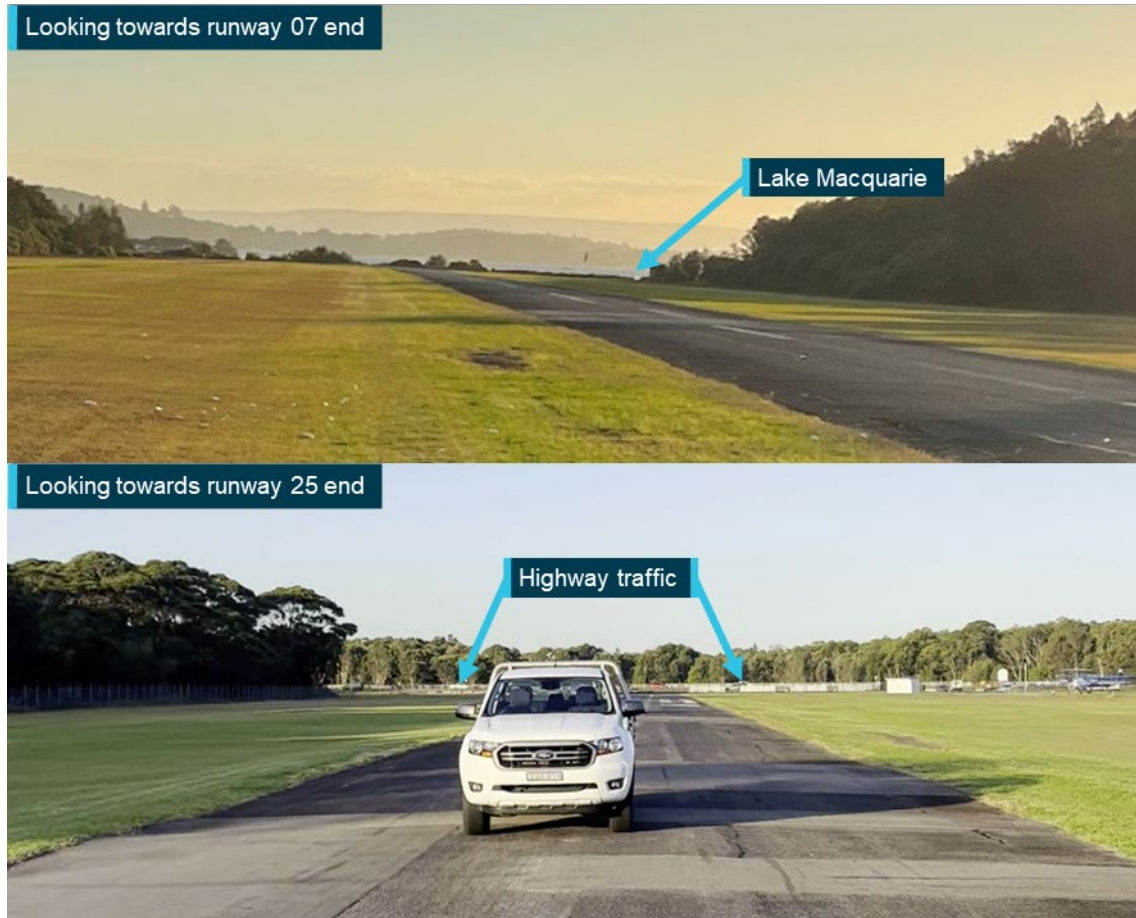
**Figure 7: background features at runway ends**

Detecting an aircraft can become more difficult against a complex background that has different colours, contours, and objects. Aircraft are more easily spotted if they have a high contrast with their background. Images taken from around the midpoint on the runway about 20 minutes after the accident (Figure 7) provided some indication of the background features present at the time of the accident:

- The background behind the runway 07 threshold end had some small dark areas of shrub where the gyroplane's white fuselage illuminated by the sun would have provided good contrast. However, the fuselage and background area covered by the shrub were small, and the light blue of the lake, and lighter terrain areas covered with haze in the distance, would have presented a lower contrast difference with the white fuselage.

- Behind the runway 25 threshold was a highway at the same elevation as the runway, which video footage showed was busy with traffic around the time of the occurrence, with trees illuminated by the sun behind the highway. Although the Extra's yellow nose and spinner would have been illuminated by the sun during the wheel balance exercise, the background behind the Extra had the sideways motion of traffic at the same level as the Extra creating a more complex scene. In addition, the trees in the background were also illuminated by the sun potentially reducing the contrast of the nose and spinner as the Extra moved closer to the gyroplane.
