# Engine room fire on board *MPV Everest*

Southern Ocean, 5 April 2021

**ATSB Transport Safety Report**

MO-2021-003

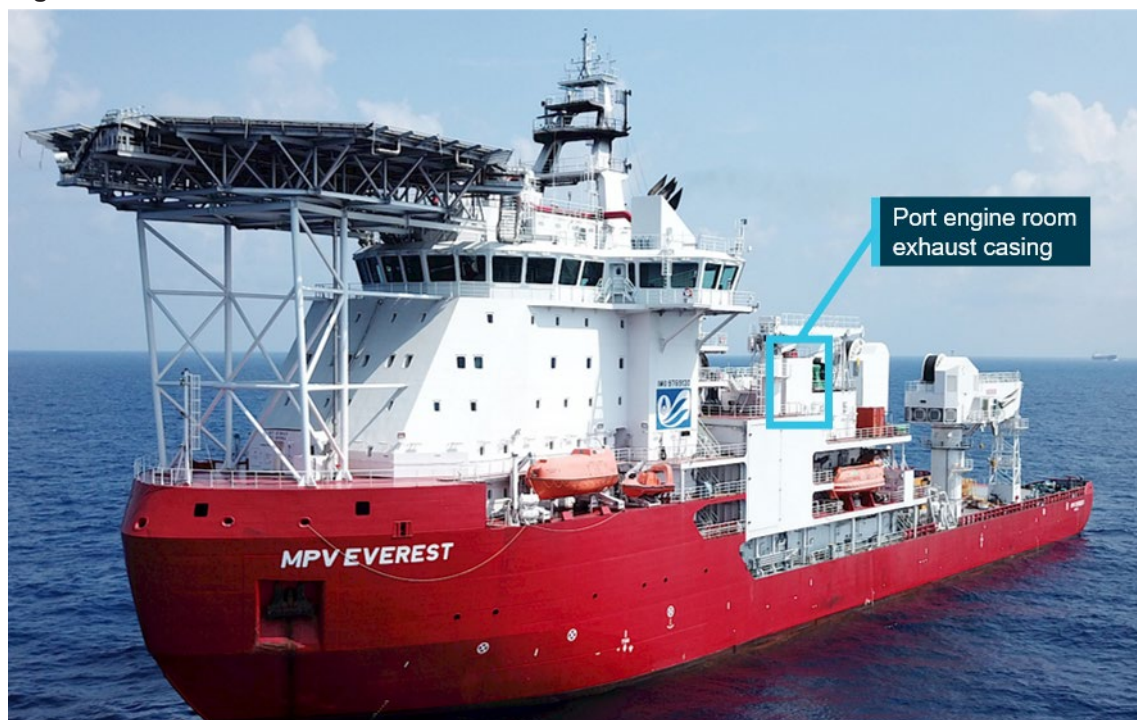
**Figure 3: MPV Everest**

Note the location of the port engine room exhaust casing above deck.

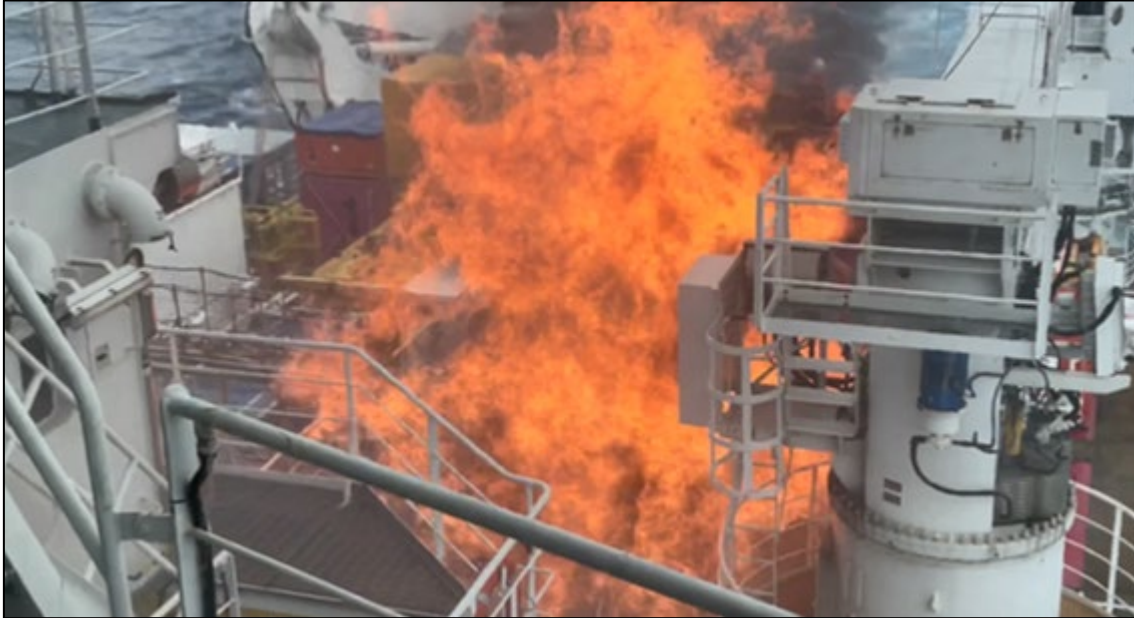
The flames quickly engulfed two rubber watercraft and equipment stowed inboard of the exhaust vent casing and set them alight (Figure 4). The master hurried up to the bridge and raised the alarm by announcing on the ship's public address system that there was a fire, instructing crew and expedition staff to report to their emergency muster stations. As expedition staff began mustering at their stations on the forecastle deck, the ship's crew were preparing fire-fighting equipment and hoses.

**Figure 4: Flames from the port engine room exhaust casing**

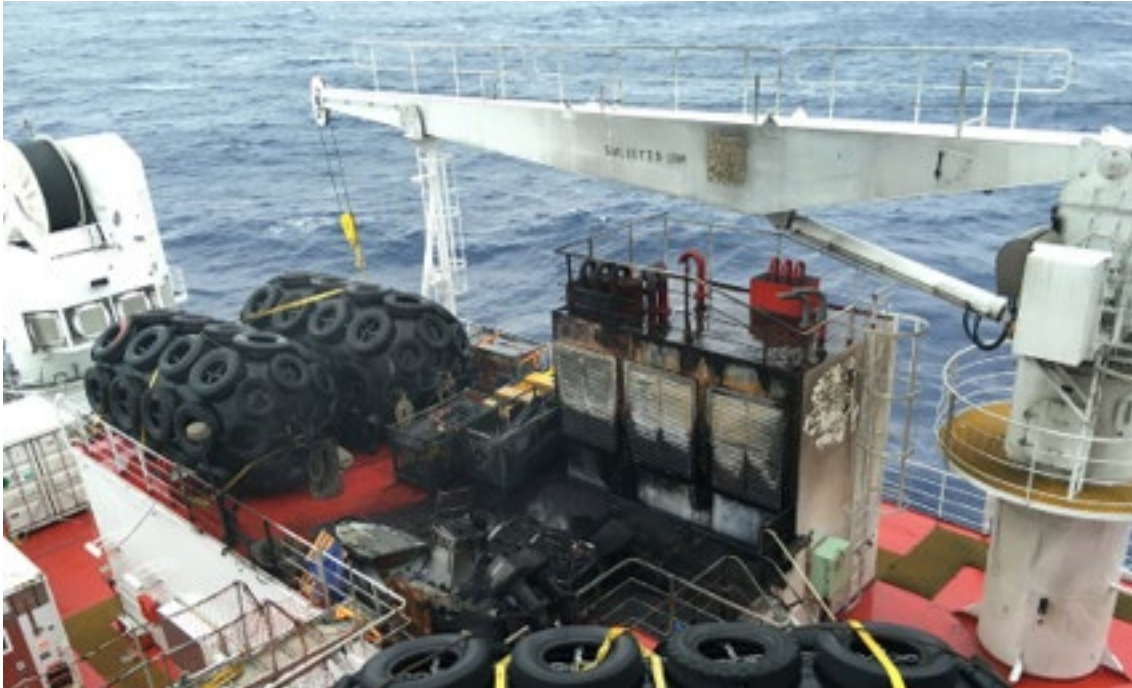
The fire resulted in two AAD watercraft being destroyed on deck along with some other associated equipment in the vicinity (Figure 5). The fire also resulted in substantial damage to the port engine room including to machinery and electrical cabinetry (Figure 6).

**Figure 5: Fire damage on deck including the burnt-out watercraft adjacent to the casing**

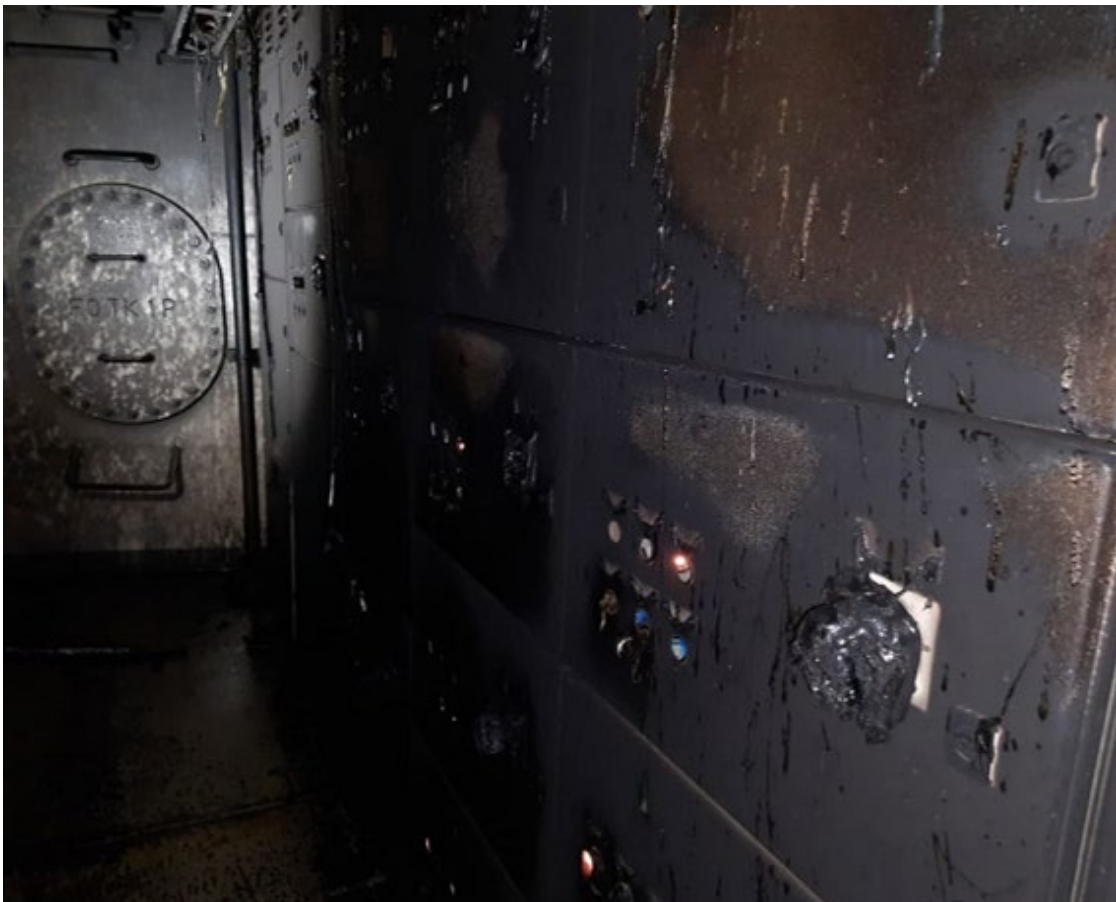
**Figure 6: Fire damage inside the port engine room**

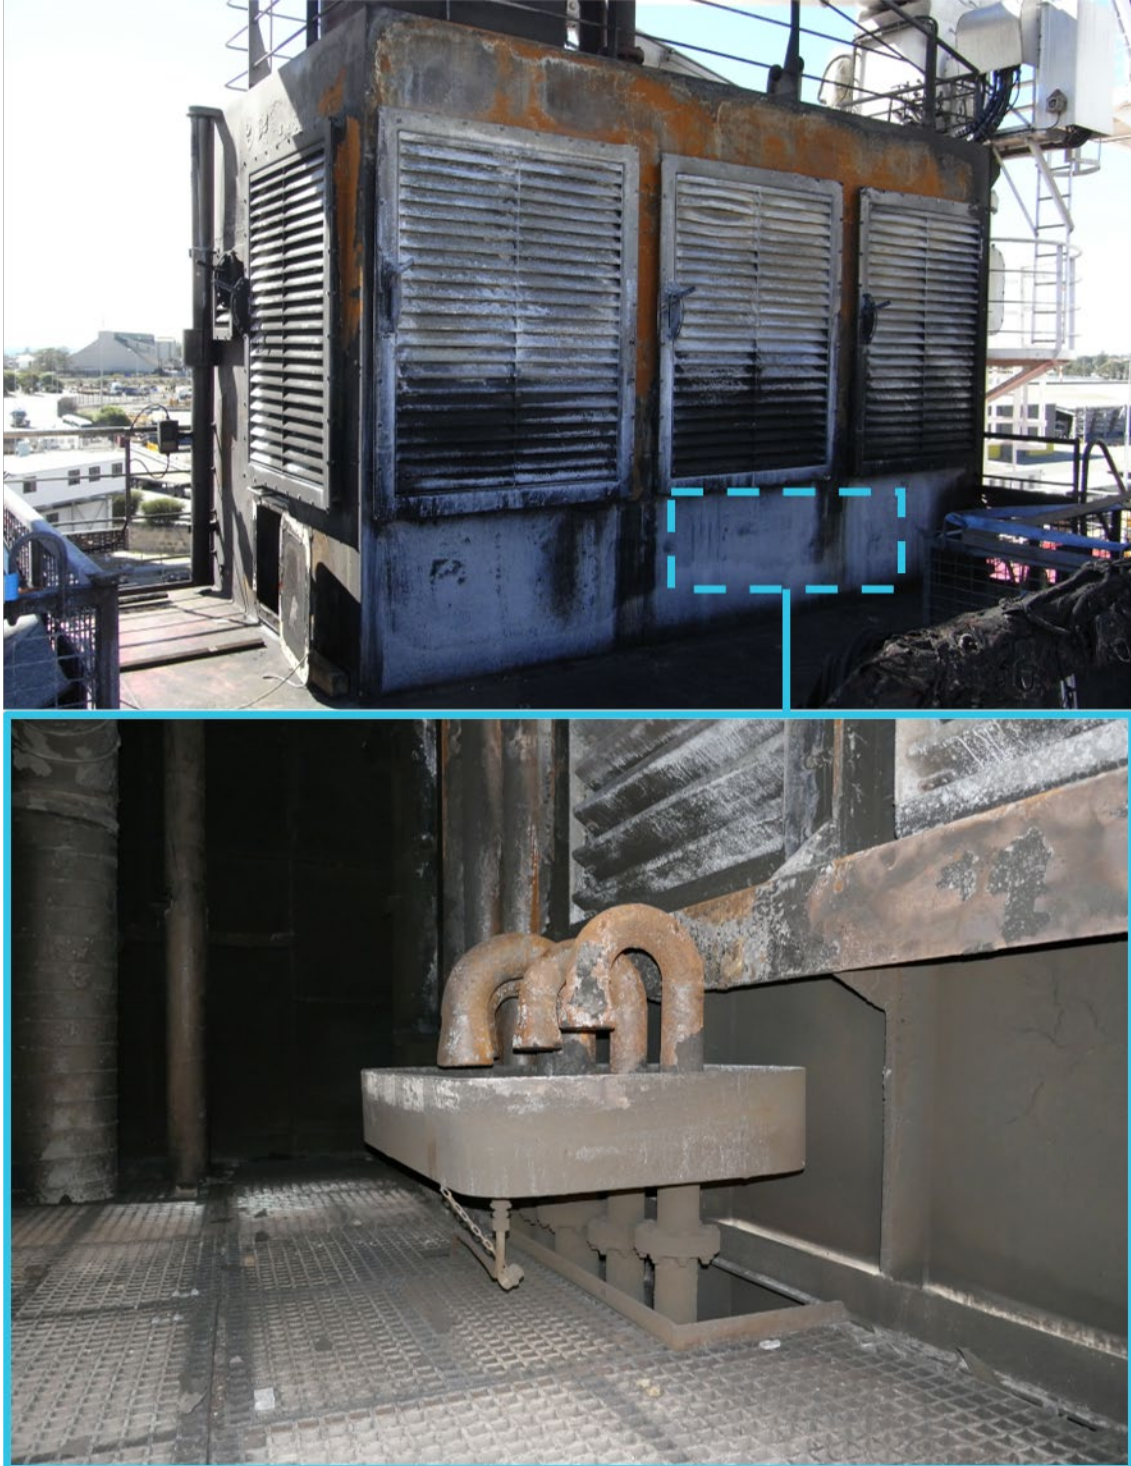
During initial inspections of the fire-damaged engine room, the crew observed fuel oil dripping down into it from within the exhaust vent casing above. In addition to the exhaust piping for the engines, air vent pipes for several engine room fuel oil tanks and other spaces are situated within

the casing. Some of these vent pipes terminate on top of the casing while others terminate internally within the casing (Figure 7). Those that terminated inside the casing, included the port fuel oil settling tank that was being filled on the morning of the fire. The IAS data indicates that this tank probably overflowed sometime after 1030 that morning.

**Figure 7: Port engine room exhaust casing (inset photo: close up of internal vent pipes)**
