ATSB TRANSPORT SAFETY REPORT

MO-2011-001

**Thermal oil heater explosion on board the
products tanker**

Qian Chi

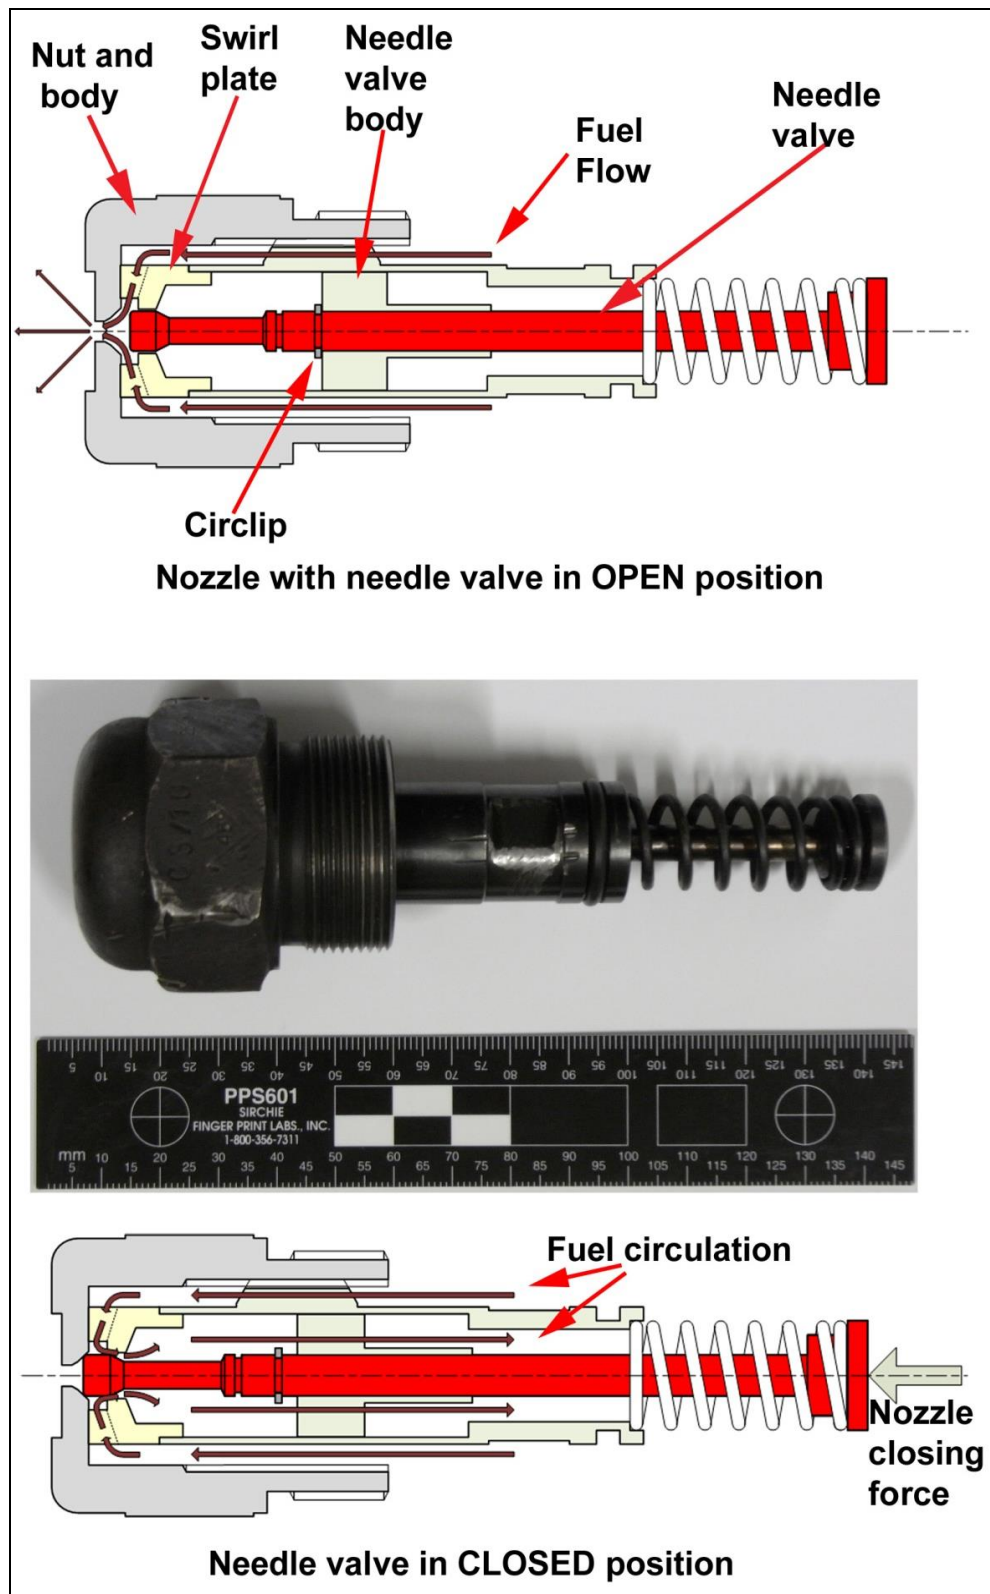
Figure 4: Burner nozzle showing open and closed positions

During the start sequence, fuel was prevented from entering the combustion chamber by the needle valve in the spray nozzle (Figure 4). The needle valve was held closed by a solenoid actuated operating rod acting on the top of the needle valve stem (nozzle closing force).

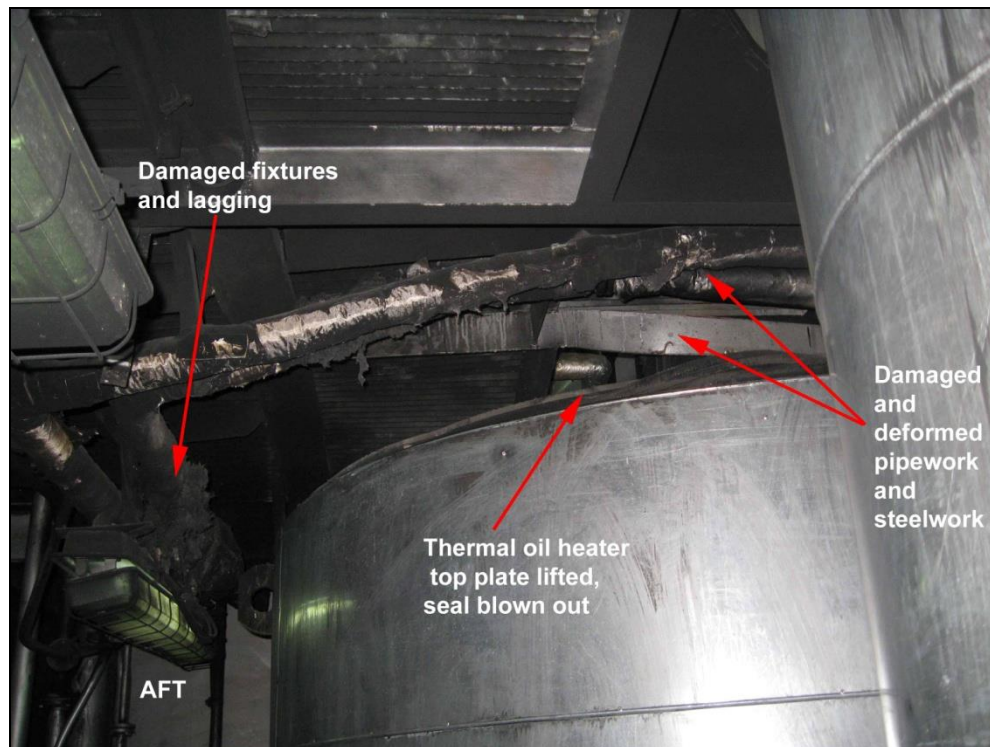
Figure 7: Thermal heater top damage – including lifted top plate, bent steel and piping and damage to fixtures and lagging

The explosion lifted the thermal oil heater casing top (Figure 7). Several securing bolts were snapped as the force of the explosion was released into the upper engine room, the funnel space and out the open access door onto deck. The burner arrangement was pushed out of alignment and the air duct inspection cover fitted to the burner was torn from its four securing bolts. The deck grating and mounting supports were upset about 300 mm vertically. The ducting from the externally mounted forced-draught fan was torn apart at the canvas flexible joint. Fuel lines running across the top of the thermal heater were deformed, and at least one began to leak from a weakened flange.

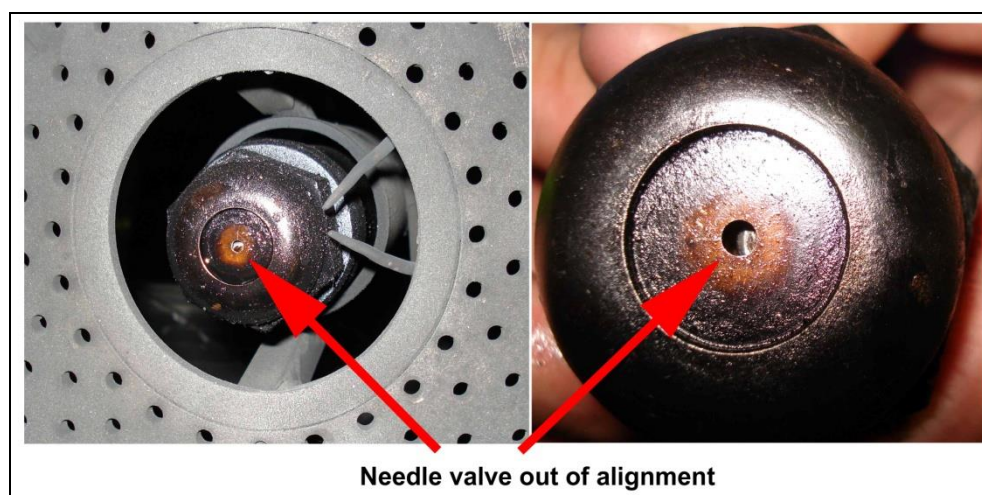
Following the explosion, the ATSB investigators inspected the thermal oil heater, its burner unit and associated systems. As a result of these inspections, the investigators determined that the fuel nozzle needle valve was not seated centrally in the nozzle housing (Figure 9). In that position, it would not have sealed the nozzle opening during the 4 minute pre-firing sequence immediately before the explosion.

Figure 9: Nozzle showing the misalignment of needle valve

Therefore, throughout the 4 minute pre-firing sequence, fuel would have been spraying from the nozzle into the thermal oil heater furnace while the forced-draught fan was supplying fresh air to the furnace in an attempt to purge it of combustion gases.

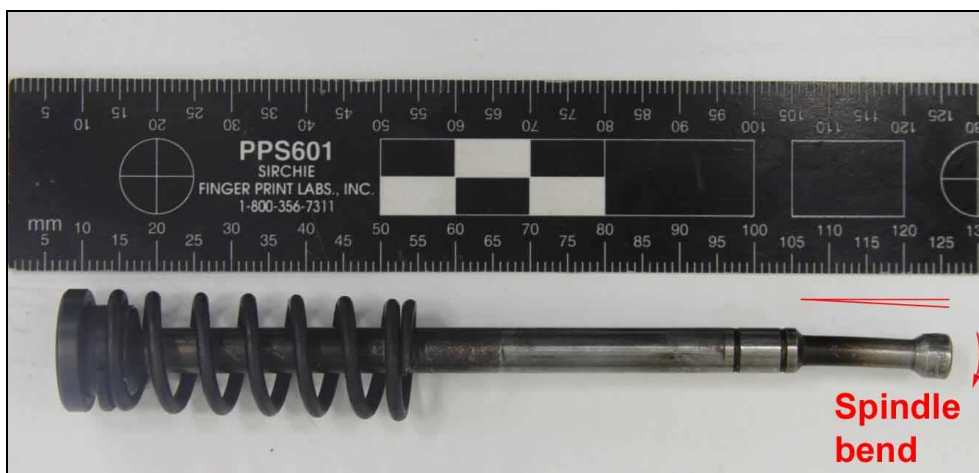
During the investigation, the nozzle was removed from the burner lance and inspected. The inspection revealed that the needle valve head was offset within the nozzle orifice and the nozzle spring was compressed about 7 mm more than was measured on a spare nozzle. Upon dismantling, the needle valve stem was found to be bent about 20 mm above the valve head (Figure 10).

Figure 10: Nozzle needle valve with bend

The nozzle was retained by the investigators and examined in detail in the ATSB's technical analysis laboratory. This examination revealed markings consistent with incorrect assembly. These included:

- circular surface impressions in the upper ring of the swirl plate consistent with the diameter and thickness of the lower ring of the needle valve body;
- galling on the valve head, on the opposite side to the direction of bending in the valve stem; and
- witness marks on the tapered inner bore of the swirl plate matching the galling on the valve head. These marks were of the same size as the galling on the valve head and were diametrically opposite the surface impression in the upper ring of the swirl plate.

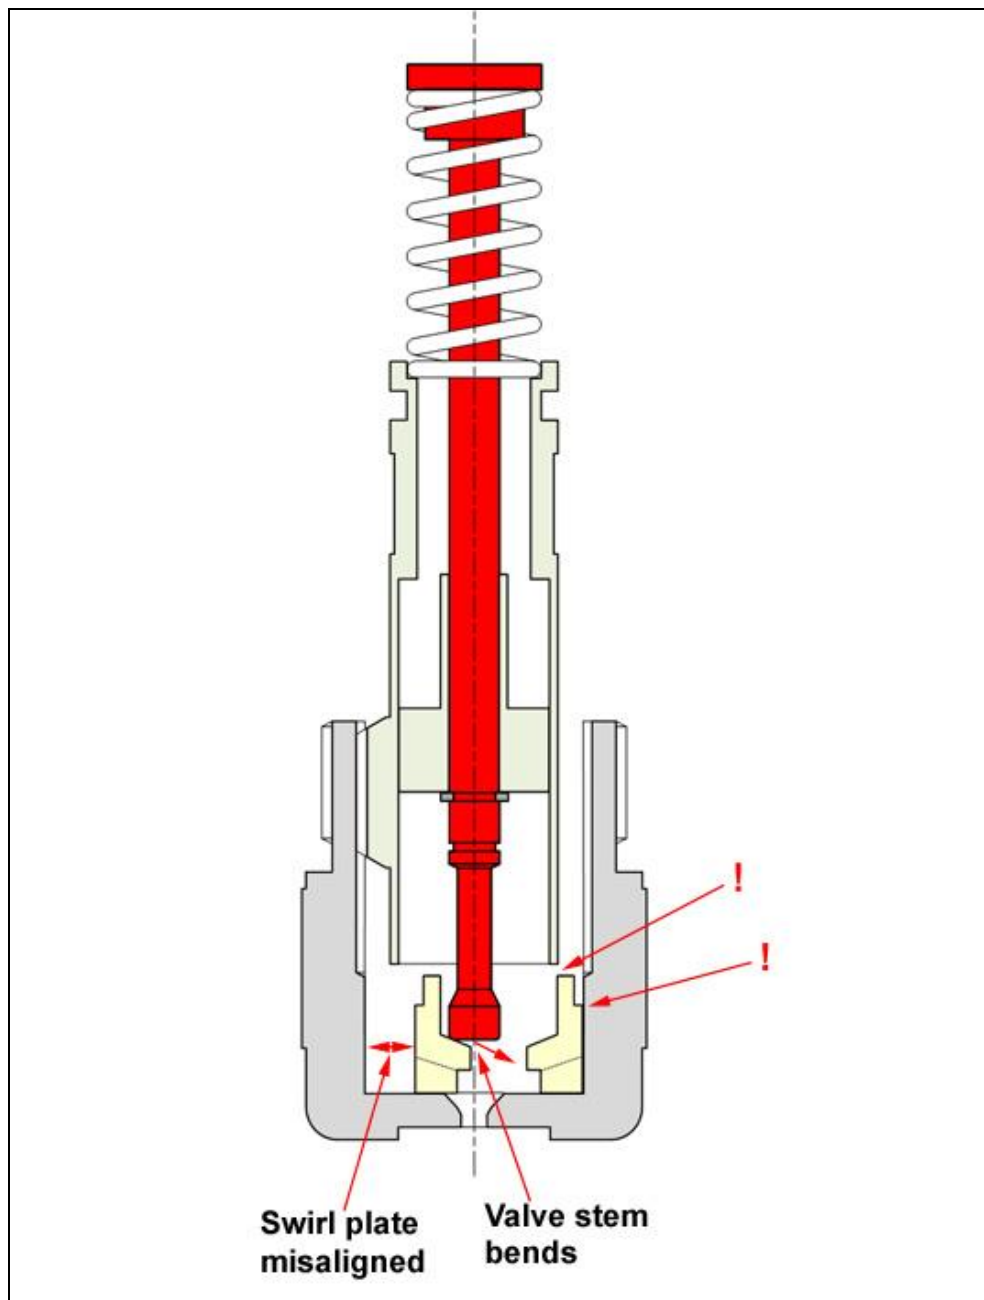
When correctly assembled, the swirl plate should have been located centrally in the valve body. However, the swirl plate was 6 mm smaller in diameter than the surrounding internal diameter of the nozzle nut. If assembly of the nozzle was not carried out correctly, this clearance could result in misalignment of the valve stem and the swirl plate (Figure 11).

Figure 11: Burner nozzle showing misalignment of the needle valve head in the swirl plate

It is likely that this is what occurred during the nozzle assembly on the day of the incident. Then, when the nozzle was fitted to the lance, the needle valve head contacted the tapered internal surface of the swirl plate. As the nozzle was tightened into the lance, the closing force on the end of the needle valve overstressed the valve stem bending the head of the needle valve. The misaligned swirl plate and valve body allowed the valve head to jam in the swirl plate orifice. This resulted in the excessive compression of the nozzle spring found when the nozzle was initially inspected.

Because of the misalignment and resulting bend in the valve stem, the nozzle was never able to shut off the flow of fuel. Therefore, during the 4 minute start-up cycle, fuel flowed continuously into the furnace.

In any hierarchy of risk controls, the first and best control is to eliminate the risk. In this case, this would have included designing the burner nozzle so that it could not have been assembled incorrectly while maintaining the need for fuel flow and maintenance operations. There were a number of engineering design options which could have been employed to positively locate the swirl plate within the nozzle body and ensure correct alignment with the needle valve and body whilst maintaining sufficient flow paths for fuel circulation.

The ATSB was advised by the China Shipping Development Company that repairs conducted on the ship after the explosion included replacing the burner equipment with a new design from a different manufacturer, but sourced and supplied through a Garioni Naval partner company. The installation of the new burner system included components and alterations to the control system which better reflected the operational needs of the thermal oil heater. These changes significantly reduced the possibility of a furnace explosion of the severity experienced in this incident. This new burner unit, however, included a nozzle of substantively the same design as that of the nozzle described in this report, and supporting documentation of a similar standard.

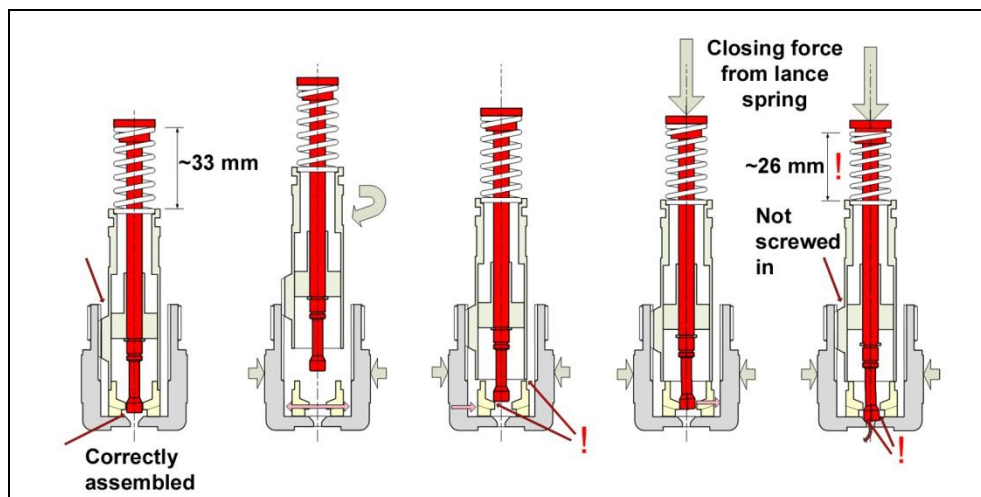
Figure 12: A method of nozzle assembly leading to valve stem bending and leakage

The burner nozzle needle valve performs a critical task in sealing the fuel flow, and preventing leakage, during the burner pre-ignition sequence. Given the possibility of incorrect assembly this arrangement required some means of verifying correct assembly. The lack of clear maintenance instructions and of a suitable apparatus for leak testing meant that acquired knowledge and experience were the only means available at the time. Therefore, when the nozzle was assembled, insufficient experience and a lack of awareness of the intricacies of the seemingly simple component led to an understandable but incorrect method of assembly. There was then no method or means in place to check that the assembly was correct. Consequently, the needle valve stem was bent, the valve failed to seal and the resulting leak provided the fuel for the explosion.

following reassembly should have included, but not been limited to: sighting the correct location of the needle valve through the nozzle hole, verifying the correct length of the nozzle assembly, checking for freedom of movement as the spring was compressed and, desirably, leak testing.
