# Wrong running direction involving passenger train 165-S

Mt Druitt, New South Wales | 12 March 2015

**ATSB Transport Safety Report**  
Rail Occurrence Investigation  
RO-2015-005  
Final – 29 January 2016

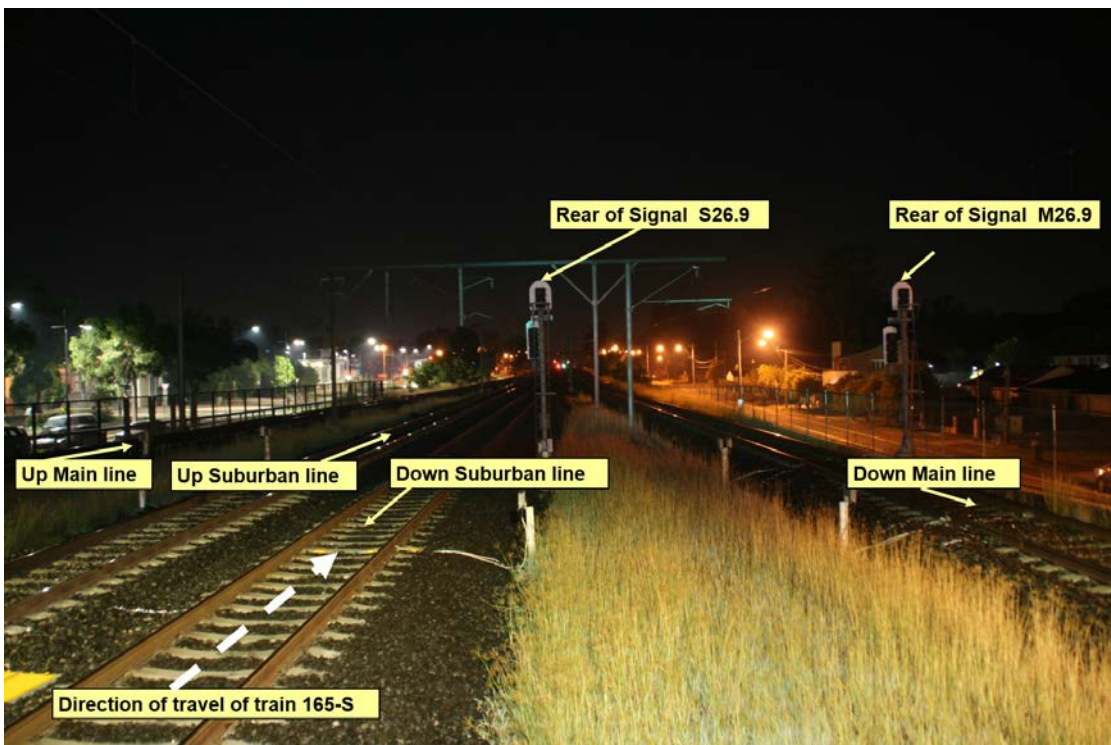
**Figure 1: Night time view from Platform 3 (city end)**

*The white arrow shows the wrong running direction that train 165-S travelled on the Down Suburban line.*

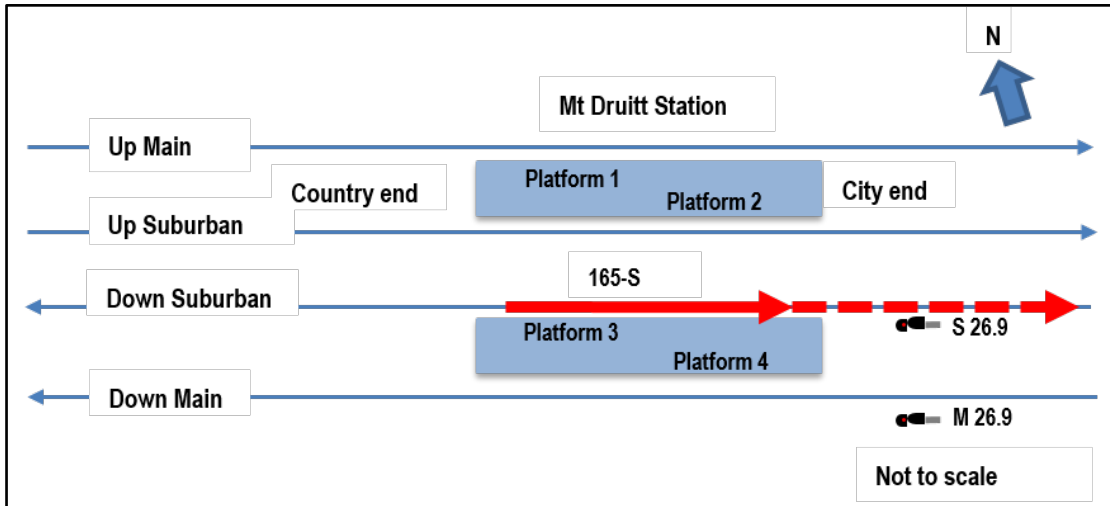
**Figure 3: Line information Mt Druitt**

The red arrow shows the direction that train 165-S travelled on the Down Suburban line.
